Appendix H Supplemental Photographs

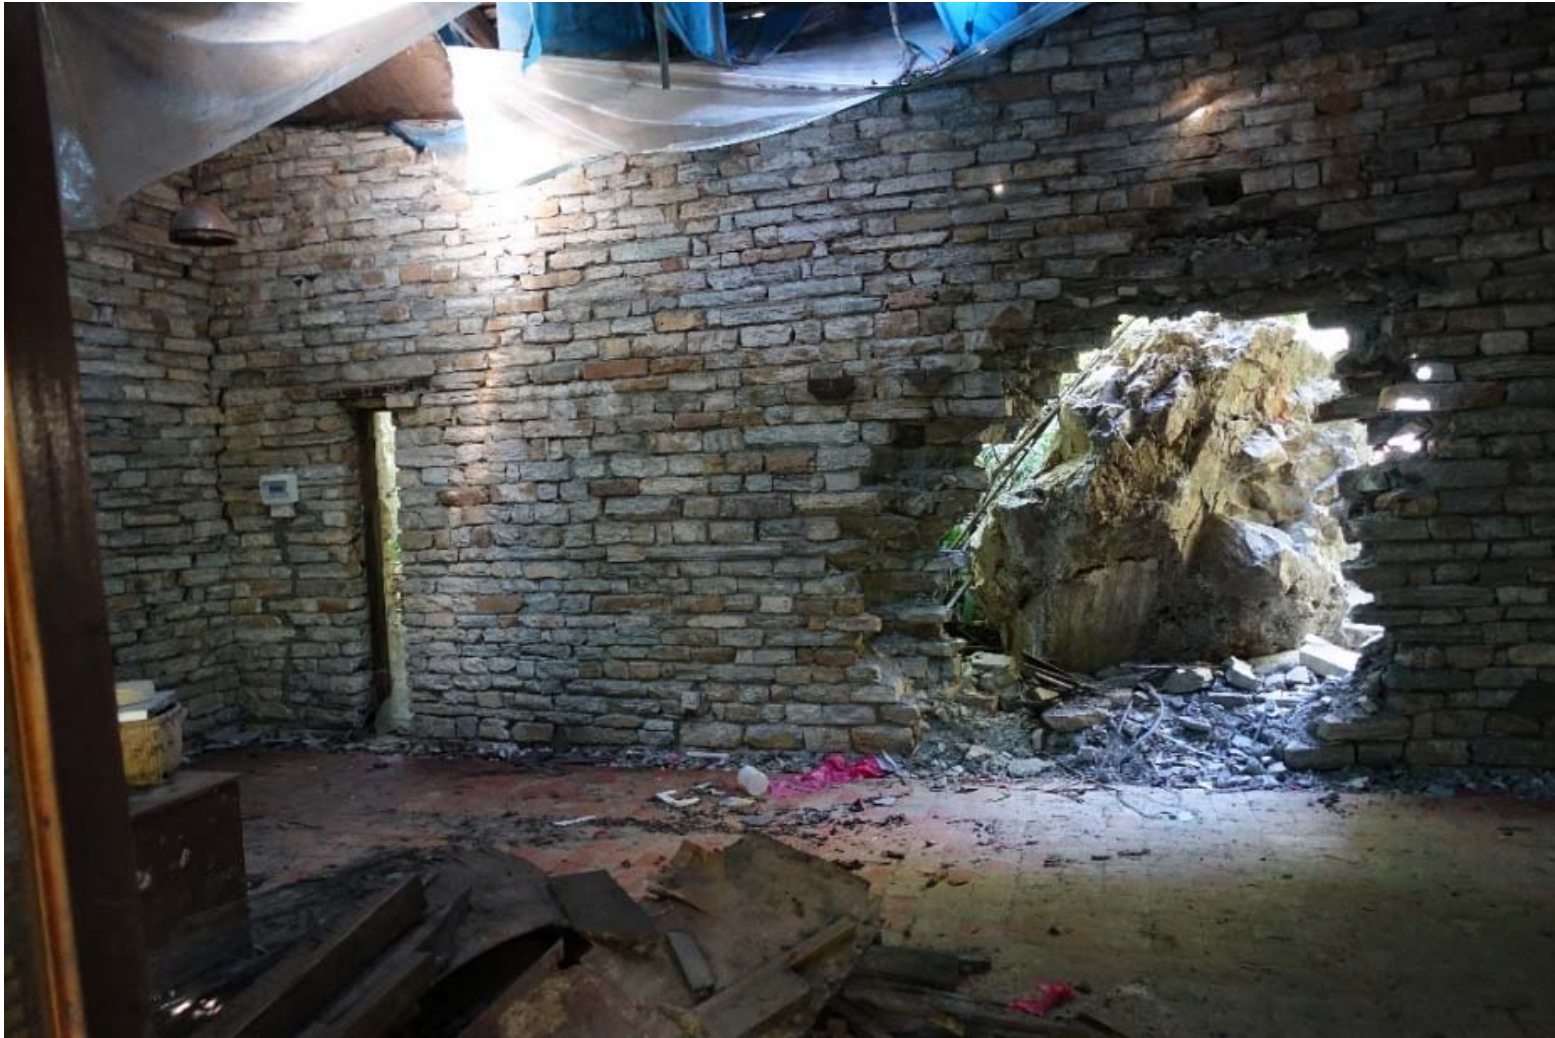
Figure H 1. Brecciated boulder lodged into the back of the spa facility at TLR. Boulder is approximately 2 m tall and 3 m in length. Photograph taken November 13, 2016.

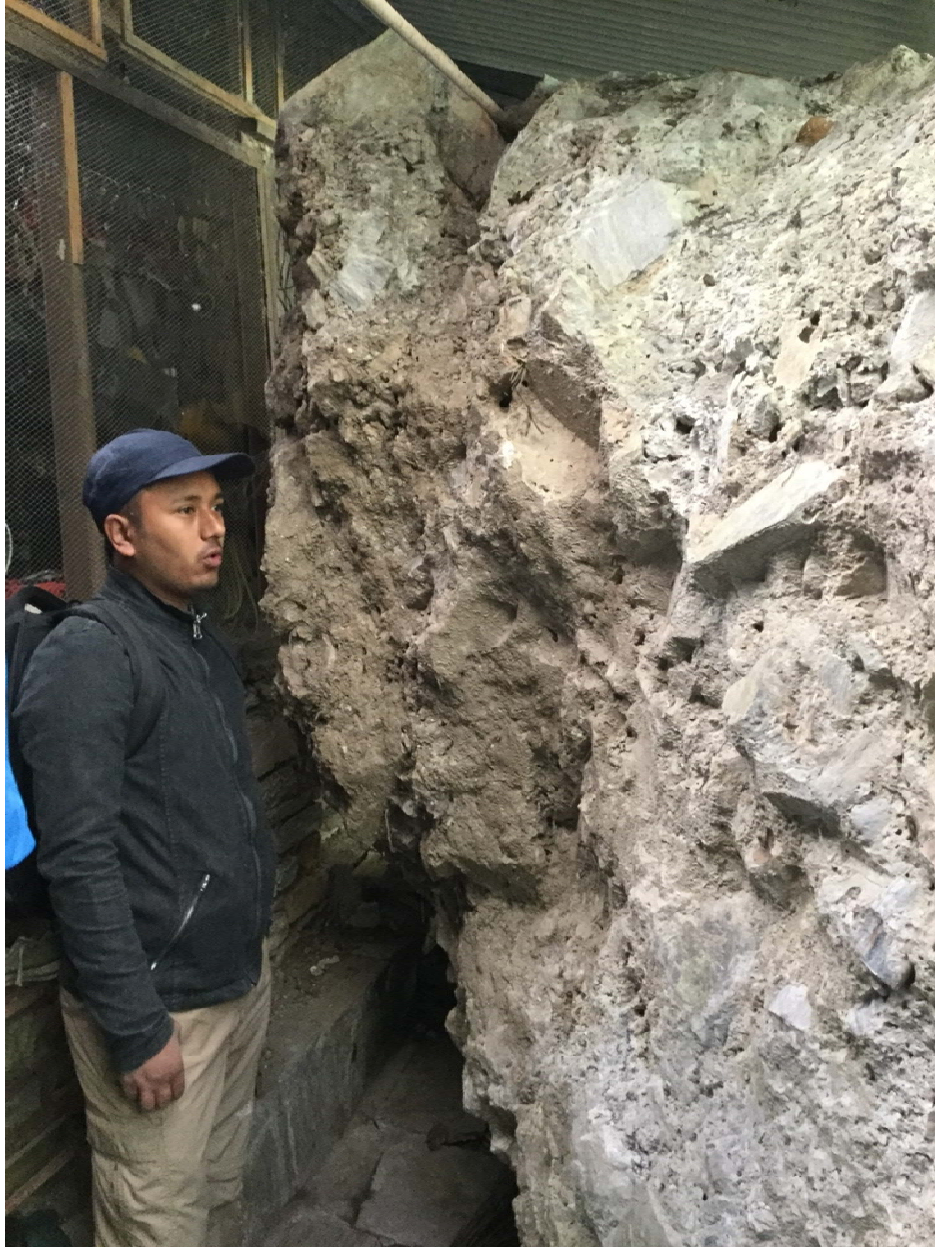
Figure H 2. Rockfall boulder with evidence of tectonic cataclasis that impacted the back of an equipment room at TLR. Photograph taken November 13, 2016.

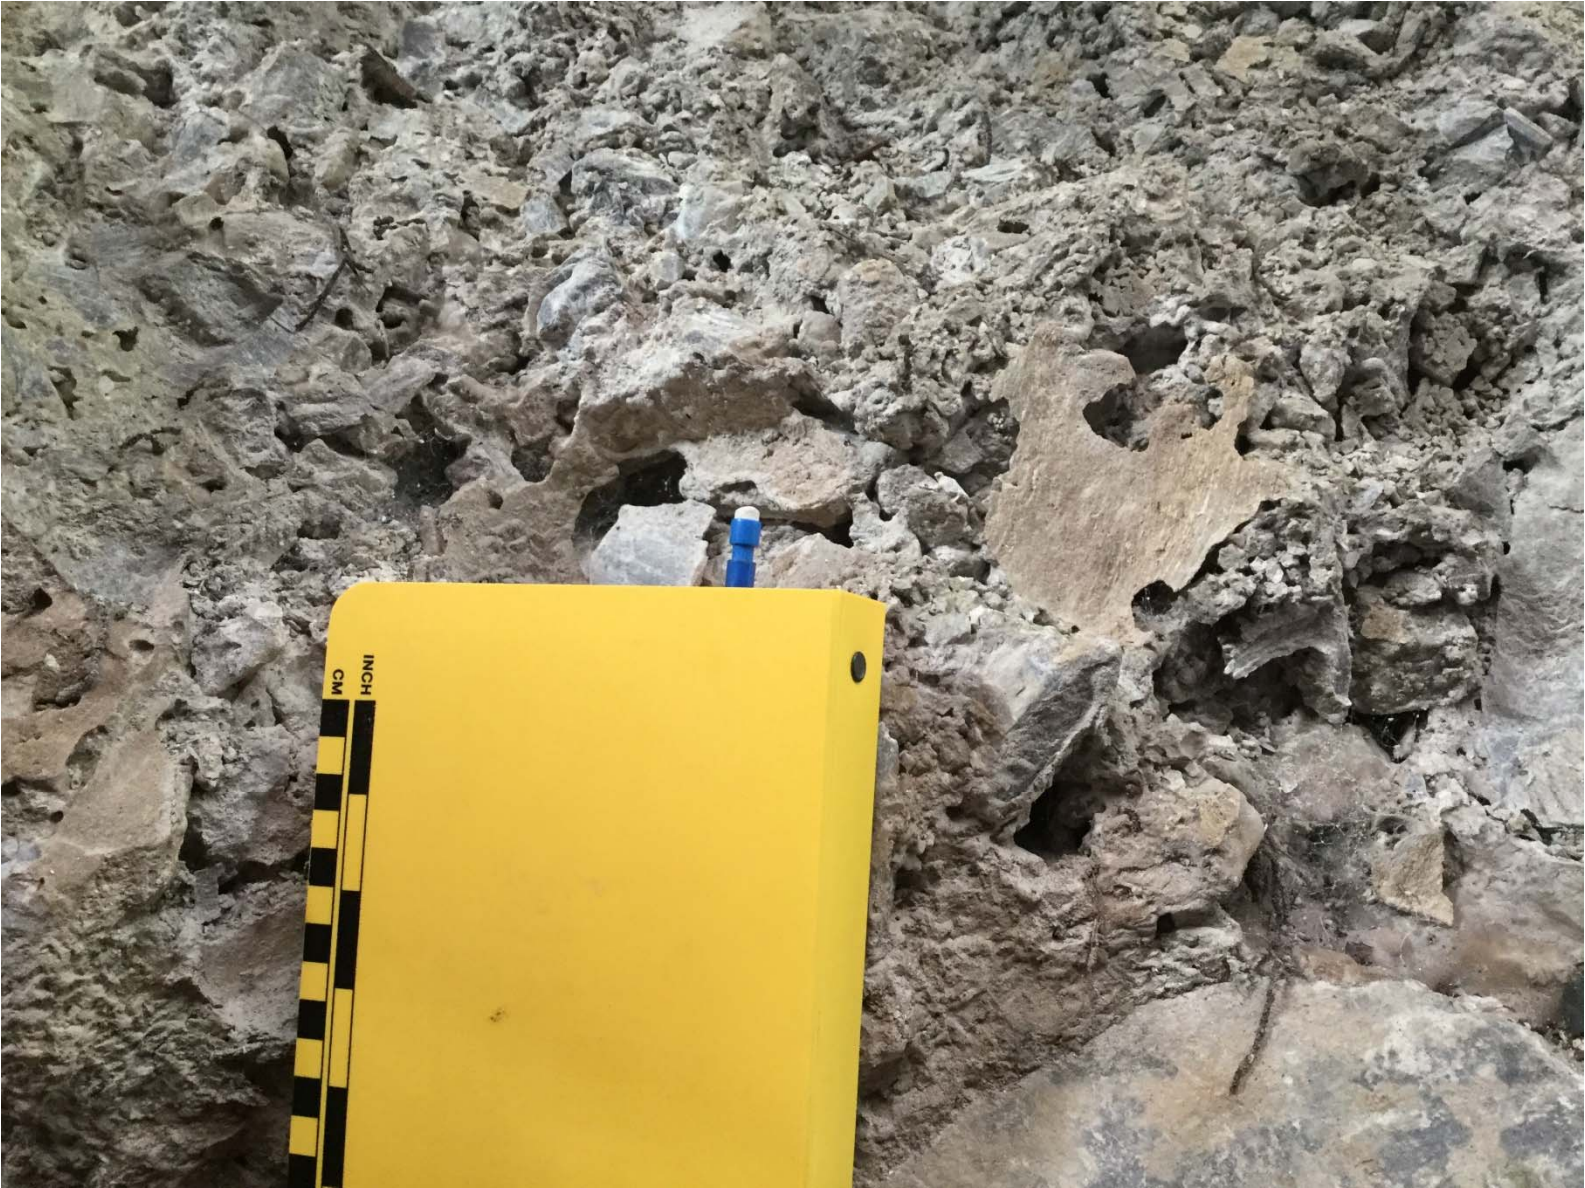
Figure H 3. Close up view of tectonic cataclasis in rockfall boulder at TLR. Photograph taken November 13,2016.

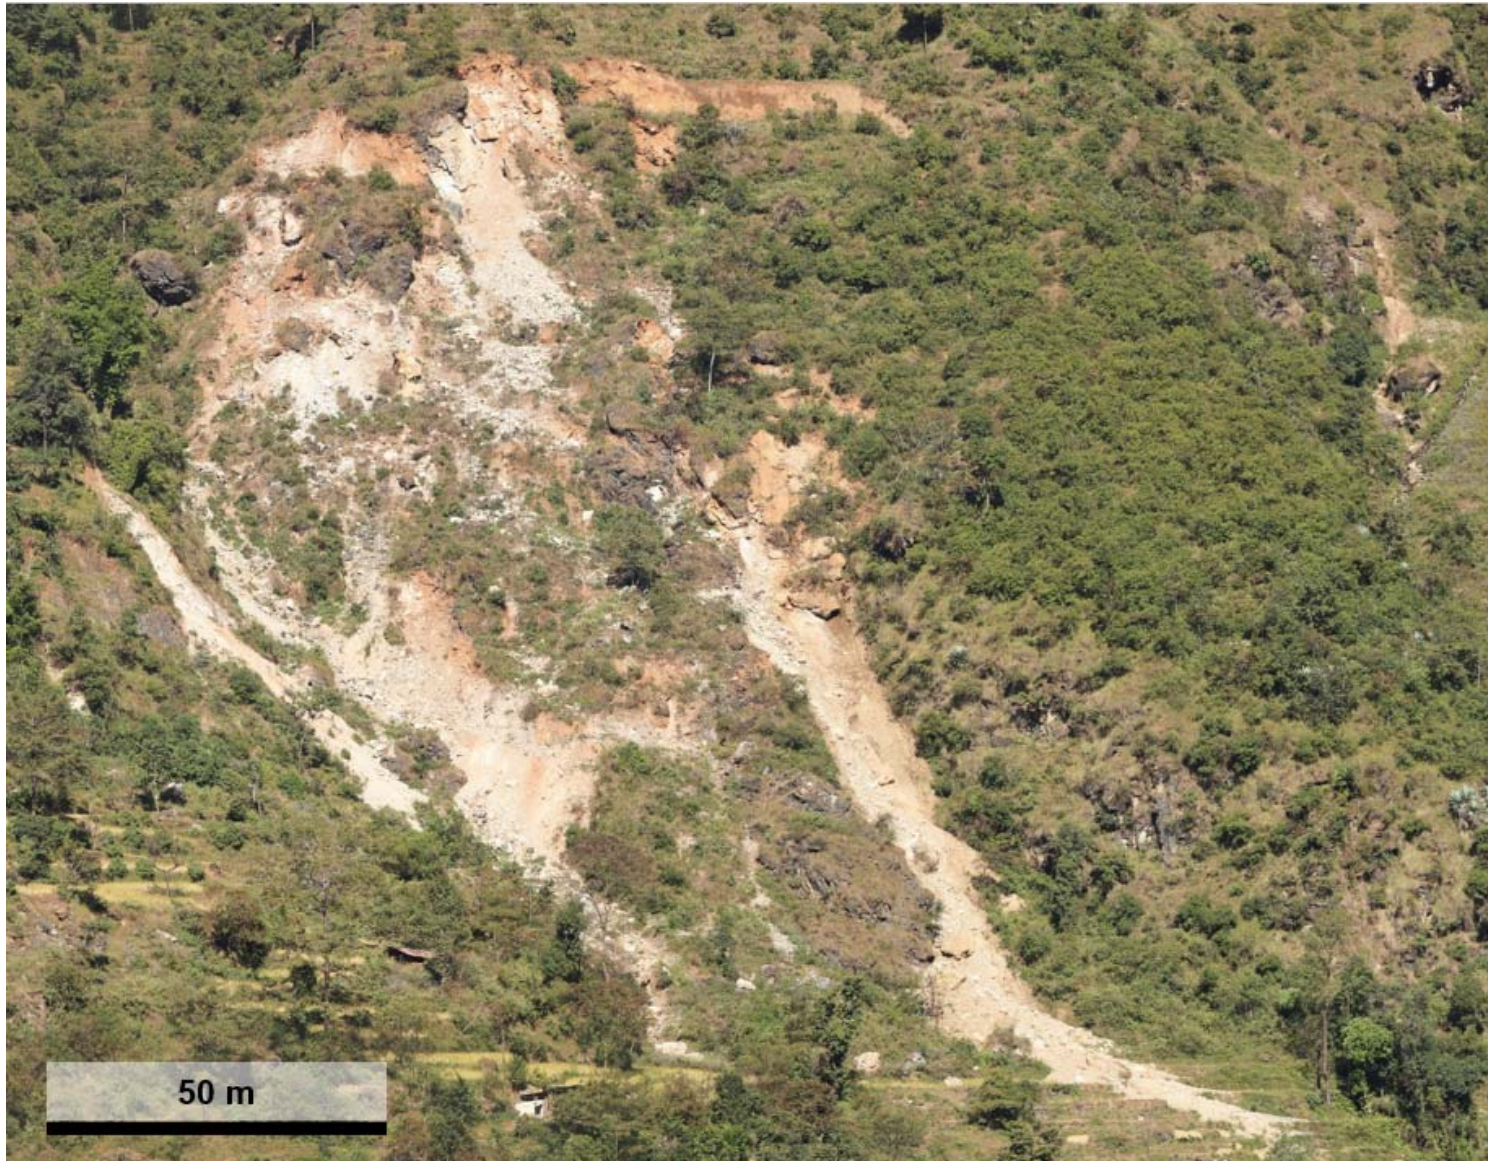
Figure H 4. Composite image of failure west of TLR as shown in Figure 5-2(a) in main body of thesis. Created from photographs collected November 6, 2016 looking north-west.

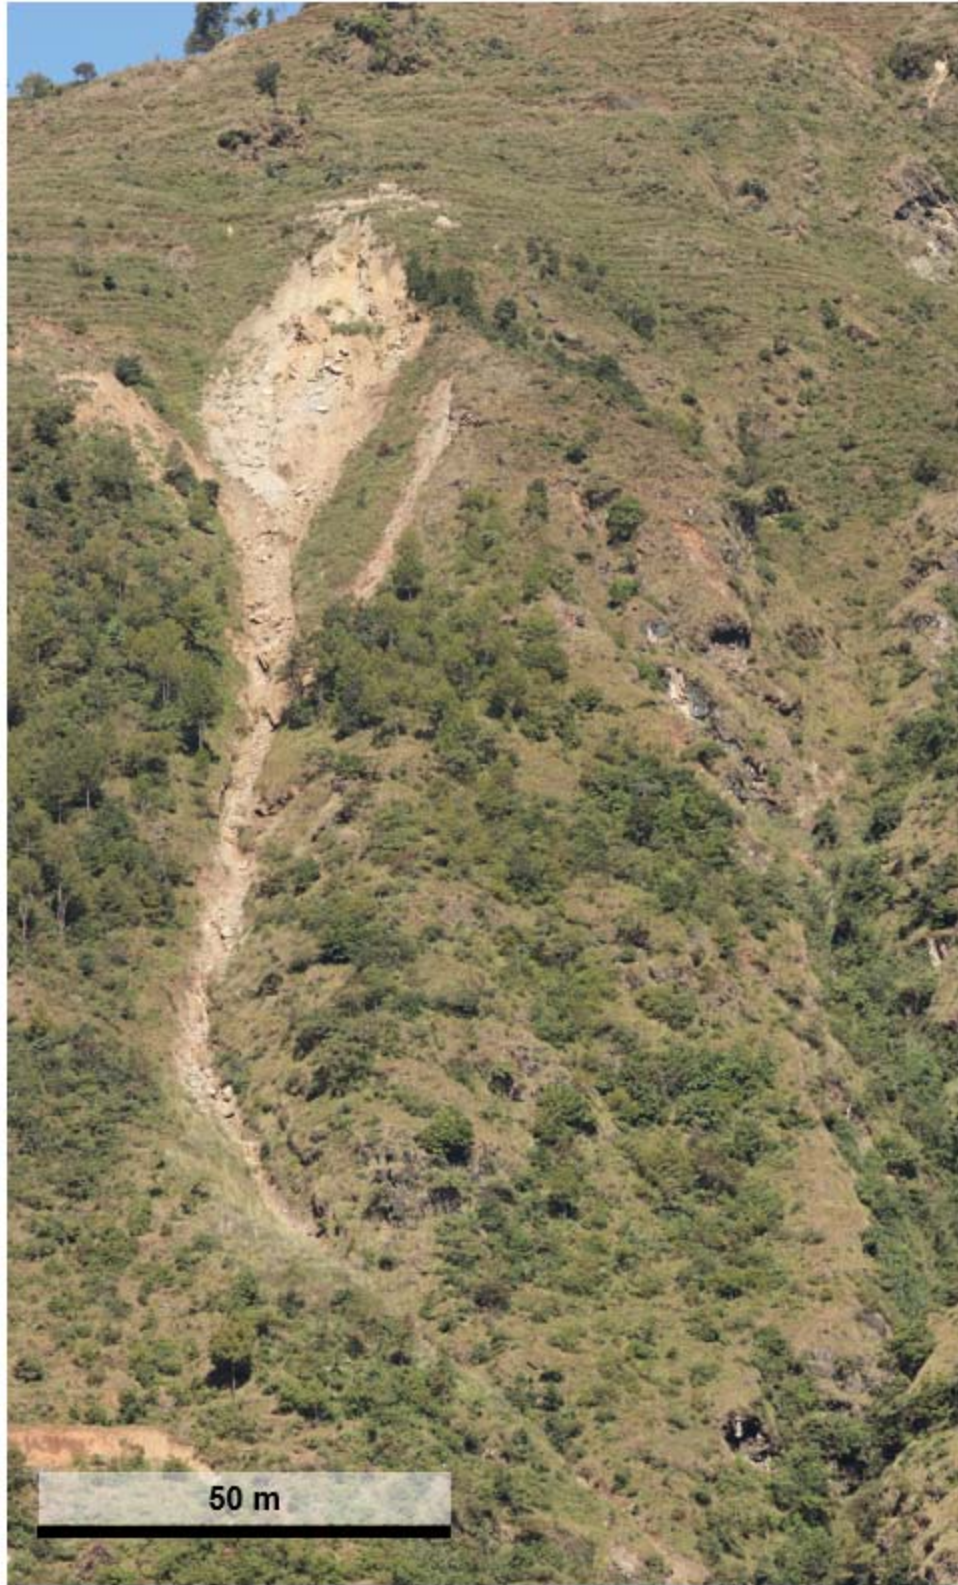
Figure H 5. Composite image of failure west of TLR as shown in Figure 5-2(b) in main body of thesis. Created from photographs collected November 6, 2016 looking north-west.

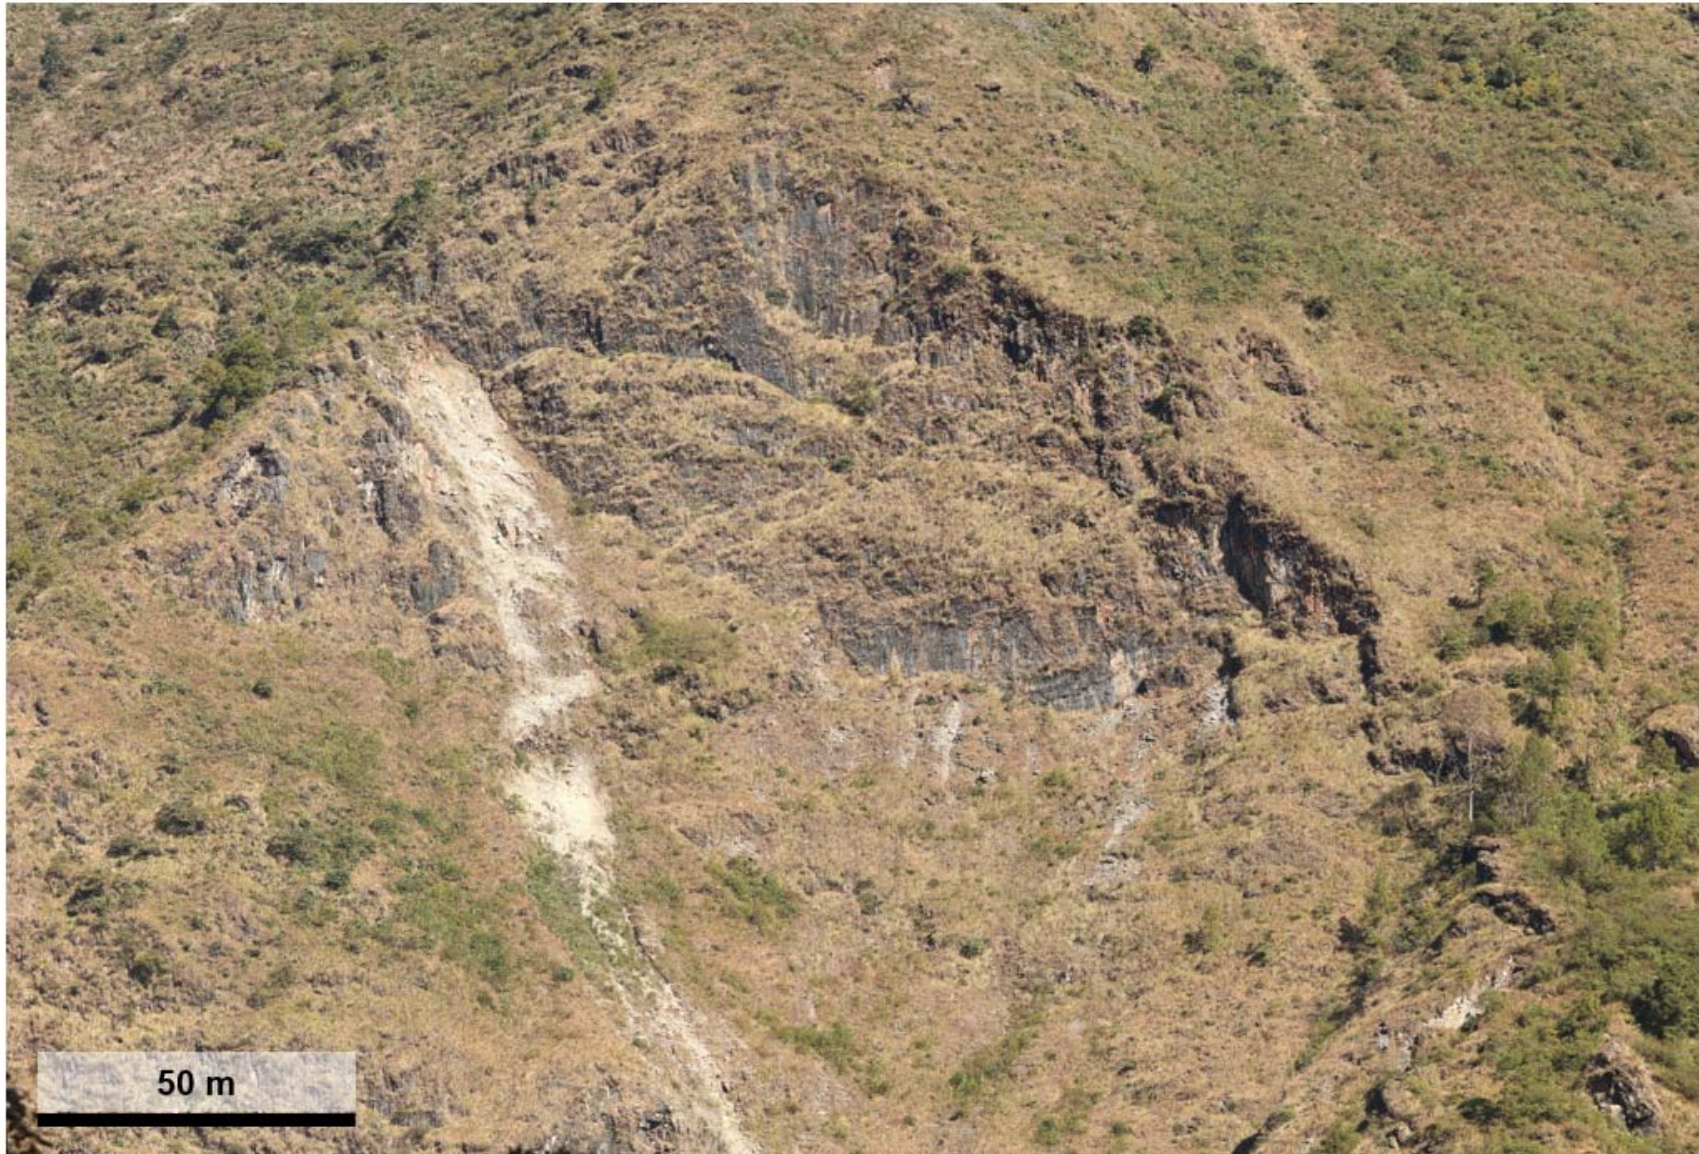
Figure H 6. Composite image of failure west of TLR as shown in Figure 5-2(c) in main body of thesis. Created from photographs collected November 6, 2016 looking north.

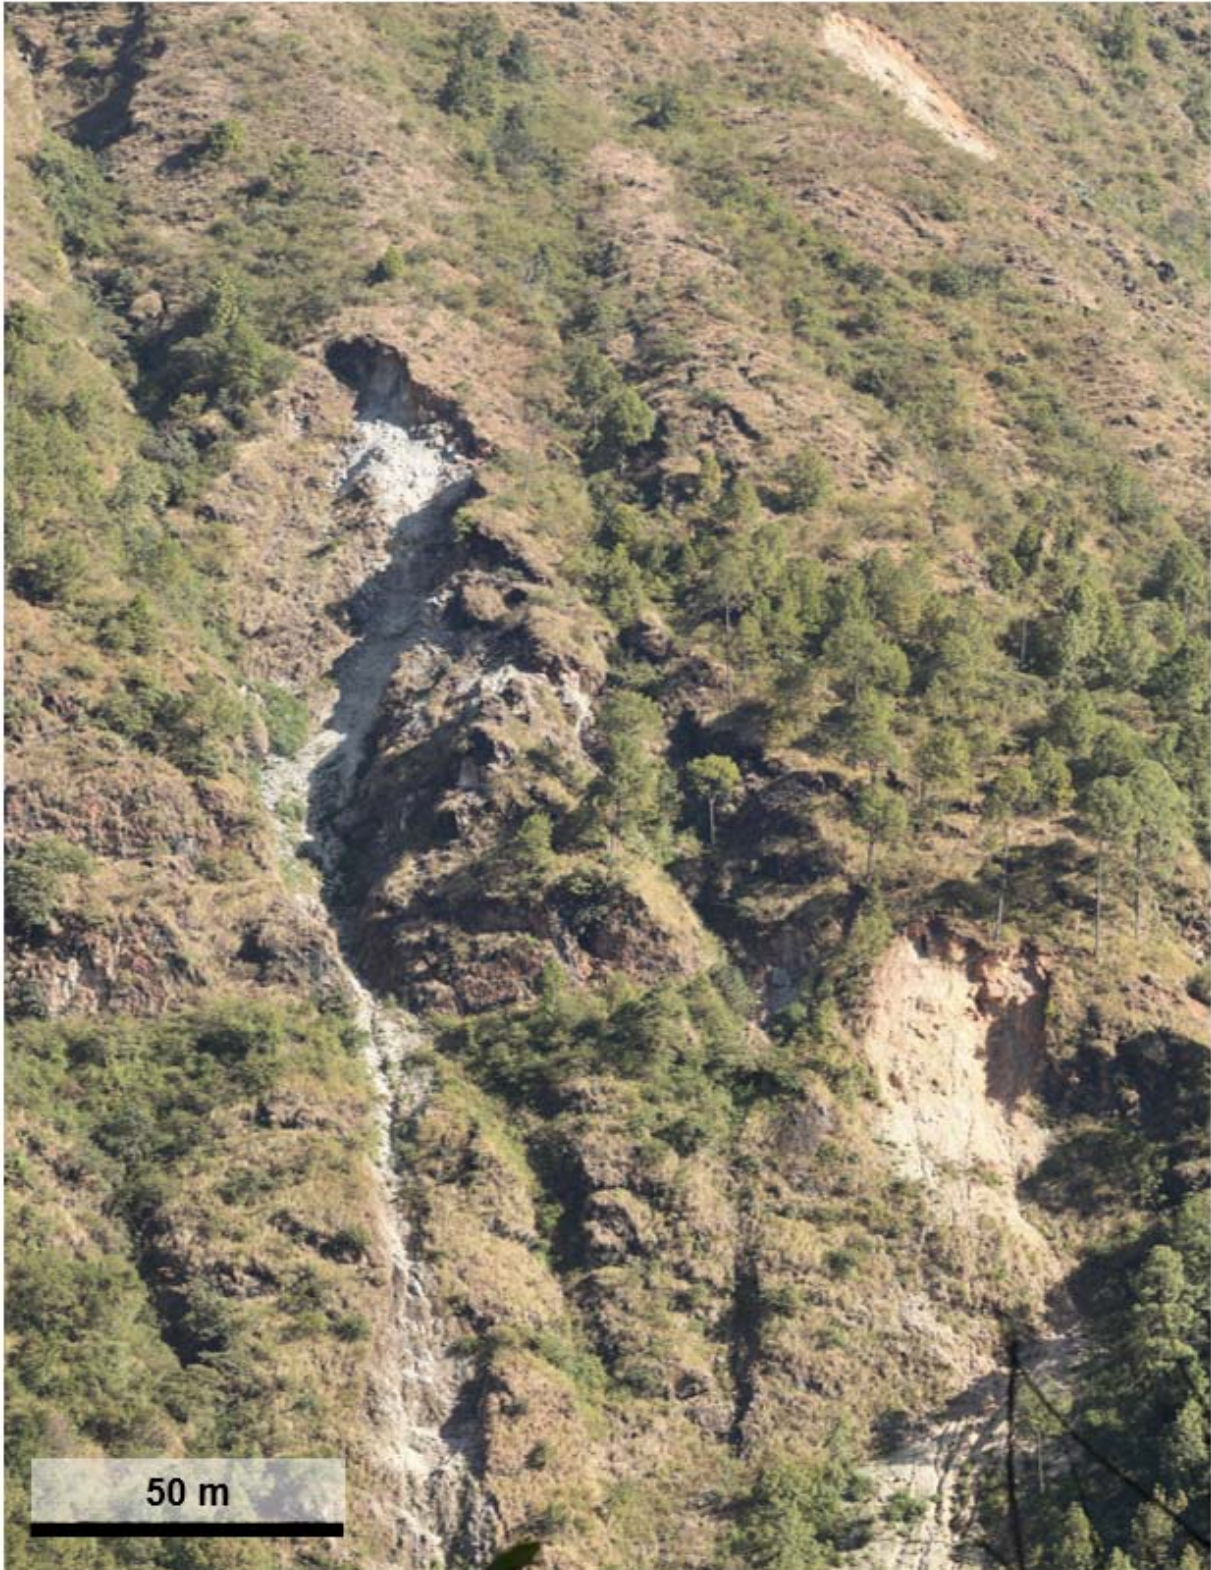
Figure H 7. Composite image of failure above TLR as shown in Figure 5-2(d) in main body of thesis. Created from photographs collected November 6, 2016 looking north, north-east.

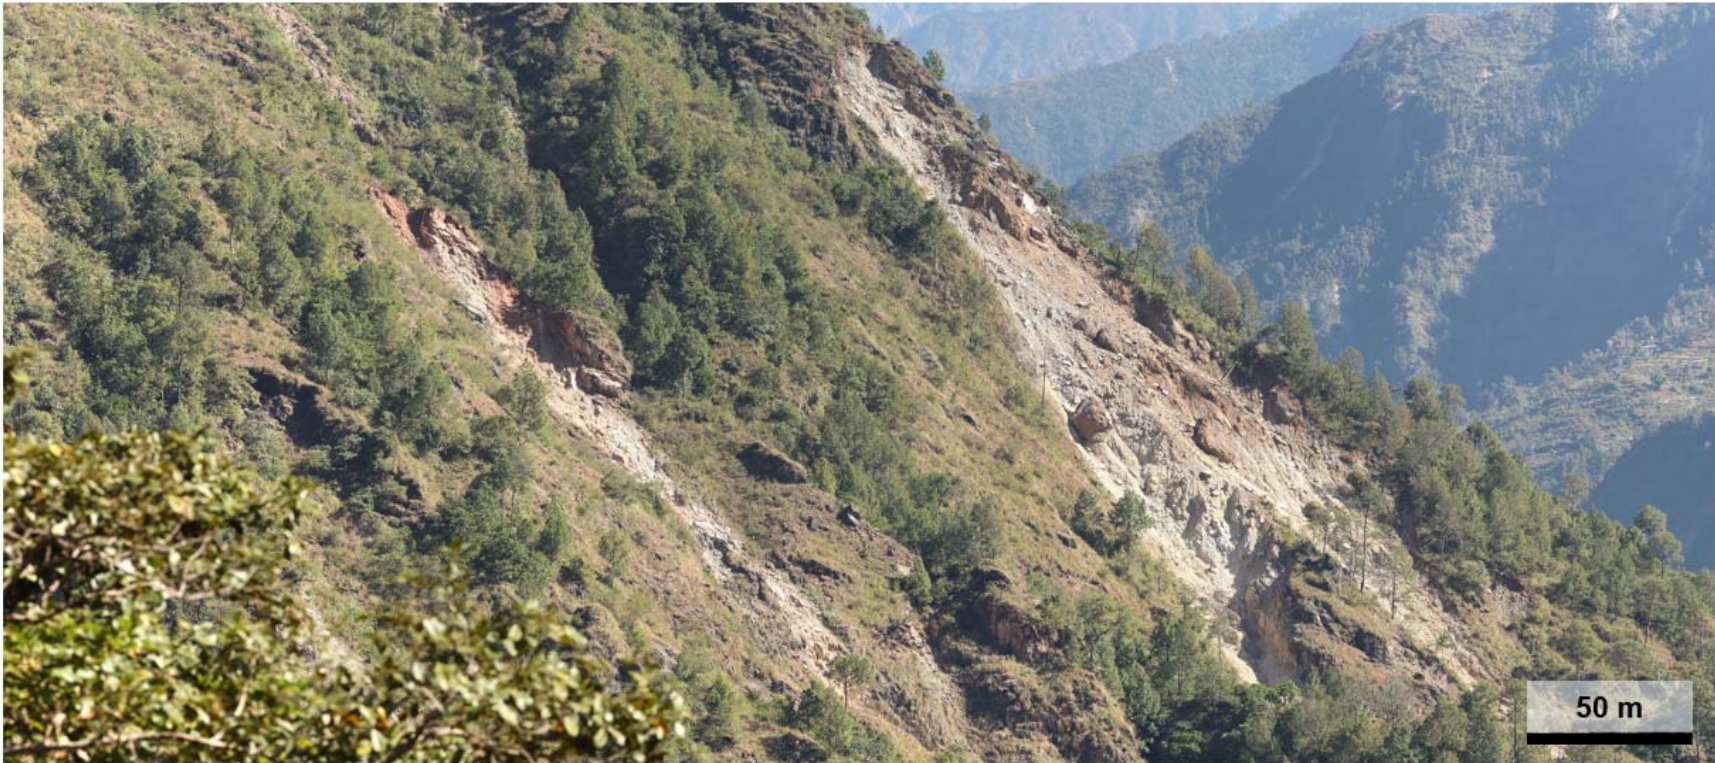
Figure H 8. Composite image of failures east of TLR as shown in Figure 5-2(e ,f) in main body of thesis. Created from photographs collected November 6, 2016 looking north-east.
