An Assessment of the Restoration of Shade in the Stoney Creek Habitat Improvement Project

By Yoko Lu, Melissa Orobko, and Marta Spira

EVSC 205, Simon Fraser University. April 2013

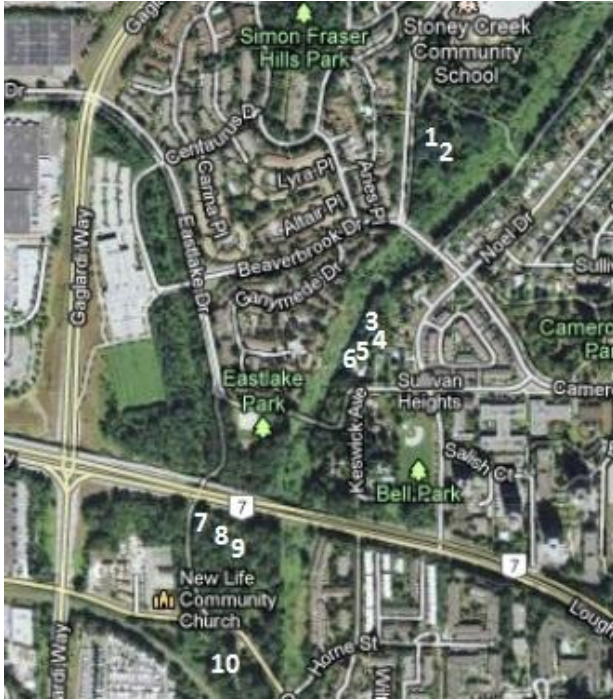
Figure 3. A full view of all of the sites (1-10) in Stoney Creek that were sampled.

On our first field day on April 2nd we performed fish-eye photography analysis on ten sites along the stream, as shown in Figures 3 through 7. Three were unrestored sites and seven were restored sites. In the unrestored area upstream of the restored area we used two sites, one that was naturally more open and one that was naturally more closed (Figure 4). The only downstream site we used was also naturally more closed (Figure 7). We included both more open and closed sites because we do not know if the restored sites used to be naturally more open or closed, so we must be able to compare them to either type.

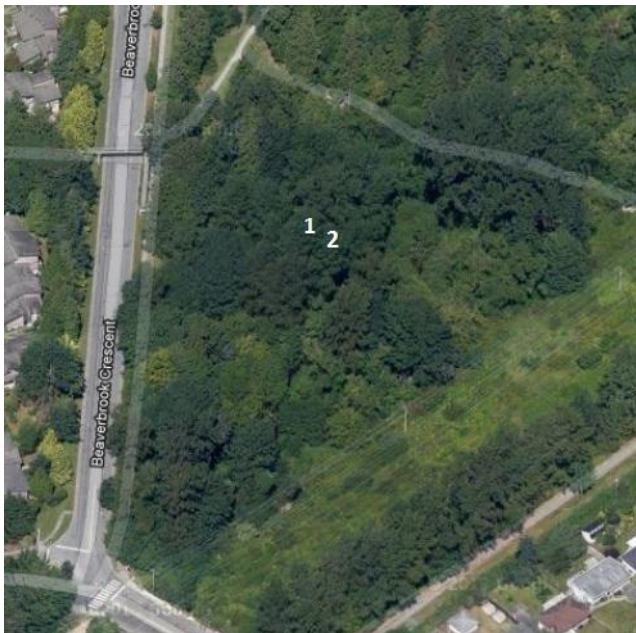
Figure 4. A closer view of the unrestored assessment area upstream from the weirs: (1) unrestored upstream (open); (2) unrestored upstream (closed).

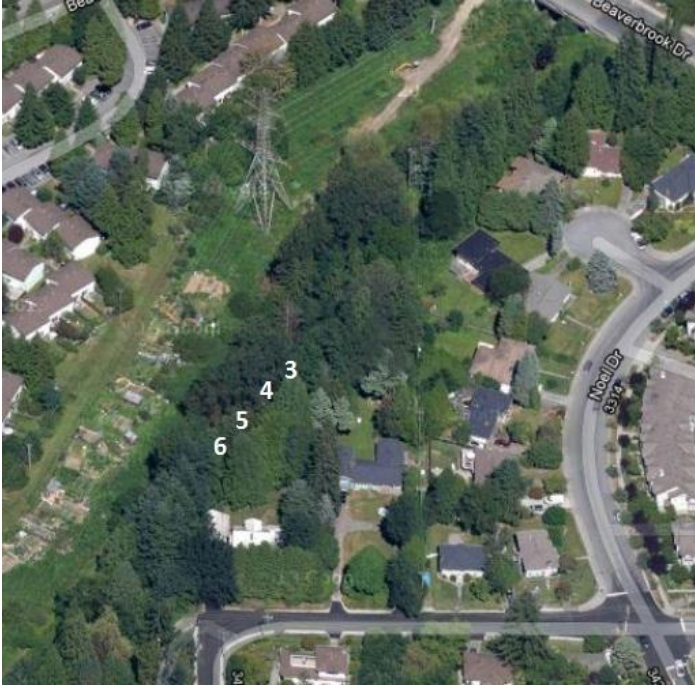
After assessing ten locations using our revised fish-eye photography method it was discovered that not all locations have actually had their levels of shade restored, when comparing them to unrestored sites. The areas at weir 1, between weir 1 and weir 2, at weir 3, and the section of stream at the pond intake point (sites 3, 4, 5 and 7; see Figures 5 and 6) have been restored to a sufficient level of shade, while the disturbed area just downstream of weir 3, the pond, and the stream from the pond to the creek (sites 6, 8, and 9; again, see Figures 5 and 6) have not had their levels of shade sufficiently restored.

Figure 5. A closer view of the areas assessed at the weirs: (3) weir 1; (4) between weir 1 & 2 under a tree; (5) weir 3; (6) disturbed site downstream from weir 3.

to re-grow. Therefore, it is recommended the frequent monitoring be done to assess whether the vegetation cover is growing enough and if it will be sufficient enough to act as a temperature buffer for salmonids. As part of restoring the levels of shade in areas that were disturbed we recommend that more planting be done in these areas.

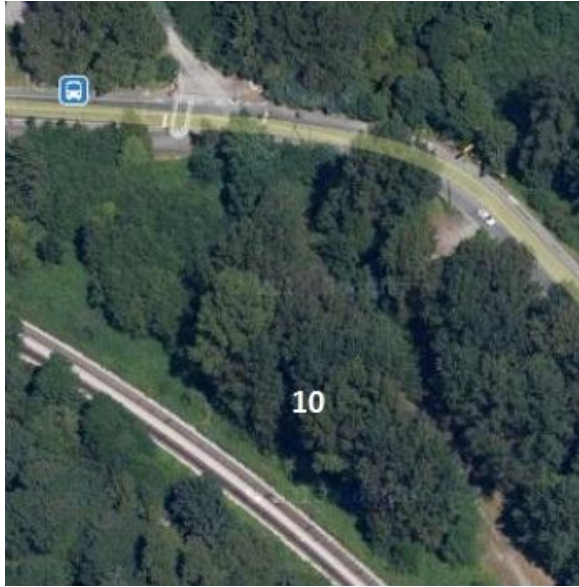
Figure 7. A closer view of the area assessed downstream from the pond, across Government Street, next to the train tracks: (10) unrestored downstream.
