# **Field Trials on a Living Dike in British Columbia: Wave Attenuation of Edge Treatment Features**

Project Submitted in Partial Fulfillment of the  
Requirements for the Degree of  
Master of Science

in the  
Ecological Restoration Program  
Faculty of Environment (SFU)  
and  
School of Construction and the Environment (BCIT)

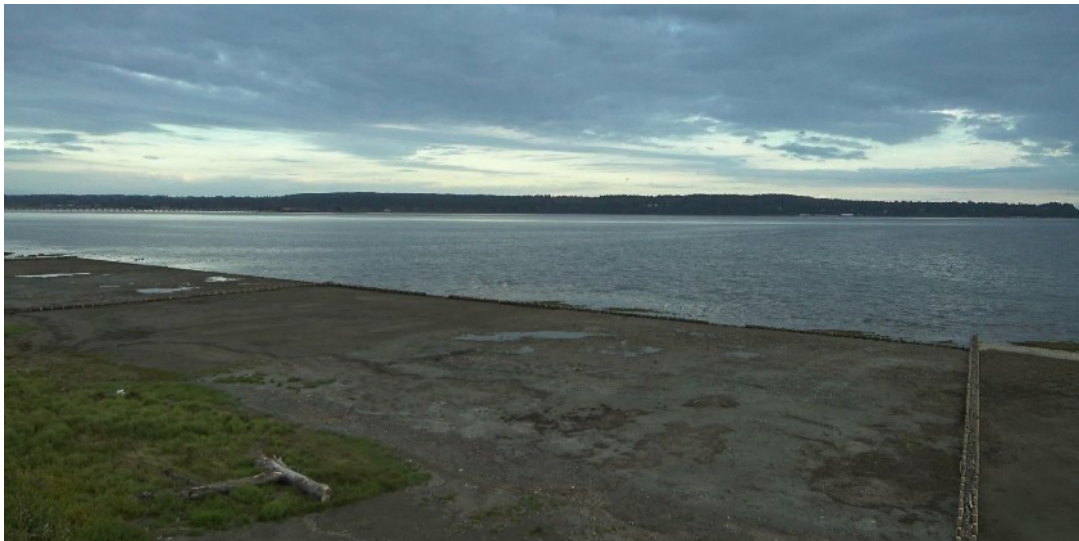
Figure 2: Picture overview of the Living Dike pilot project S1 site in Boundary Bay, British Columbia. View south overlooking the test plots. Image courtesy of City of Surrey.

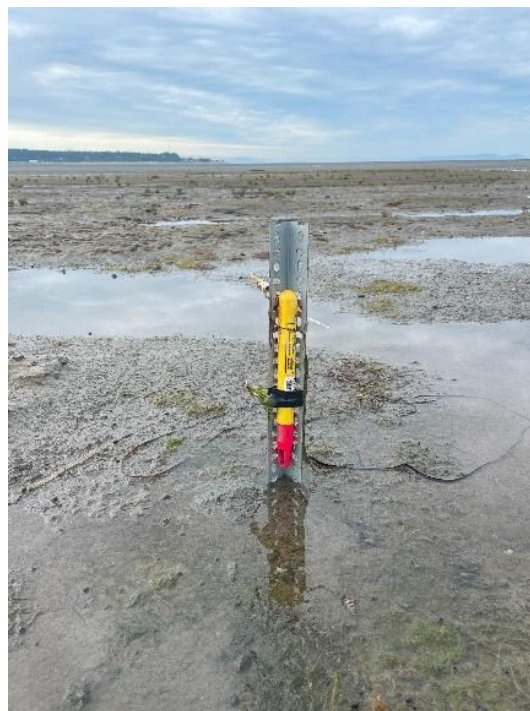
Figure 5: Image showing an RBRsolo instrument attached to a perforated L-shaped angle bar at the S1 LDPP study site in Boundary Bay, British Columbia, used to obtain wave data from October 2023 to January 2024.

The RBRsolo pressure sensors operated in *wave* mode, sampling 4096 points per sample at 16 Hz with a 20-minute sampling interval. Positioned 0.05 m above the substrate, the RBRsolo sensors were affixed to perforated L-shaped angle bars driven into the substrate (Figure 5).

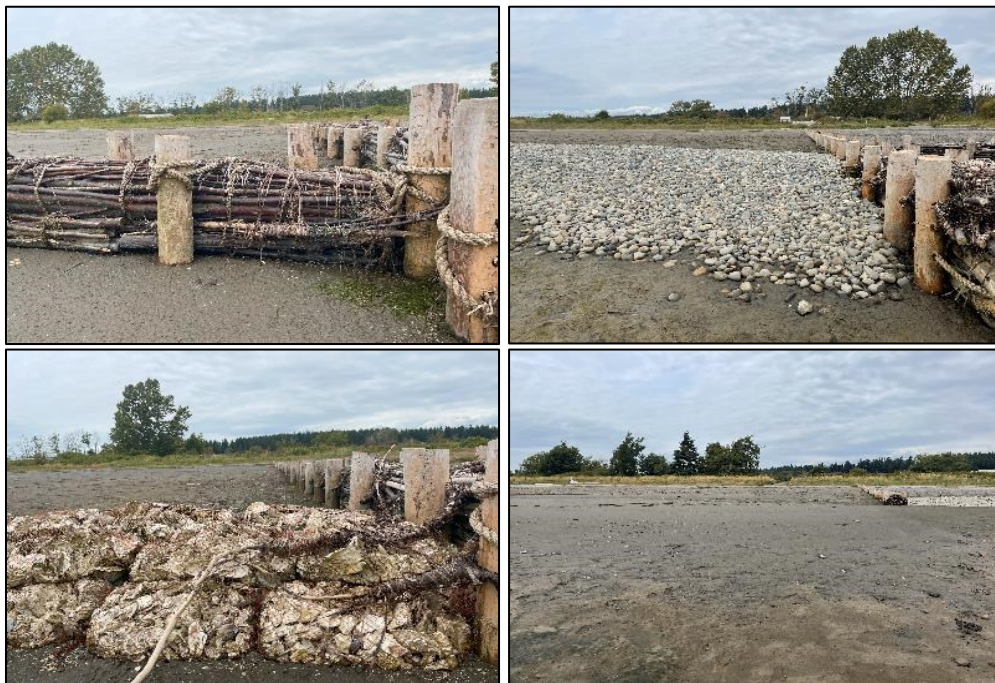
Figure 6: Image showing the four edge treatments at the S1 LDPP study site in Boundary Bay, British Columbia. Clockwise from the top left: brushwood dam, gravel berm, sand berm, oyster bag berm.

The brushwood dam stands 0.40 m tall and consists of untreated wooden posts, each with a diameter of 0.15 m, serving as anchor points (Figure 6, 7). Bundles of brushwood, measuring 0.30 m wide, and 2.0 m in length, are held together by 6 mm biodegradable twine and are securely fastened to the posts using 16 mm biodegradable rope. The gravel berm has a width of 2.0 m at its peak and has a seaward slope of 1(V):8(H) towards the mudflat (Figure 6, 8). Approximately 0.35 m in height, the berm uses  $D_{50} \approx 70$  mm gravel, with an additional granular filter gravel positioned along the landward side of the plot. The sand berm spans 15.0 m in width, stands at approximately 0.40 m in height, features a frontal slope of 1(V):4(H), and is composed of imported sand material ( $D_{50} = 0.30$  mm; Figure 6, 9). The oyster berm is approximately 0.40 m tall, 1.0 m wide, and consists of oyster shells enclosed in biodegradable plastic meshing with a mesh size of 1.0 cm (Figure 6, 10). The berm is stacked with three bags on the bottom layer and two on the top, with a granular filter gravel placed on the landward side of the plot. The elevations (in meters above geodetic datum, CGVD28GVRD2018) of the top of each structure are as follows: the brushwood dam ranges from 1.3 m to 1.4 m, the gravel berm stands at 1.1 m, the sand berm at 1.0 m, and the oyster bag berm varies between 1.1 m and 1.2 m. For context, Higher High Water Mean Tide is 1.1 m elevation (CGVD28GVRD2018) and 4.0 m elevation (Chart Datum).

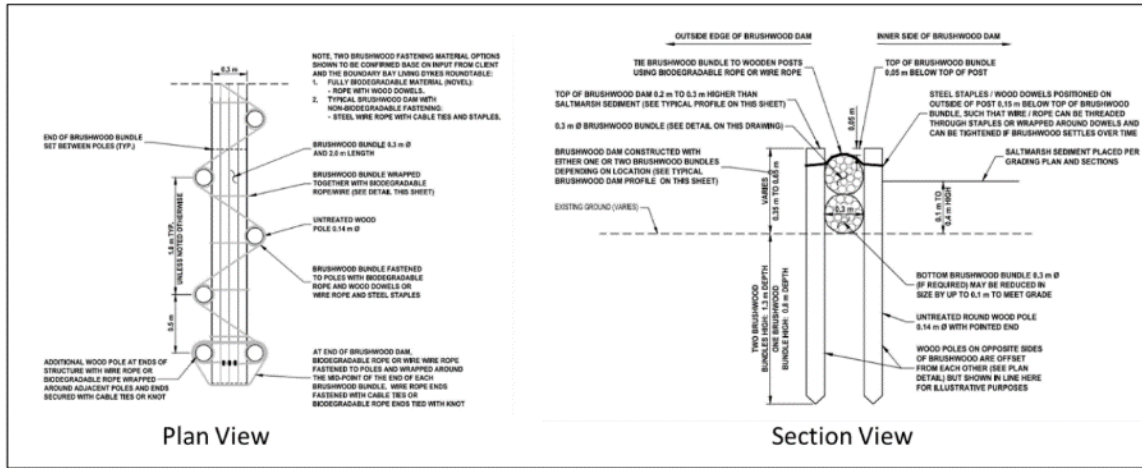
Figure 7: Proposed S1 design detail of the brushwood dam edge treatment [30].

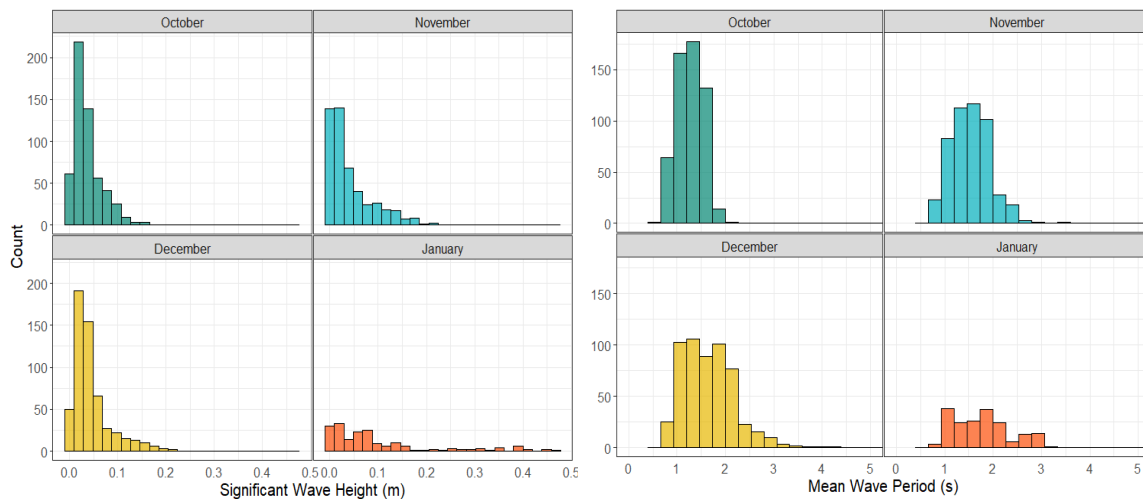
Figure 11: Histograms showing the distribution of Significant Wave Heights (left) and Mean Wave Periods (right) per month throughout the October – January study period at the S1 site in Boundary Bay.

Wave heights during the wave monitoring period (October 2023 to January 2024) ranged from 0.05 m (the chosen minimum value) to 0.46 m during a large southwestern storm in January 2023; mean wave periods were between 0.5 s and 3.5 s; and the greatest water depth at the first instrument in the control transect was 1.33 m. The wave heights and wave periods increased month-to-month from October to January, with the highest waves and longest wave periods observed in January (Figure 11). This seasonality of larger storm events in the winter was anticipated.

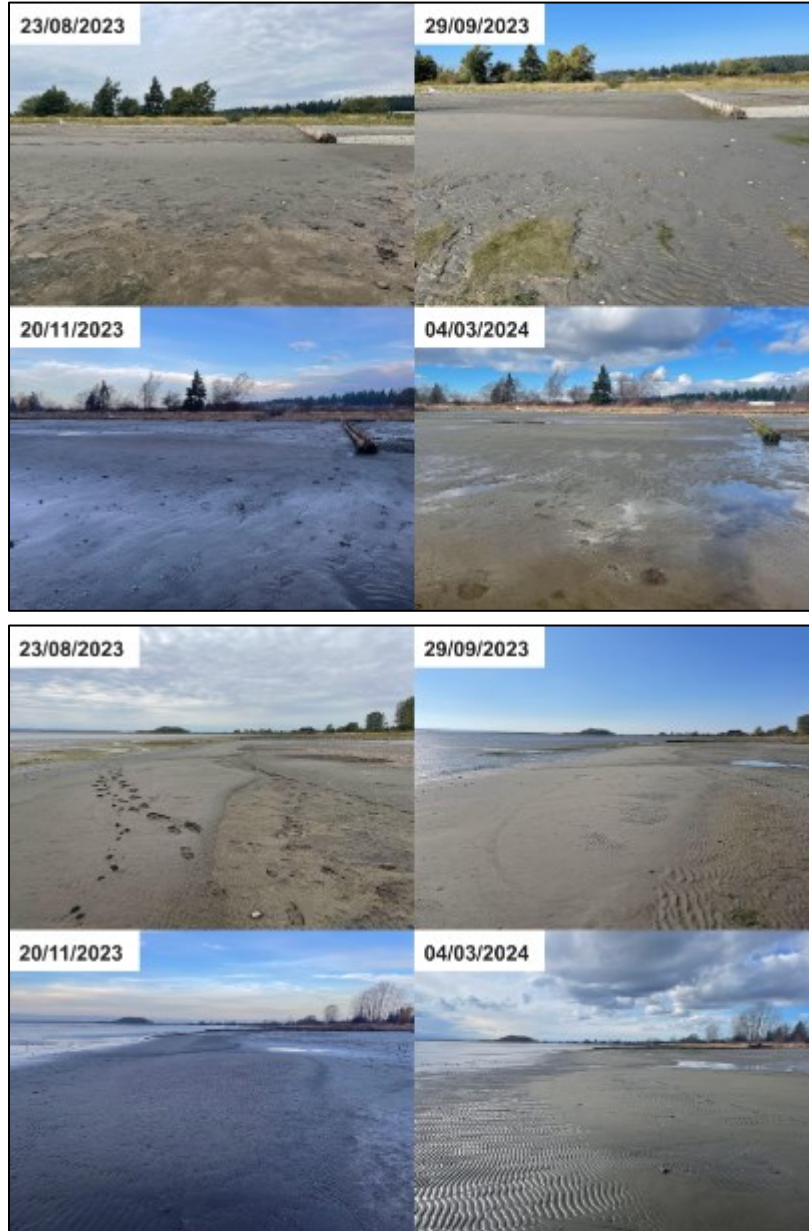
Figure 15: Photo monitoring of the sand berm treatment between August 23<sup>rd</sup>, 2023 and March 4<sup>th</sup>, 2024 at the S1 LDPP site in Boundary Bay, British Columbia.

The sand berm began to deform three weeks after construction was completed, and movement was noted during small summer storm events ( $H_s < 0.15$  m). Large storm events in November 2023 and January 2024 further flattened the berm slope and moved sand onto the mudflat and fill sections of the plot. It was observed that most of the

sediment movement occurred during storm events ( $H_s > 0.15$  m). At the conclusion of this study, the sand berm had decreased in height by approximately 0.10 m and expanded seaward and landward by approximately 3.0 m in both directions. The marsh fill behind the sand berm experienced the most reshaping out of the four treatments and exhibited a 0.14 m decrease in elevation. The initial frontal slope of 1(V):4(H) for the sand berm reshaped to a final slope of approximately 1(V):30(H).

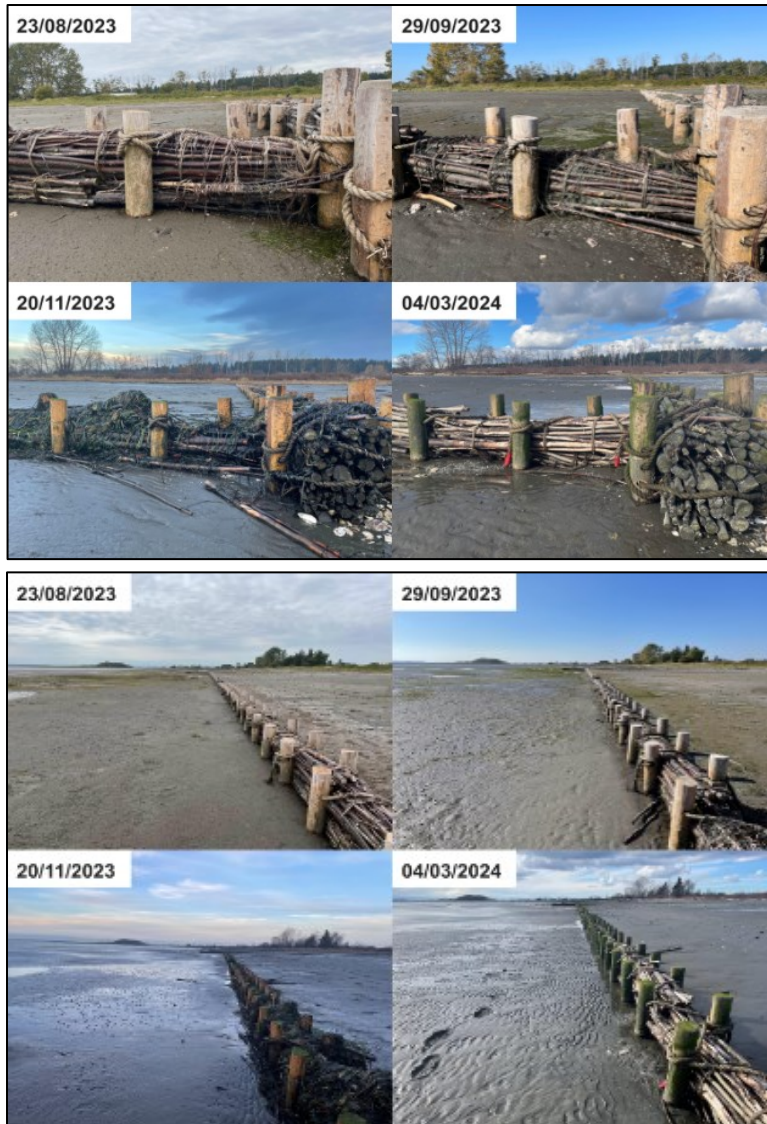
Figure 17: Photo monitoring of the brushwood dam treatment between August 23<sup>rd</sup>, 2023 and March 4<sup>th</sup>, 2024 at the S1 LDPP site in Boundary Bay, British Columbia. The March 4<sup>th</sup>, 2024 image shows a repaired brushwood bundle.

The brushwood dam began to exhibit fraying on the 6 mm biodegradable twine, used to secure the bundled brushwood, in November 2023, three months after installation. The thicker 16 mm biodegradable rope used to secure the bundles to the posts did not show signs of fraying. After the November 2023 storm event ( $H_s = 0.30$  m), one bundle of brushwood had split open, and that portion of the dam likely became ineffective. Further signs of fraying on the rest of the bundle twine was noted in December and two more sections of the dam came apart after a storm event in January 2024 ( $H_s = 0.46$  m). The placed marsh fill elevation, at the interface with the brushwood dam, decreased by approximately 0.10 m and the slope landward of the structure steepened from the constructed 1(V):100(H) fill slope to a slope of 1(V):25(H). The new slope extended approximately 8.0 m landward of the dam before returning to the original fill elevation.

The brushwood dam was shown to hold up well to wave conditions, which was expected given their use on similar projects in Europe and Asia [25,11]. However, the study observed recurrent failures in the twine binding the brushwood bundles, a phenomenon not reported in prior research. It is hypothesized that the abrasion of the

bundle twine by driftwood during high tides might be a contributing factor. This hypothesis is supported by the lack of fraying on the perpendicular brushwood dividers (used to separate plots) that were not exposed to driftwood impacts and associated damage. Boundary Bay's abundance of driftwood may explain why such weathering/damage mechanisms were not previously documented in European or Asian studies. Increasing the thickness of the bundle twine could mitigate the risk of failure, irrespective of the underlying cause, thereby prolonging the longevity of the brushwood dams. Failure of the brushwood dam was not reported in Provan et al.'s [9] laboratory study which highlights the importance of conducting field trials. Studies such as Schmitt et al.'s [31] investigation into bamboo and rope brushwood dams indicated that minor adjustments in design could potentially extend their lifespan to five-to-seven years [11].

Primary recommendations for the brushwood dam focus on bolstering its durability. The bundle twine securing the brushwood bundles was susceptible to fraying, compromising the structure's efficacy. Increasing the bundle twine diameter is recommended to mitigate this design concern and enhance the brushwood dam's longevity. The brushwood dam was the only edge treatment to attenuate waves at all tested values of  $R_d/H_s$  and provided the most wave attenuation at values of  $R_d/H_s \lesssim -2$ . These results indicate that with minor design changes the brushwood dam may be a desirable edge treatment option for future projects in locations with similar tidal and wave conditions to this study.

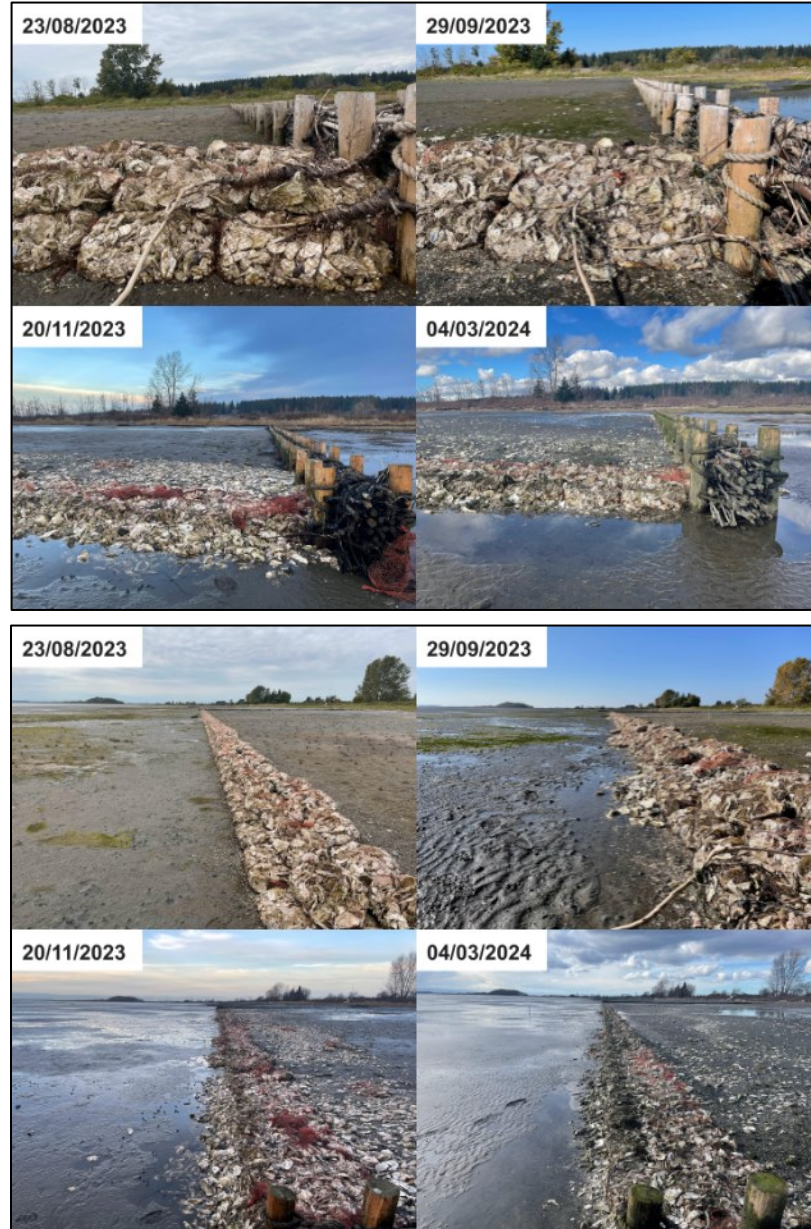
Figure 18: Photo monitoring of the oyster-shell bag berm treatment between August 23<sup>rd</sup>, 2023 and March 4<sup>th</sup>, 2024 at the S1 LDPP site in Boundary Bay, British Columbia.

The oyster bag berm showed signs of weathering one month after construction was completed. Tears in the biodegradable bags used to hold the shells in place were evident after the first summer storms. During the November storm event ( $H_s = 0.30$  m) 60% of the bags were torn open, most of the shells in the first layer of the berm were spread across the site, and the biodegradable mesh bags were observed strewn around the site. The damage from the storm resulted in the lowering of the oyster bag berm

below its constructed height and rendered it less effective as subsequent wave data showed higher wave transmission coefficients. A subsequent storm event in January 2024 damaged the rest of the bags and at the end of the monitoring study approximately 80% of the oyster bag berm had been destroyed. During the period before the November 2023 storm, little marsh fill movement took place, and no scour was noted behind the oyster bag berm.

The oyster bag berm effectively attenuated waves but experienced the most significant weathering among all structures due to the weakness of the biodegradable bags. To address this issue, adopting steel gabion cages, designed to rust out within a few years, could offer a viable solution. This approach was proven effective in the Eastern Scheldt Oyster Reef pilot project [40], but additional testing would be required in Boundary Bay.
