# **The Effects of Timber Harvesting and Windthrow on Landslide Initiation, Southwestern Vancouver Island**

THESIS SUBMITTED IN PARTIAL FULFILLMENT OF  
THE REQUIREMENTS FOR THE DEGREE OF

MASTER OF SCIENCE

in the  
Department of Earth Sciences  
Faculty of Science

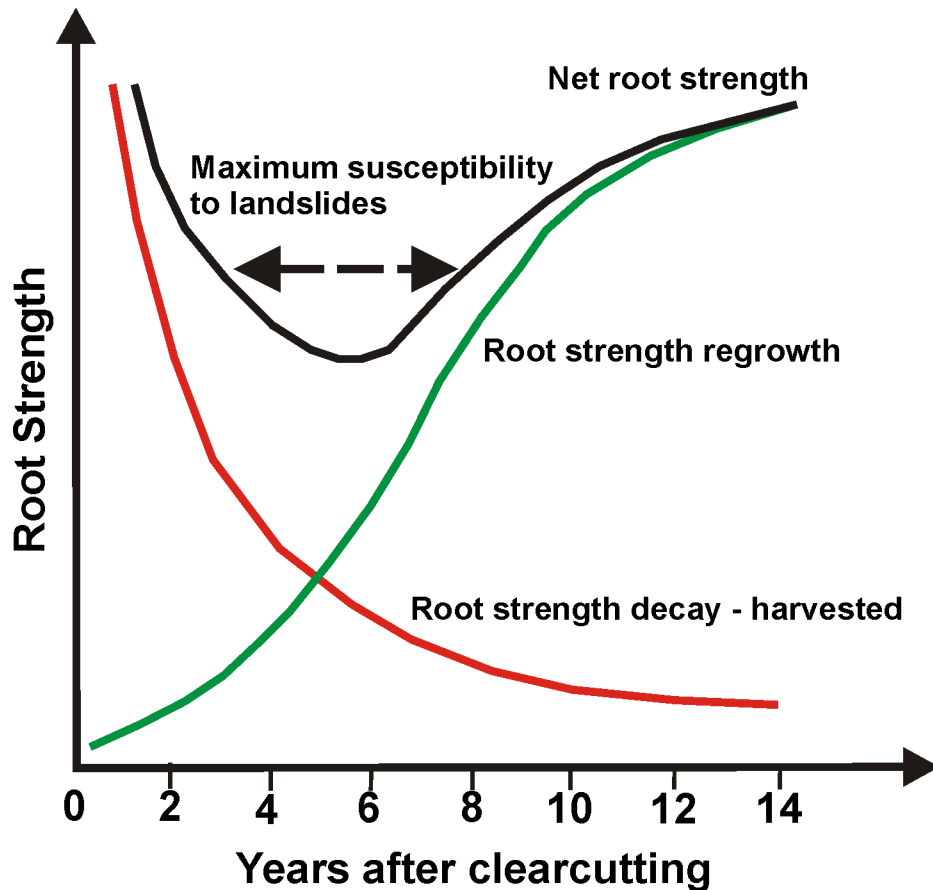
Figure 1.1: Idealized changes in root strength after timber harvesting, modified from Sidle and Ochiai, 2006.

Ziemer (1981a) found that 50% of the root reinforcement was lost within the first 2 years after harvest and that 90% was lost 9 years after harvest. In addition, it would take 15 years until the new plantation provides 50% of the original reinforcement and 26 years until it provides 100% reinforcement.

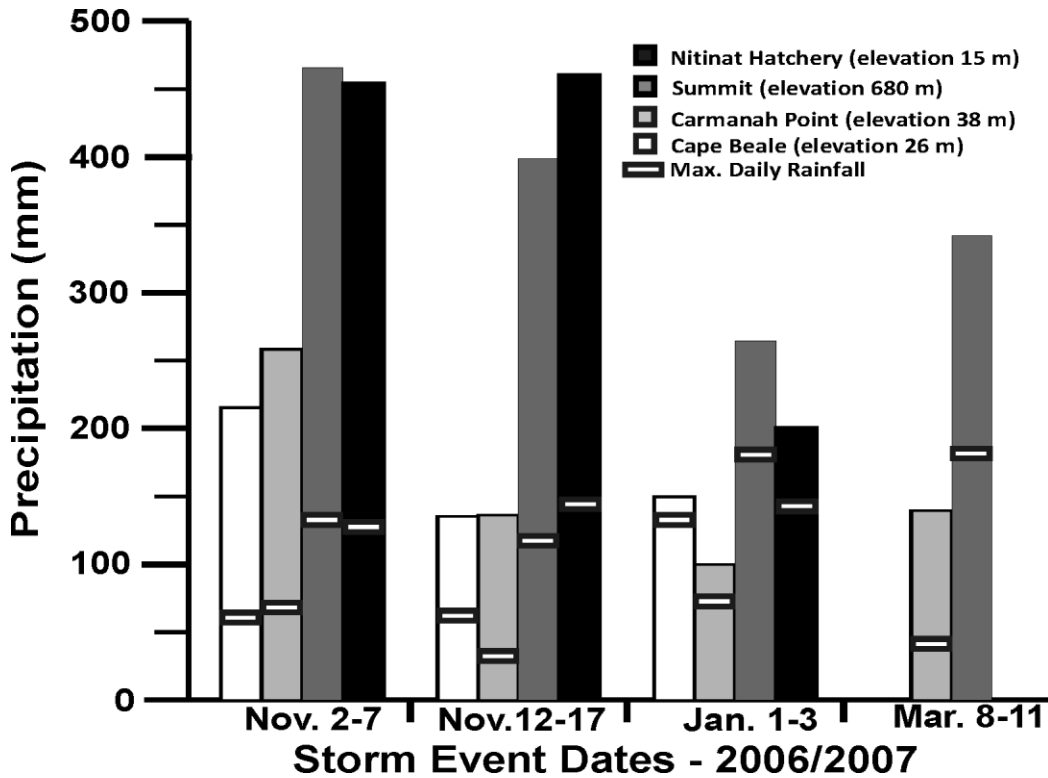
Figure 2.3: Precipitation for four main storm events at Environment Canada weather stations Cape Beale, Carmanah Point, and Nitinat River Hatchery and MOFR Summit weather station (Environment Canada, 2009a; MOFR, 2009). The coastal weather stations received considerably less precipitation than the inland stations.

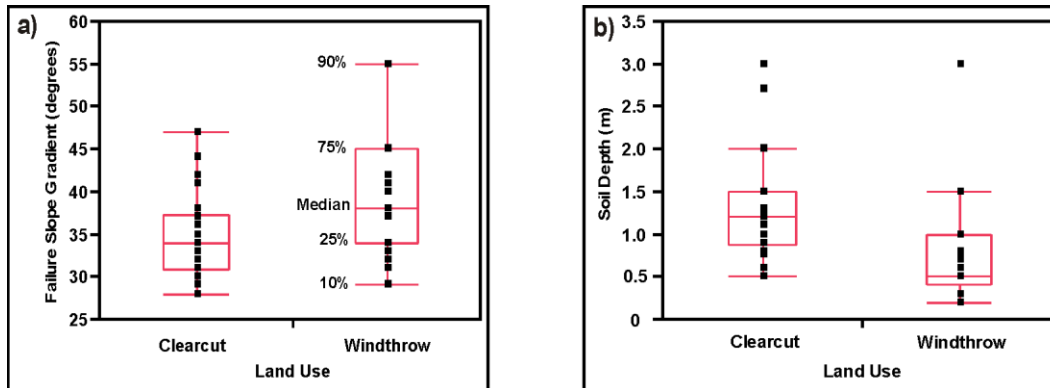
Figure 2.11: Box plots showing variability between clearcut and windthrow for a) failure slope gradient, b) soil depth. (n = 48)

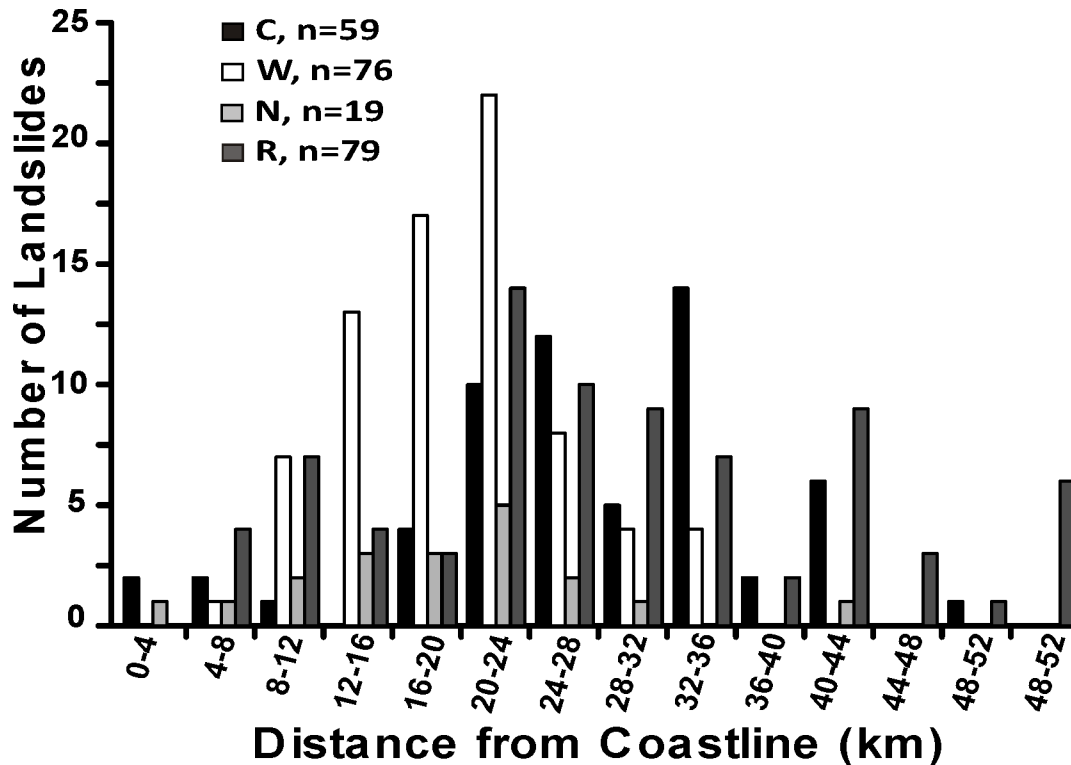
Figure 2.14: Distance to coastline by land use.

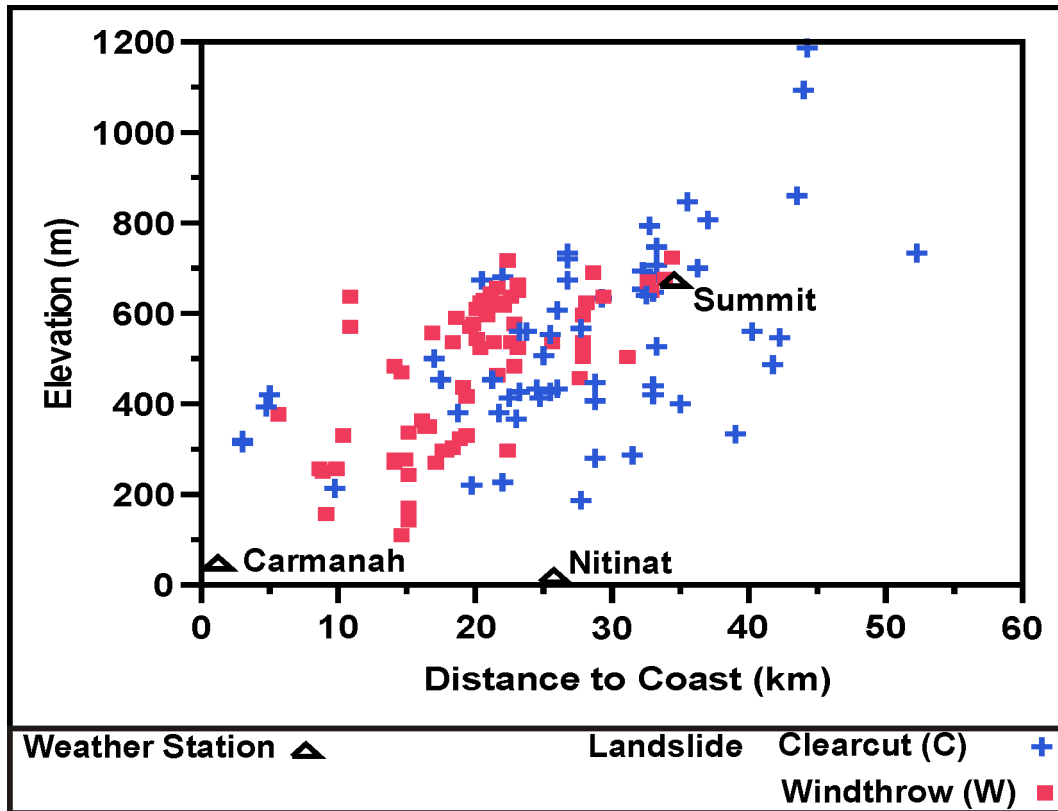
Figure 2.15: Distance from the coast versus elevation of landslides for windthrow and clearcut associated landslides. (n = 135)

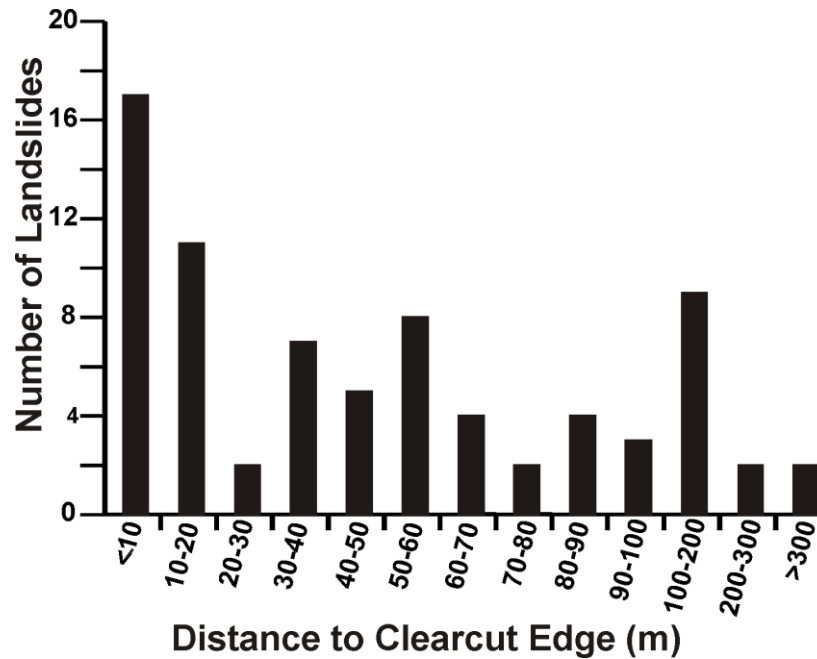
Figure 2.17: Windthrow landslide initiation distance from the clearcut edge. Note: For distances greater than 100 m from a clearcut edge, each category is in 100 m intervals. (n = 76)

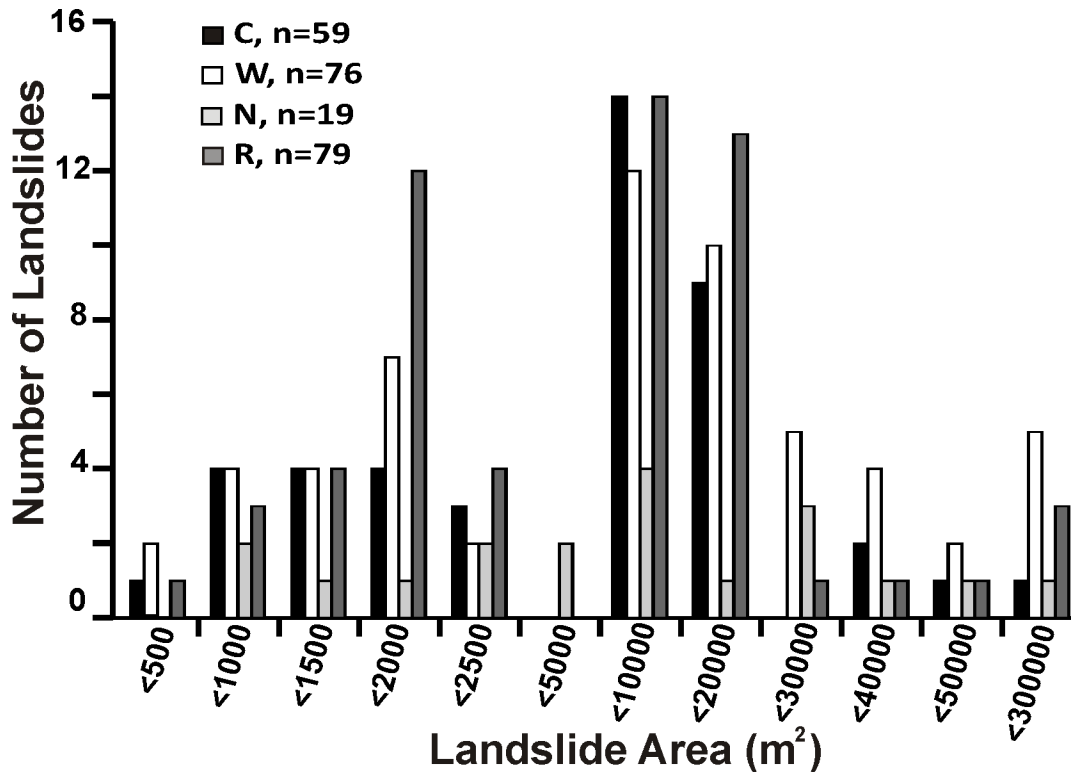
Figure 2.23: Landslide area by land use (surface area projection).

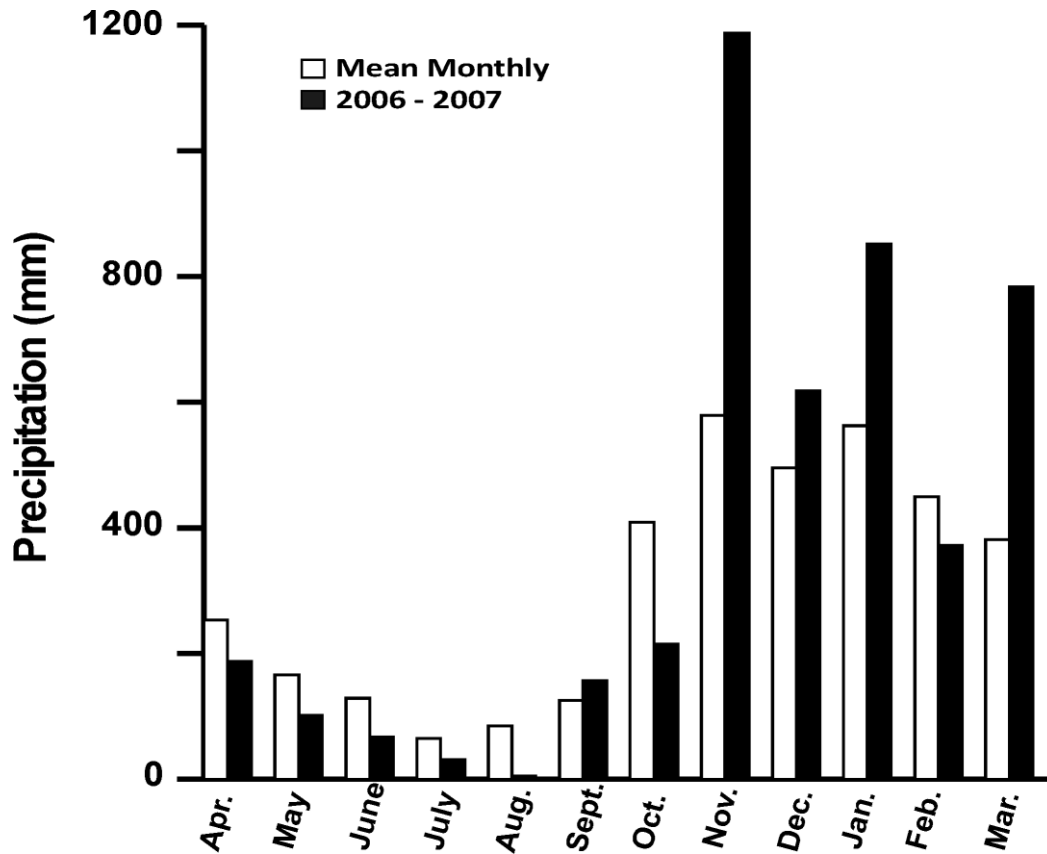
Figure 3.2: Nitinat River Hatchery weather station precipitation (Mean Monthly and 2006/2007) Environment Canada climate normals and averages 1971-2000 (Environment Canada, 2009b).

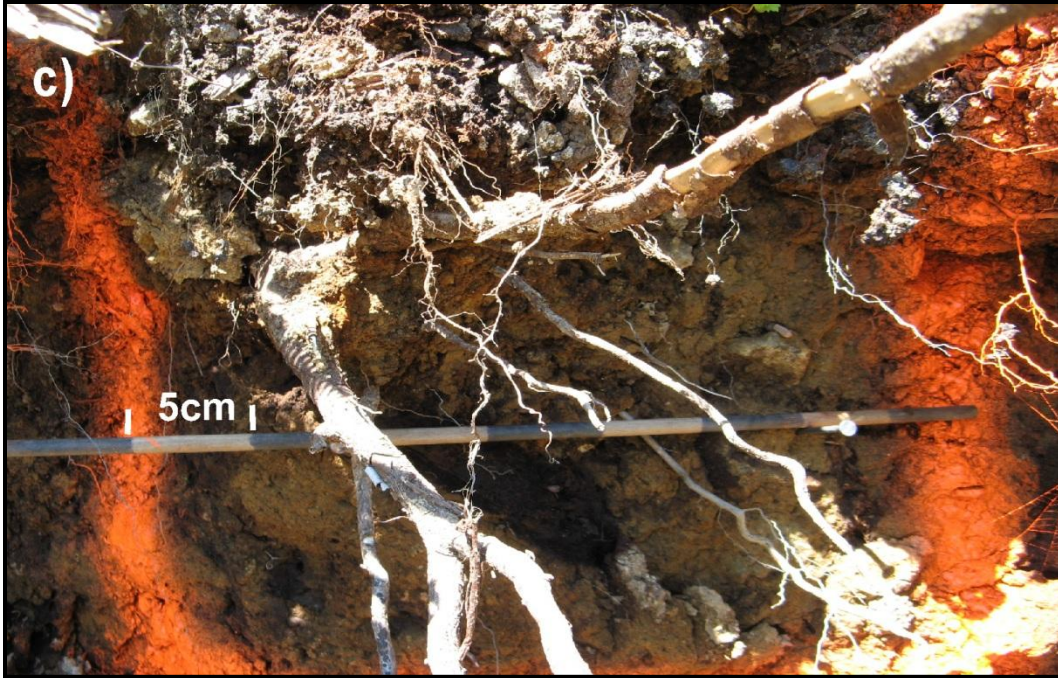
Figure 3.12: Moderate root quality in an 18 year old clearcut landslide.

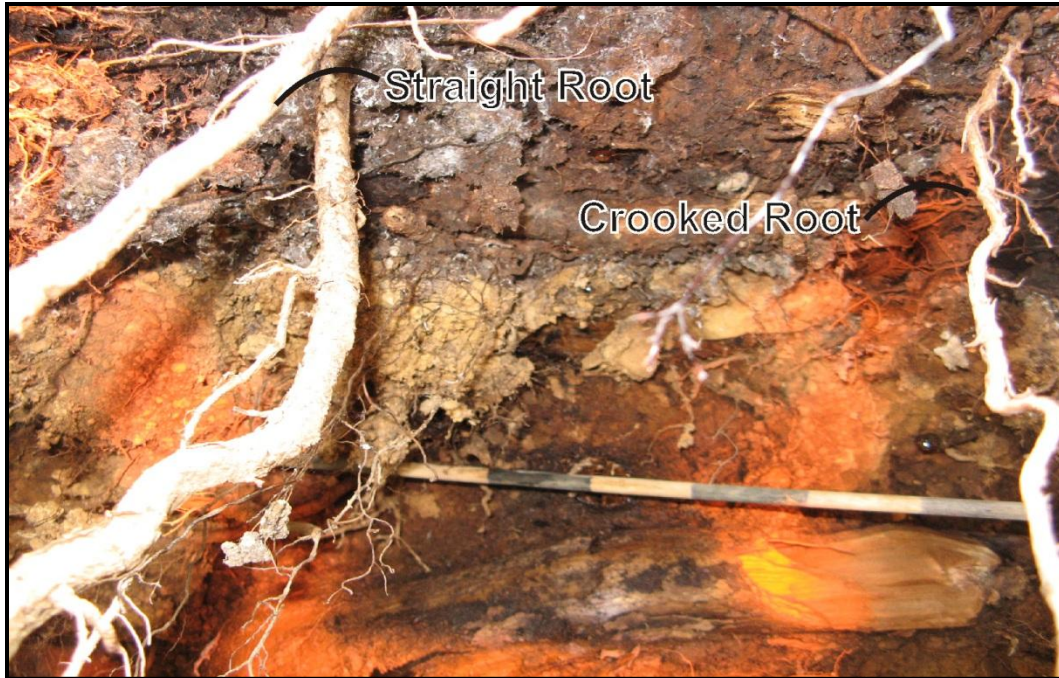
Figure 3.15: Straight and crooked roots within a landslide headscarp.

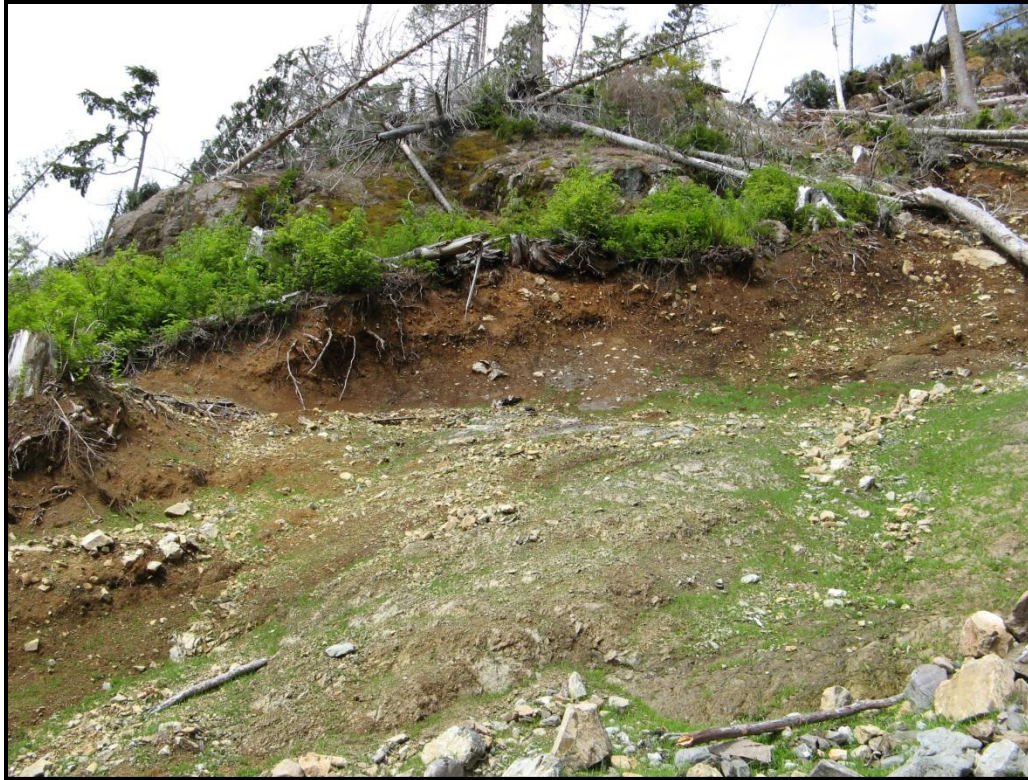
Figure 3.16: Root orientation within face of landslide headscarp. Few vertical tap roots were observed.

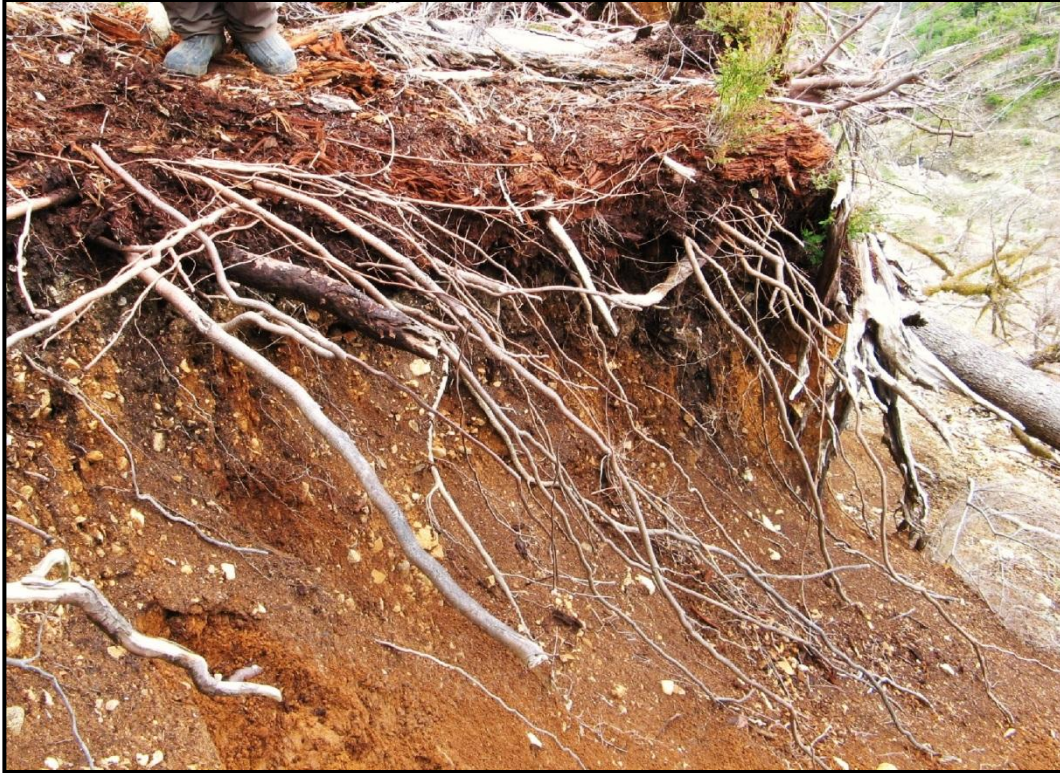
Figure 3.17: Extensive lateral rooting at a windthrow related landslide. Note the high number of roots pulled out rather than broken. Some of the pull out observed was related to liquefaction during high pore water pressures and not actual pull out of the roots.

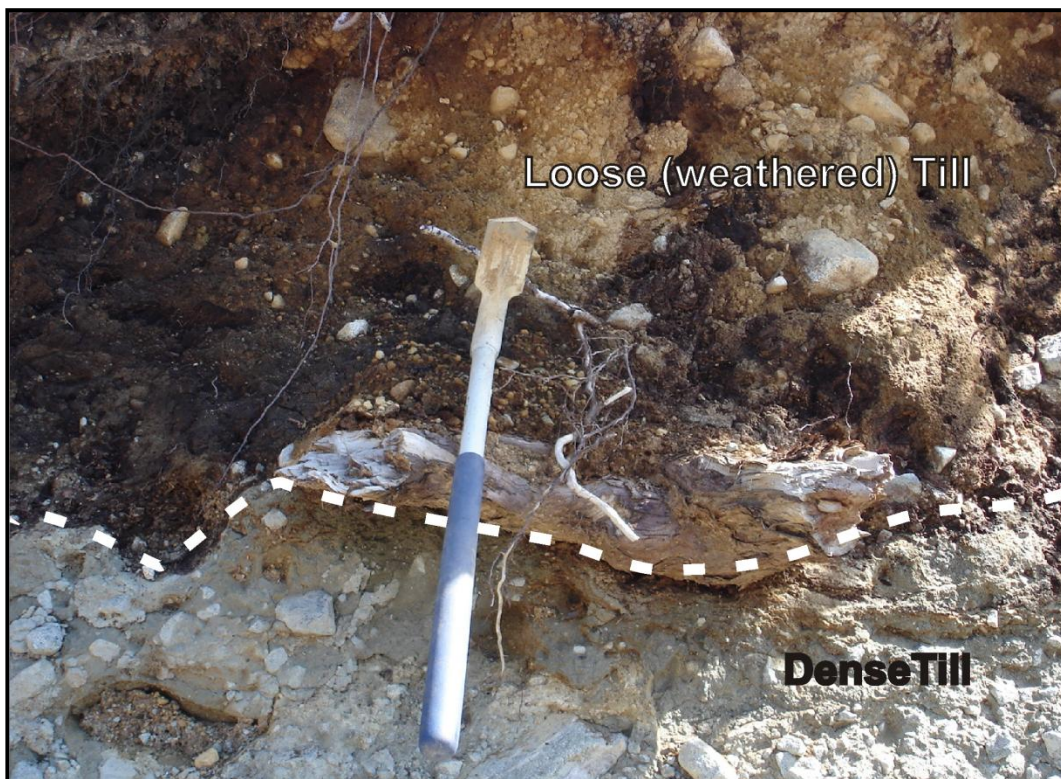
Figure 3.18: Vertical rooting restricted by dense till at 0.6 m depth. Particle size distributions showed that the till was generally a well graded sand with gravel; and the colluvium was a poorly graded gravel/sand with sand/gravel.

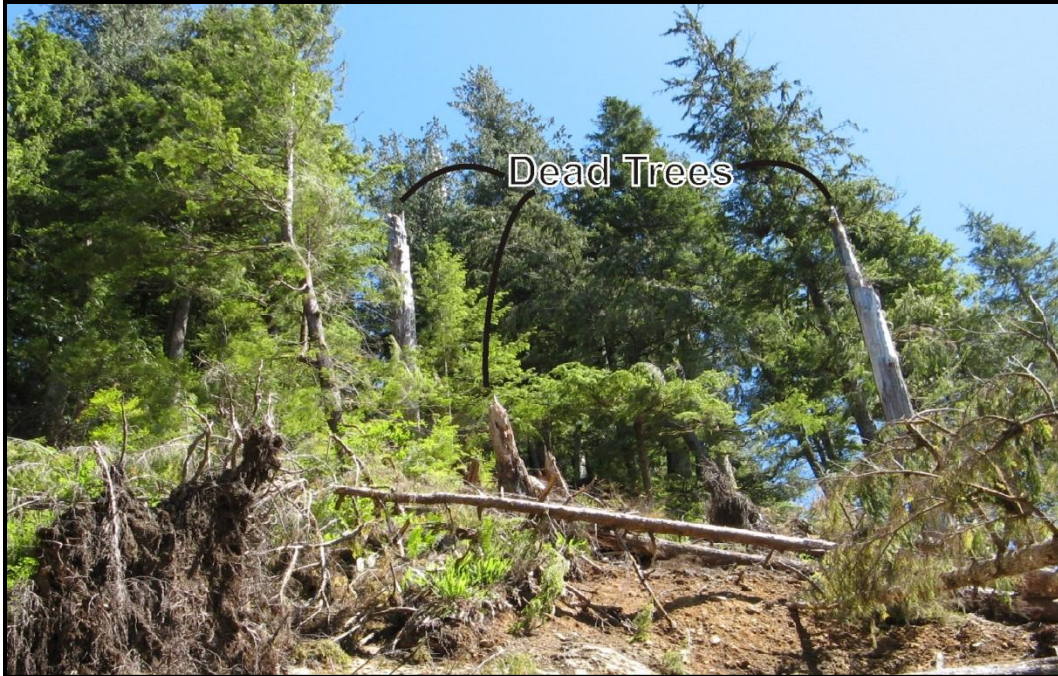
Figure 3.22: Forest opening above a landslide initiation zone. Note: dead trees, open forest, and general poor forest health. Forest cover database indicates that this forest is approximately 320 years old.

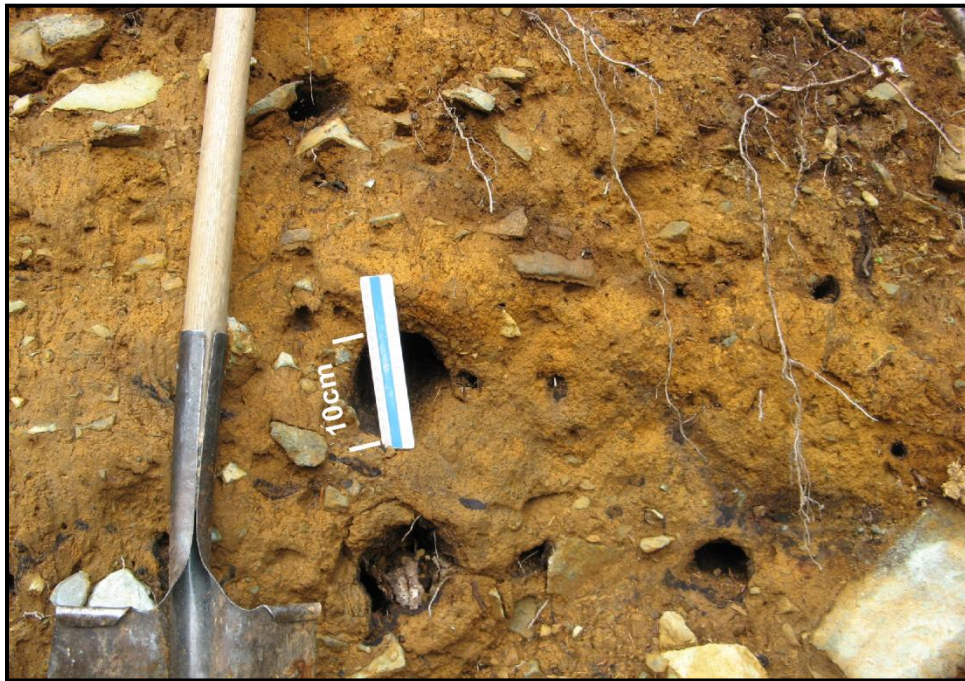
Figure 3.23: Original roots have decayed allowing the development of macropores in a 27 year old second growth forest.

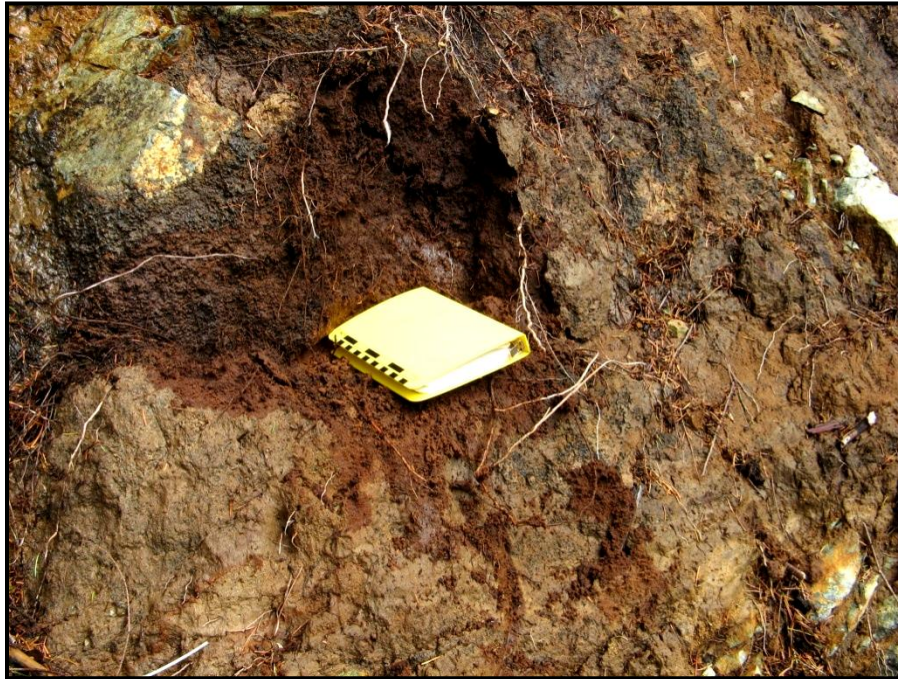
Figure 4.5: Basal organic layer approximately 40 cm thick overlying bedrock.

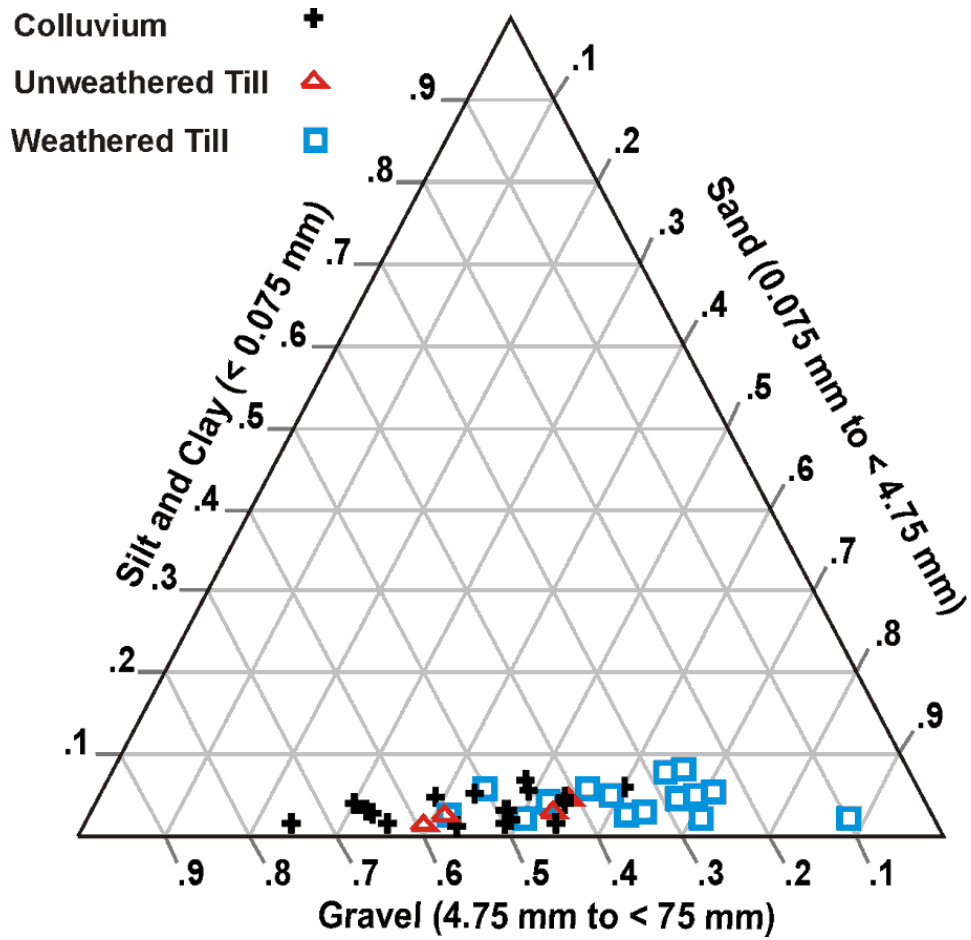
Figure 4.8: Ternary diagram showing particle size distribution for colluvium, unweathered till and weathered till observed at 36 out of 48 landslide sites visited.

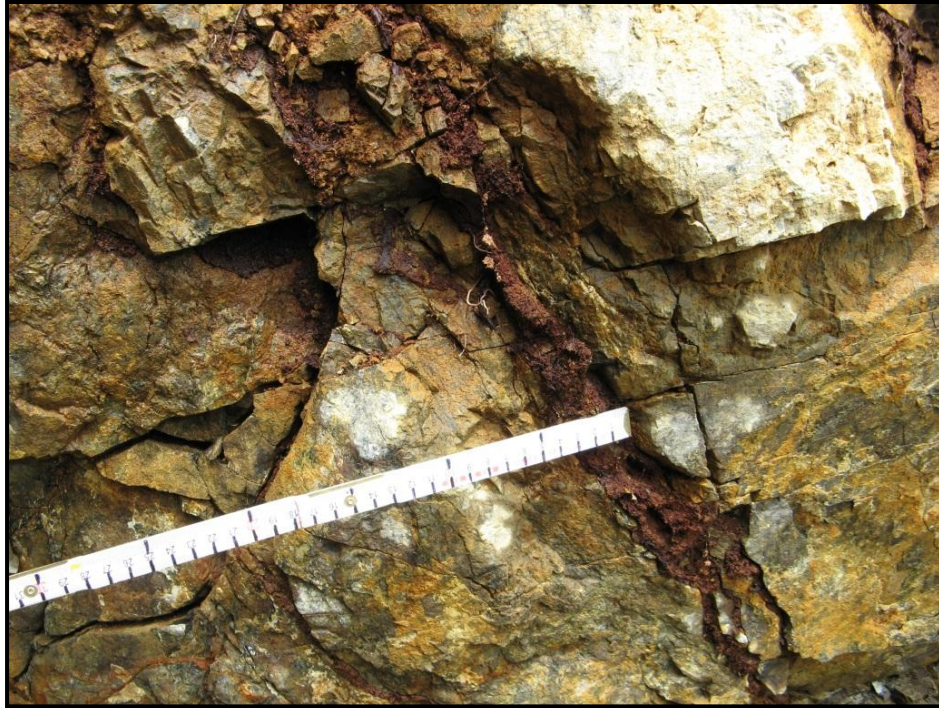
Figure 4.11: Organic layer infilling rock fractures along failure slope. Scale shows 1 cm increments.
