Restoration or Disturbance: Assessing the Impacts of a Salmon Habitat Restoration Project on Riparian Vegetation Composition

Abstract

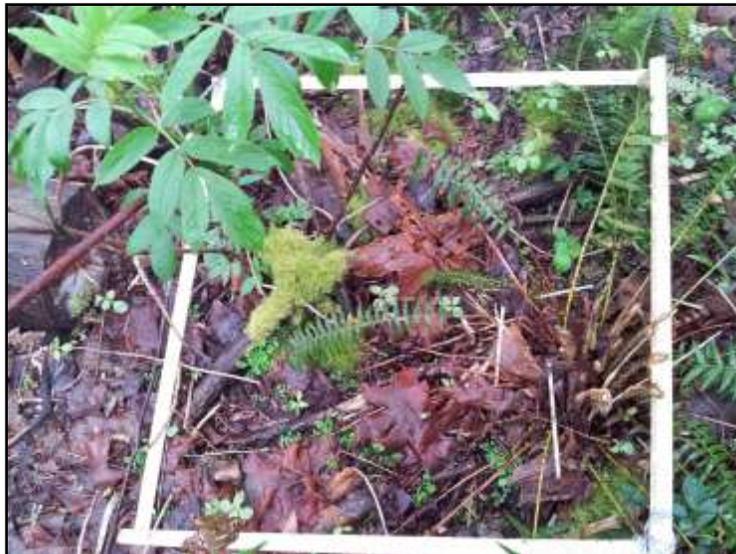
Figure 6. A typical quadrat or plot. Foliar cover was estimated visually for both total cover of the plot and for each species.

Species diversity, foliar cover of each species, and total foliar cover was assessed within each quadrat by visual estimation (Figure 6). Herbs, shrubs, and trees of less than 10 cm in diameter of both native and invasive origin were identified within each quadrat to the lowest taxa level possible. If plants were unable to be identified, they were given an arbitrary label (i.e. unknown herb 1). Assessing presence of individual species was useful to provide the most information possible, especially for noting the presence of invasive species. However, it was not absolutely necessary because only the total number of species, total foliar cover, and the foliar cover of invasive plants were required for this study.
