# LOCATIONS OF SELECTED MITIGATION SITES IN SWITZERLAND

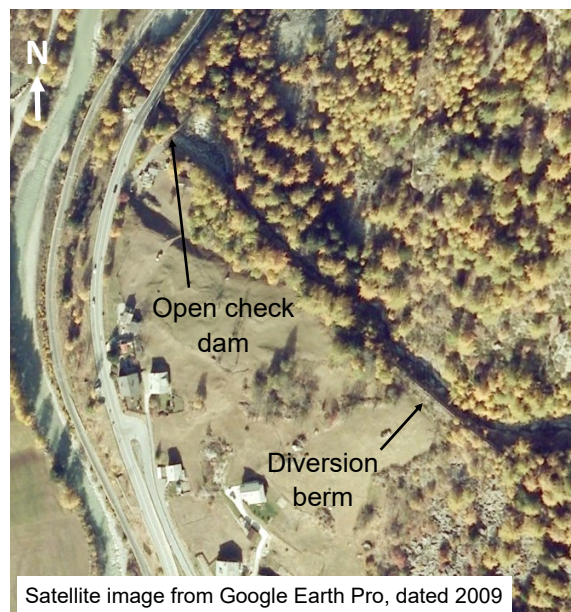
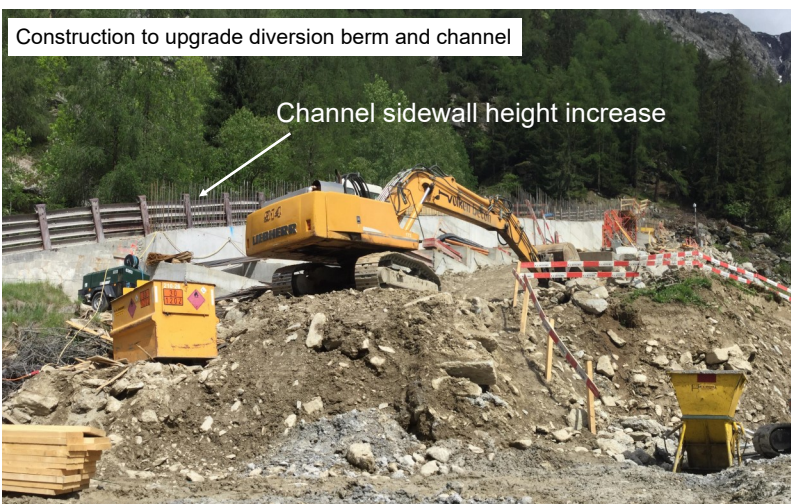
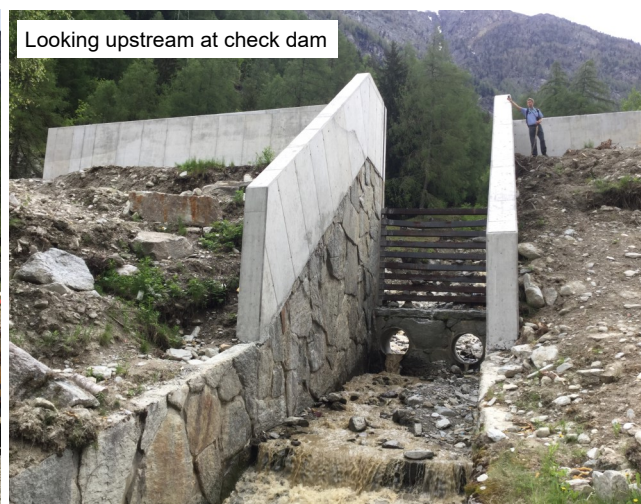
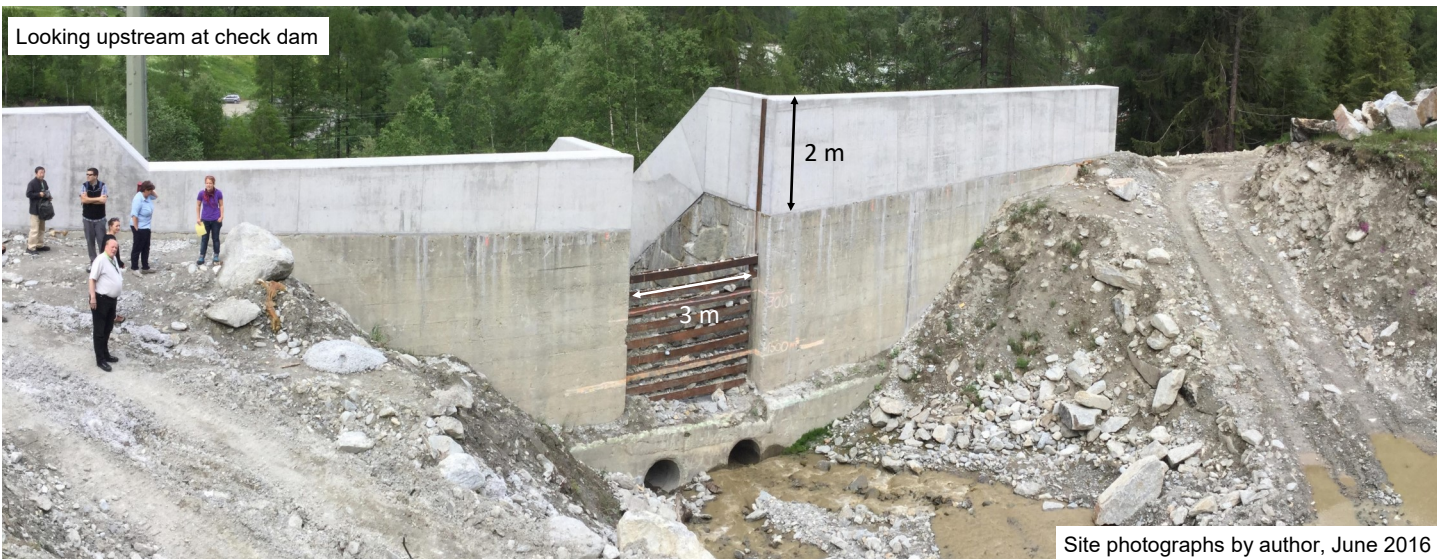
# BIELZUG, Canton of Valais, Switzerland

Mitigation measures      Diversion berm, armoured channel, open check dam  
Process type (and basis)      Debris flow  
General notes      Small basin being expanded to improve capacity

Upgrade project      Current basin capacity is 5000 m<sup>3</sup>, being upgraded to 20,000 m<sup>3</sup> (30 year event). 100 year event is 80,000 m<sup>3</sup>. A warning system is also installed because this capacity does not meet the protection targets; the village is still at risk from 300 year and extreme events. The system includes geophones in the watershed, linked to lights on the road and in the village. Cost of 1.8 million CHF (\$2.4 million CAD) and a cost benefit ratio of 2.9. Designed by the consulting firm wasser/schnee/lawinen.

Diversion and channel      Channel berms are between 2 and 4 m high. Side walls constructed from reinforced concrete. Lower channel armoured with inset boulders.

Open check dam      Outlet is 3 m wide with removeable horizontal beams. New concrete cap to increase check dam height.

Geomorphology      Some blocks up to 1 m.

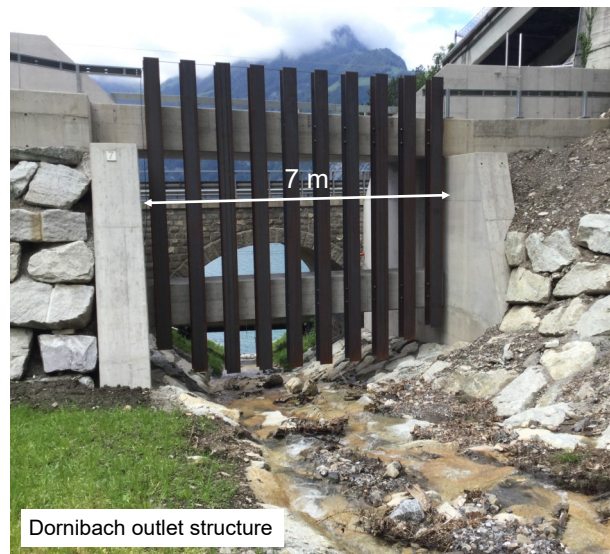
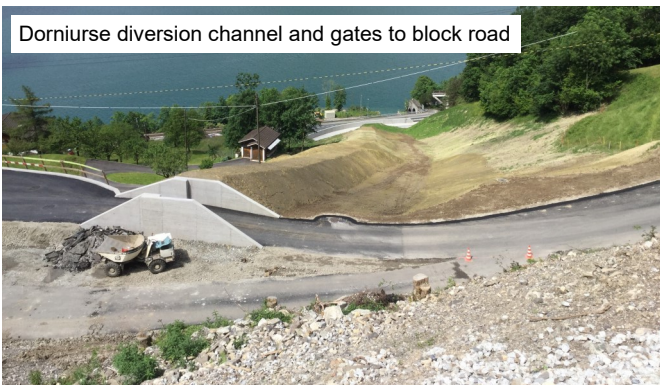
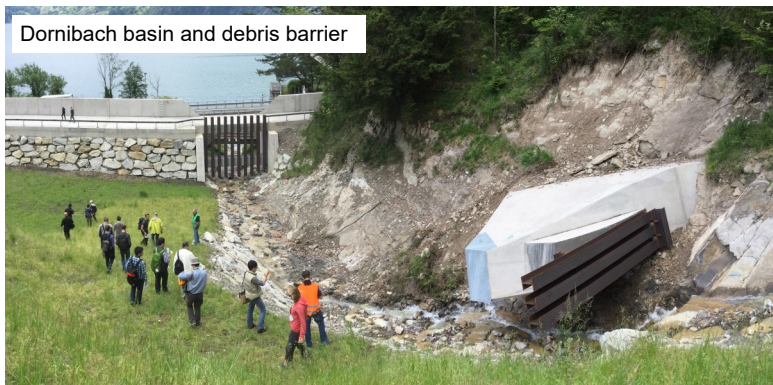
# DORNIBACH and DORNIURSE, Canton of Schwyz, Switzerland

Dorniurse mitigation	Basin; diversion berm
Dornibach mitigation	Energy dissipation structure; basin and open check dam
Process type (and basis)	Debris flows
General notes	Two creeks managed through a combined system

**Dorniurse mitigation** There was a 5000 m<sup>3</sup> rockfall in the ravine in 2009, which destroyed the old retention basin and a house in the village. New basin is planned with a 4000 m<sup>3</sup> capacity. Enough to hold the 30 year event; larger events will be diverted to Dornibach. Debris gates across the road need to be closed manually by the fire brigade.

**Dornibach mitigation** Basin and energy dissipation structure installed just above the railway. The design was tested with physical model. Breaker required to slow the flow and direct material into the basin. Estimated maximum velocity of 25 m/s; breaker slows flow to 12 m/s. Outlet opening is 7 m wide and 5-6 m high. Openings are 0.4 m wide, between 0.3 m I-beams.

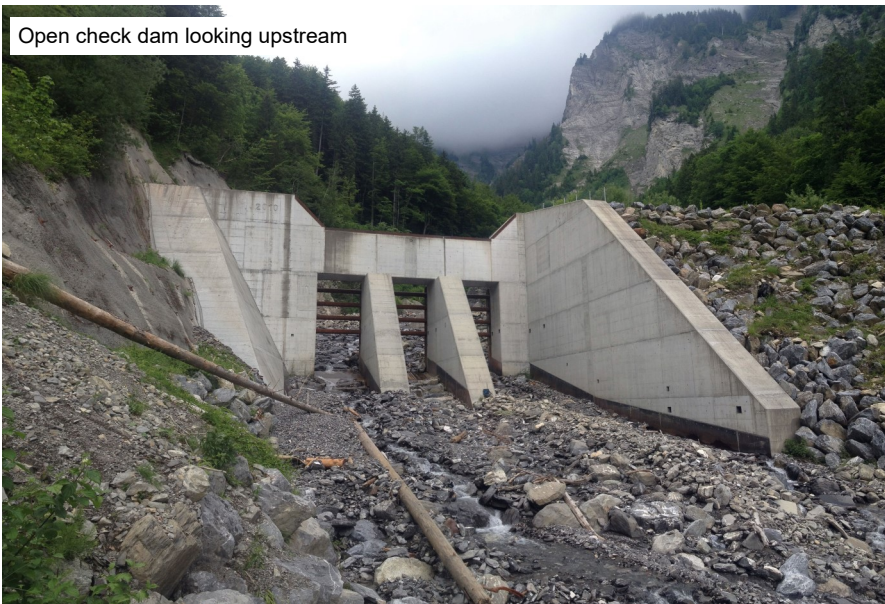
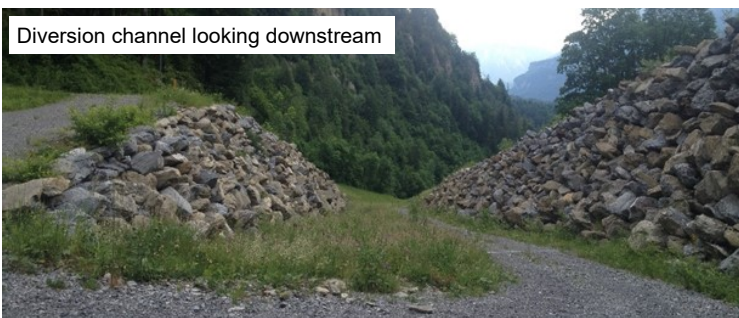
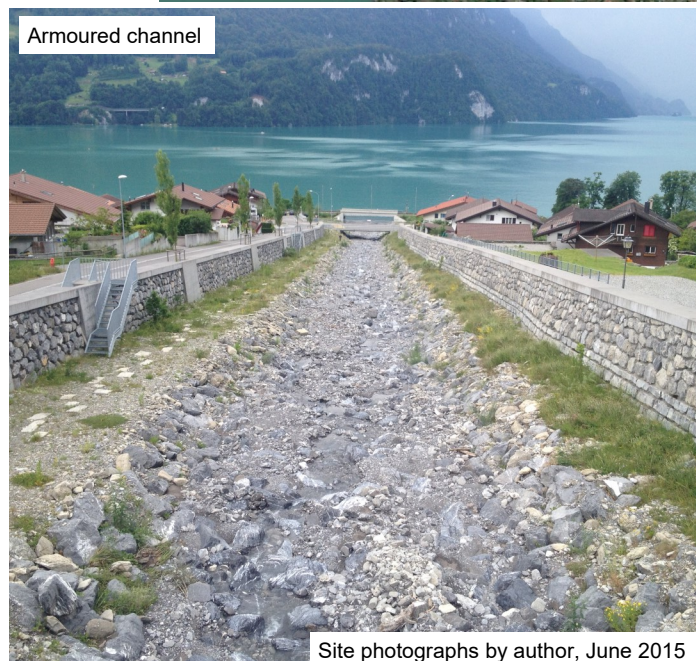
# GLYSSIBACH, Brienz, Canton of Bern, Switzerland

Mitigation measures 1) Open check dam, 2) diversion channel, 3) retention basin and berm, 4) armoured channel, 5) improved bridge conveyance

Open check dam Foundation consists of a 1.5 m thick, 17 m wide and 40 m long concrete slab. The barrier is 2 m thick, and is composed of 2680 m<sup>3</sup> of concrete and 222 tonnes of steel rebar. The downstream fins stabilize against tilting and sliding. Intended to pass small events (up to 25,000 m<sup>3</sup>); larger events are diverted into the retention basin.

Retention basin Capacity of around 75,000 m<sup>3</sup>. The tallest section is about 15 m high.

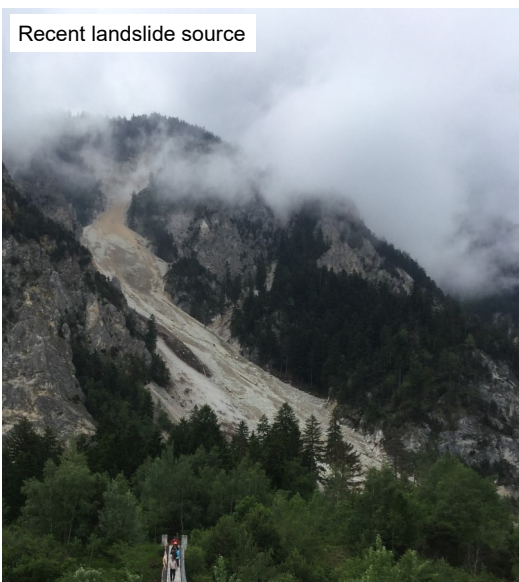
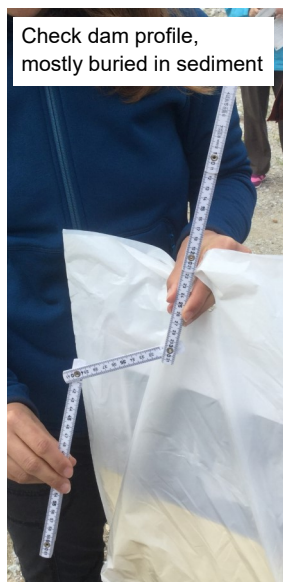
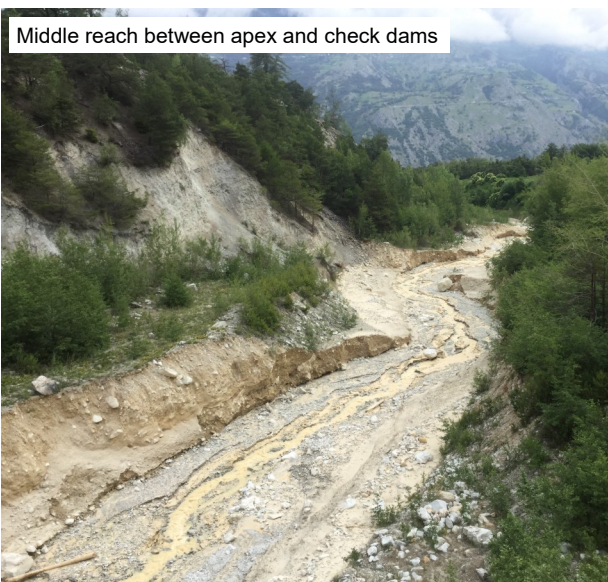
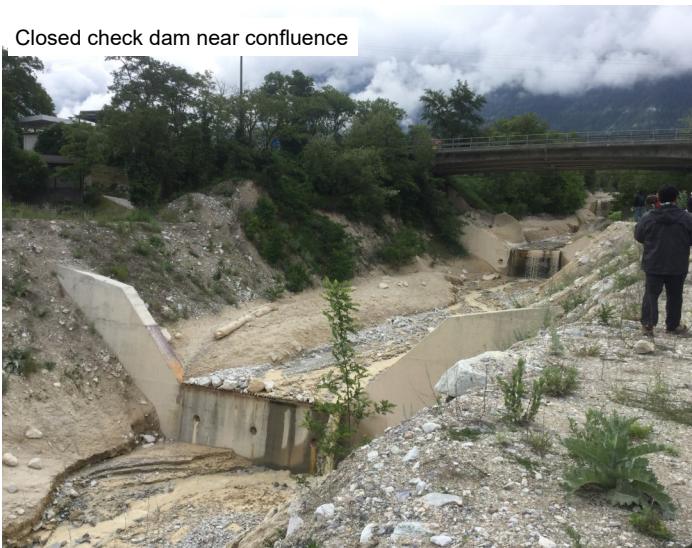
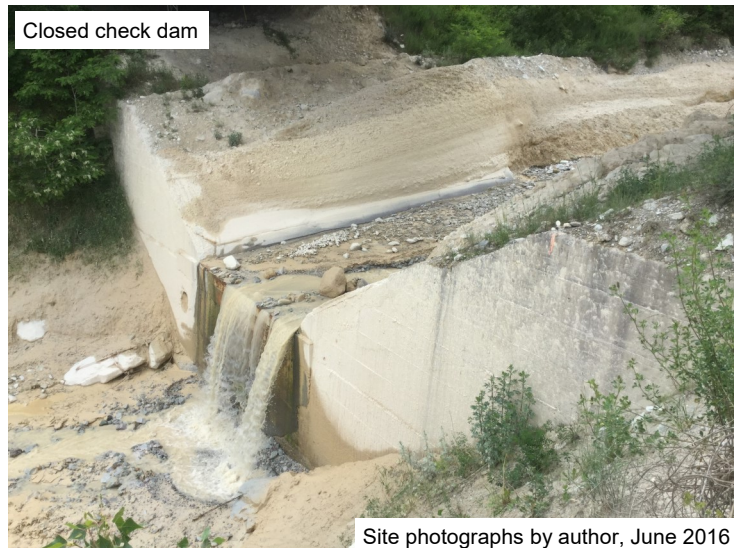
# ILLGRABEN, Canton of Valais, Switzerland

**Mitigation measures** Large closed check dam in upper watershed; series of check dams; monitoring system. Plan to add overflow weir and diversion structure (Berger et al., 2016).

**Historical construction** In 1961, a 500,000 m<sup>3</sup> debris flow prompted the construction of 30 check dams in the channel and a large consolidation dam (40 m high) in the upper watershed. Decreased frequency for a while.

**Monitoring** WSL monitoring started in 1999. System includes: rain gauges in the upper watershed; geophones; depth sensors; force plate; erosion sensors; and instrumented wall with force plates and geophones. There is also an alert system near the channel, with lights and sirens. If an alert is triggered at the upper consolidation dam, there is 5-10 minutes to escape.

**Erosion** Very large variation in channel bed. For example, 6 m between two seasons.

**Planned diversion** Overflow structure planned at the first dogleg below the fan apex. Intended to pass smaller events and divert larger events onto the western, undeveloped portion of the fan

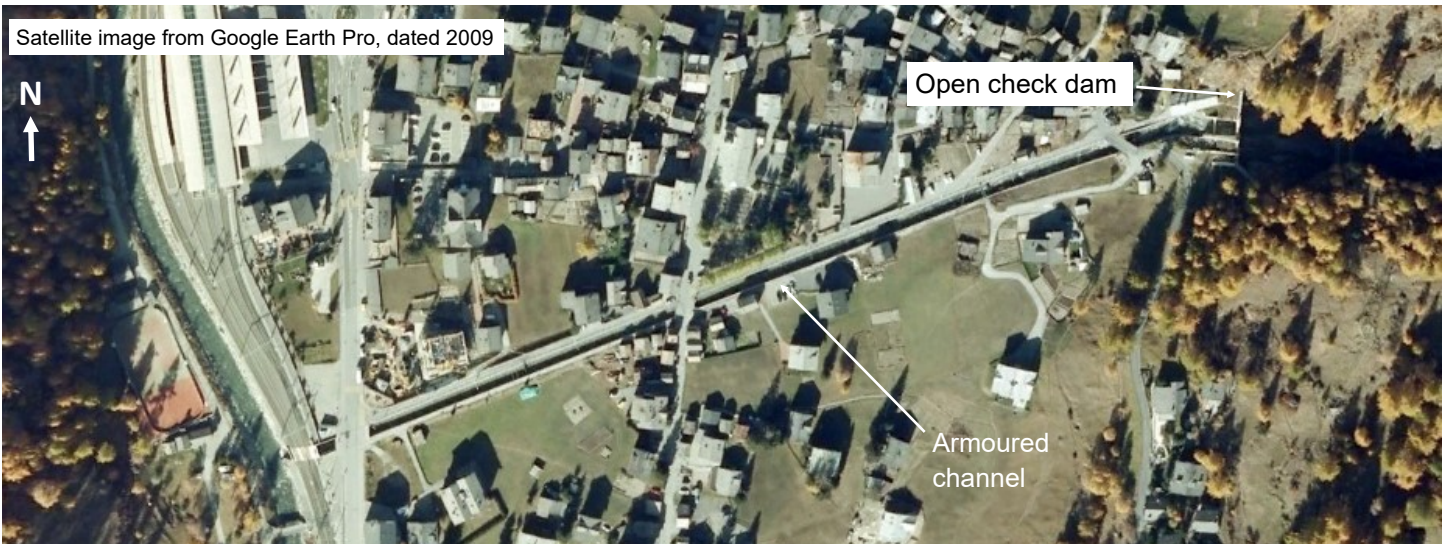
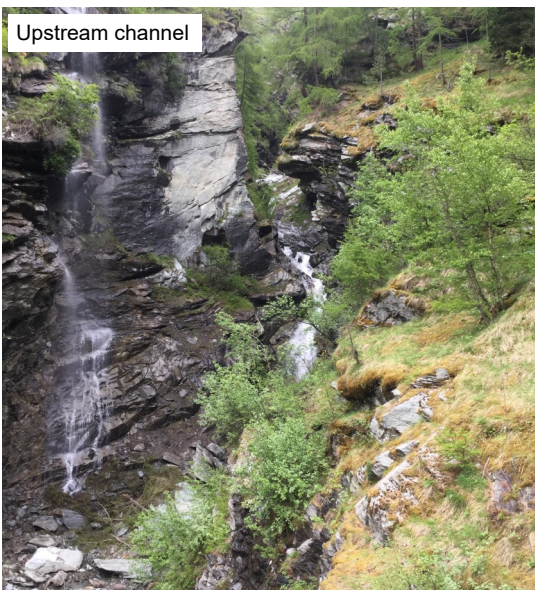
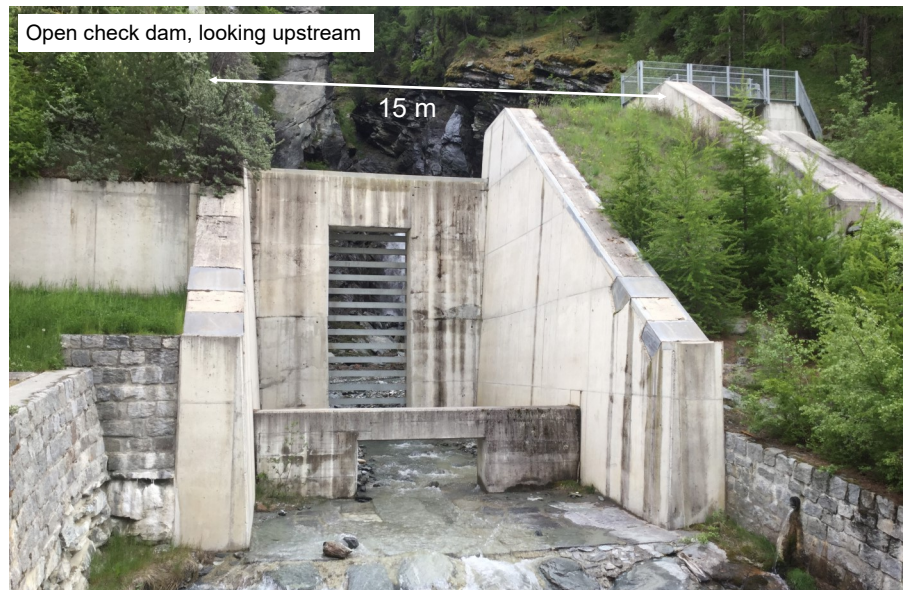
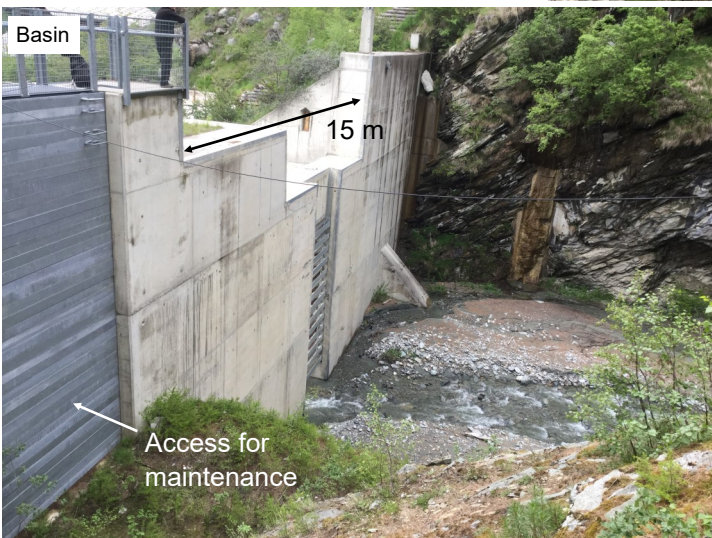
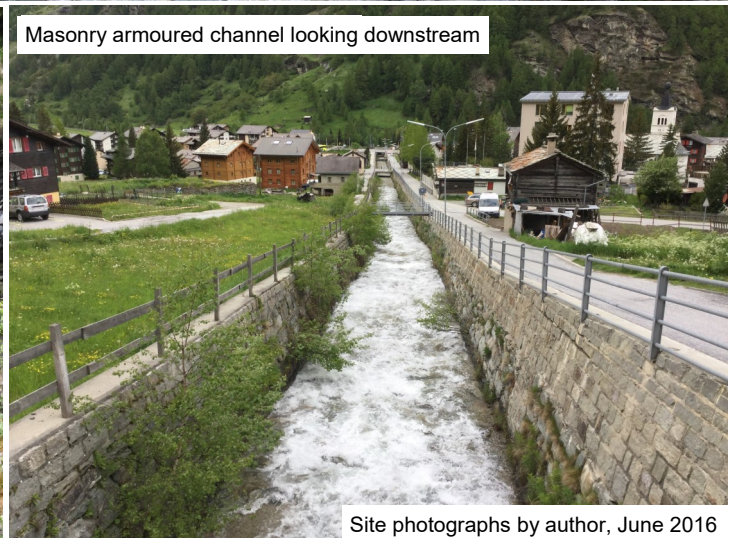
# TASCHBACH, Canton of Valais, Switzerland

Mitigation measures      Check dams in upper watershed; open check dam; masonry armoured channel  
Process type (and basis)      Debris flows, disasters in 1957 and 2001 (according to sign posted on the dam).  
General notes      Downstream side of check dam is vegetated. Spillway is about 15 m wide.

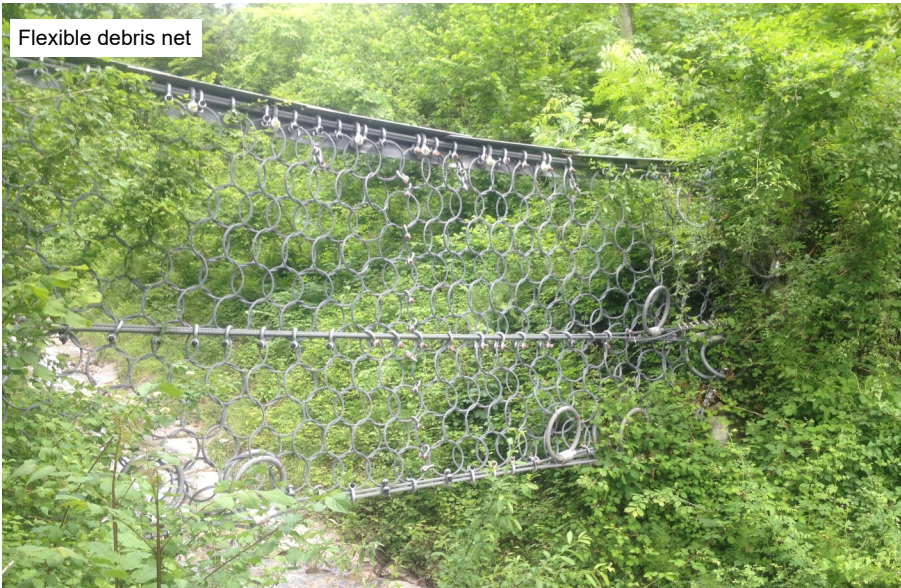
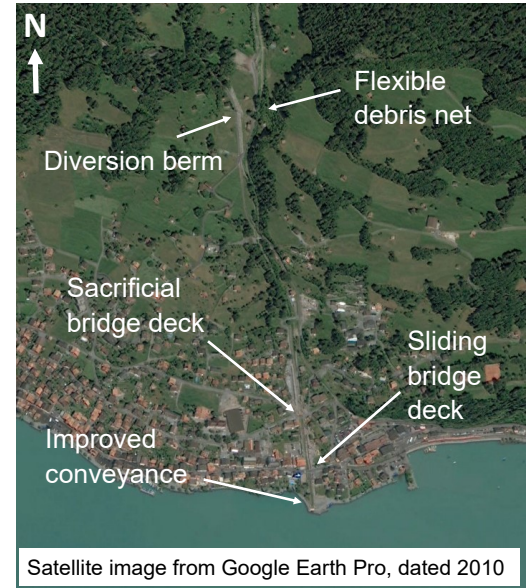
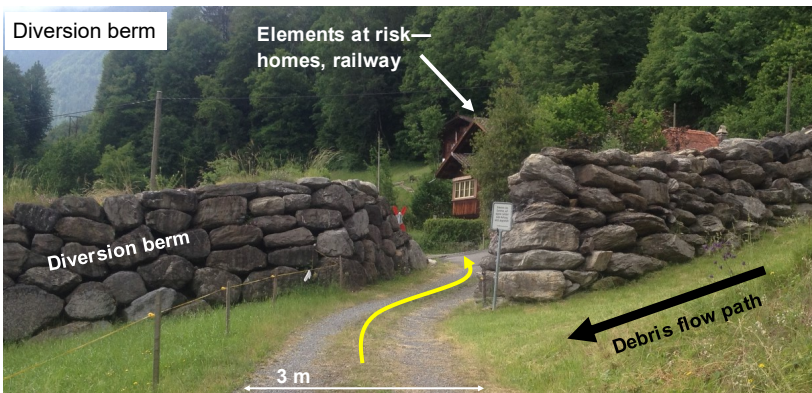
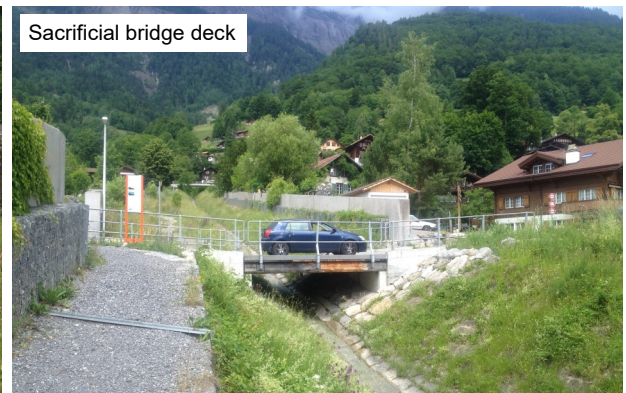
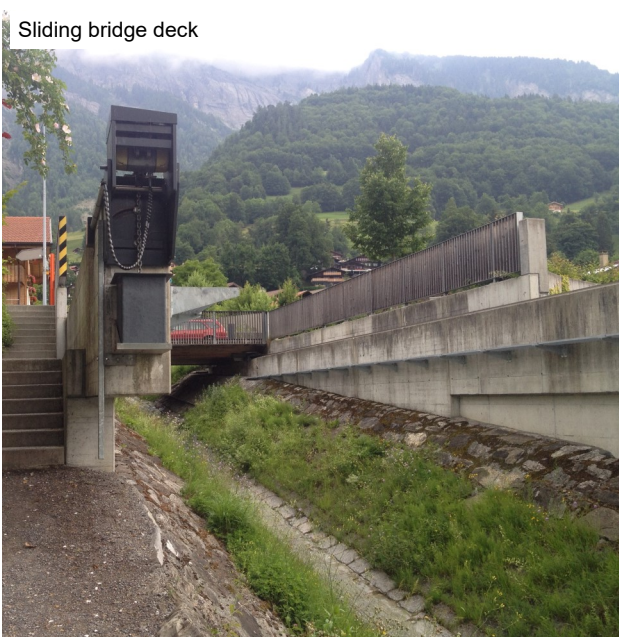
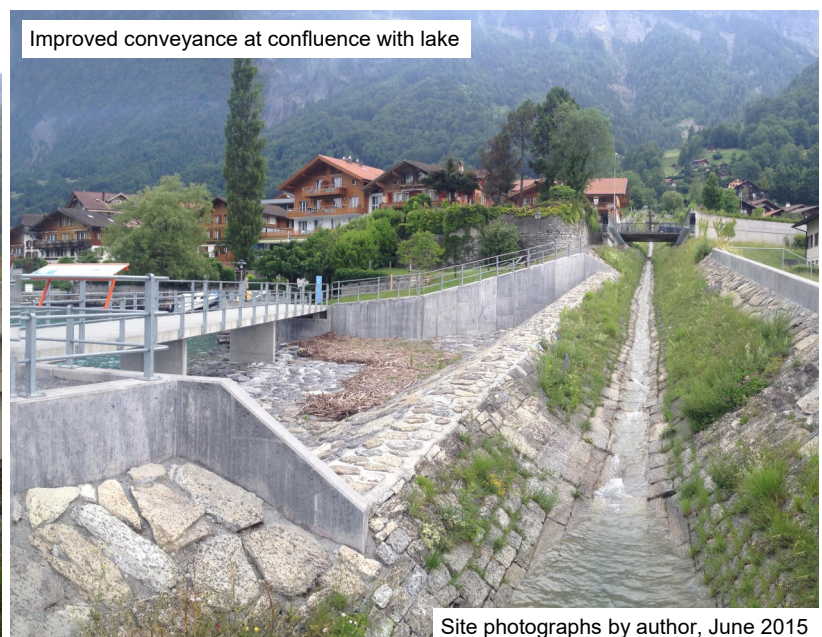
# TRACHTBACH, Brienz, Canton of Bern, Switzerland

1) Flexible debris net, 2) armoured channel, 3) bridge with sidewalls that break when subjected to flows, 4) moveable bridge, 5) improved capacity at confluence
