# LOCATIONS OF SELECTED MITIGATION SITES IN JAPAN

# YAKEGAHARA, near Kobe, Hyogo, Japan

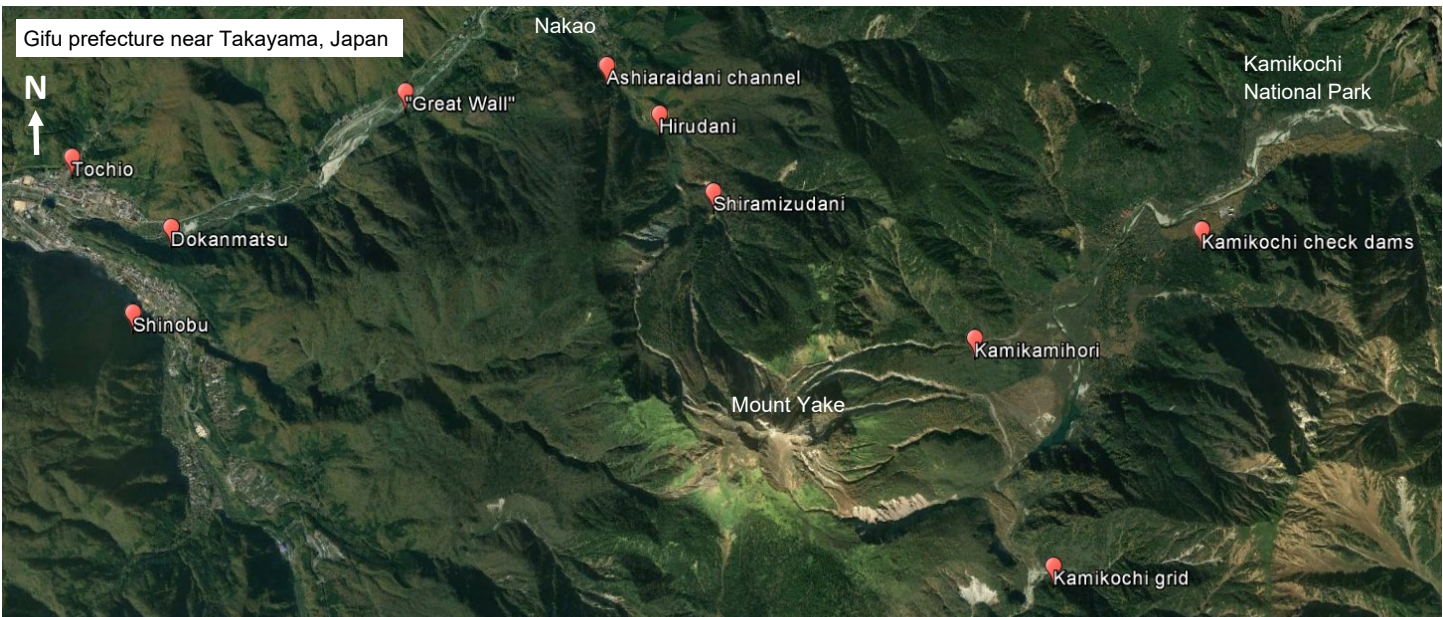
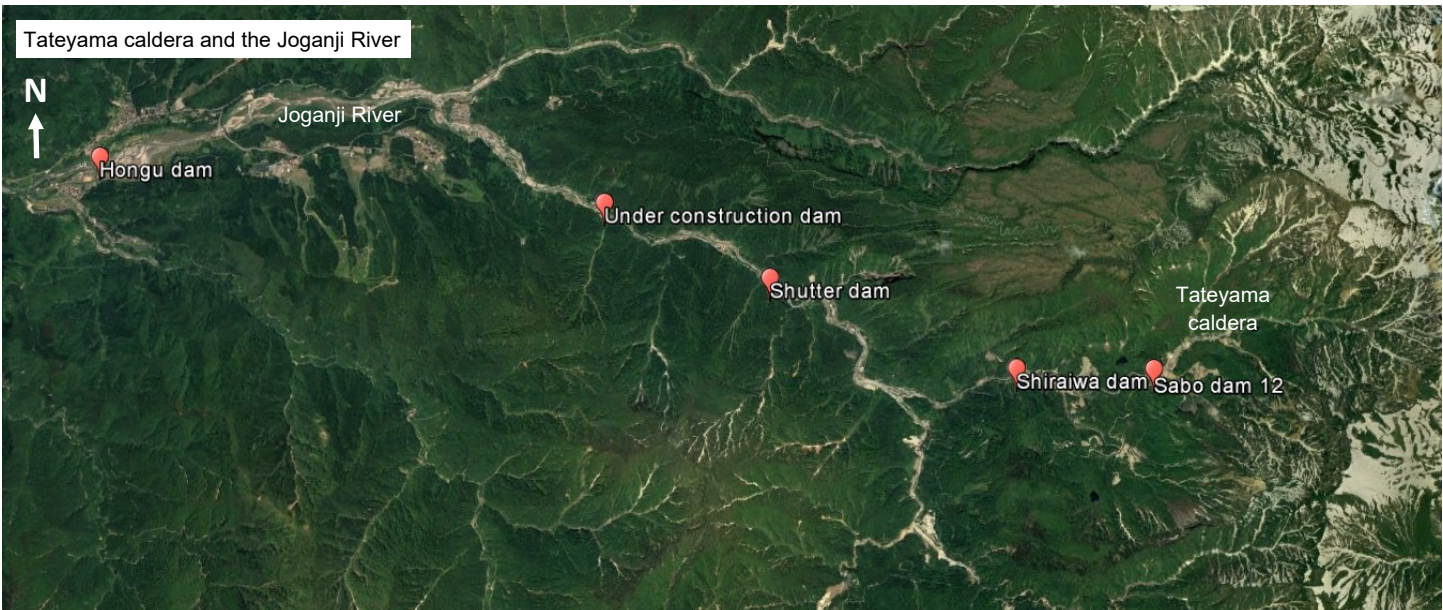
Mitigation measures Consolidation dam and concrete-lined channel  
Process type (and basis) Debris flows; consolidation of landslide sediment  
General notes Built after a landslide, but there has been little (no?) sediment transport since

Consolidation dam Concrete barrier with granite facing for decoration and aesthetics. 14 m high because of the 15 m seismic requirements. 4 m crest width. Two steel grids to block inlets to basin. Basin is concrete-lined.

Basin Concrete-lined. About 30 m deep and 100 m wide

Maintenance Culverts under the barrier are cleaned by excavator. Will require a crane for access; has not been done yet. Inspections completed every year.

Armoured channel Concrete-lined, with steps

Construction Built in 1998. Cost of about 300 million yen (in 1998?) - \$3.4 million

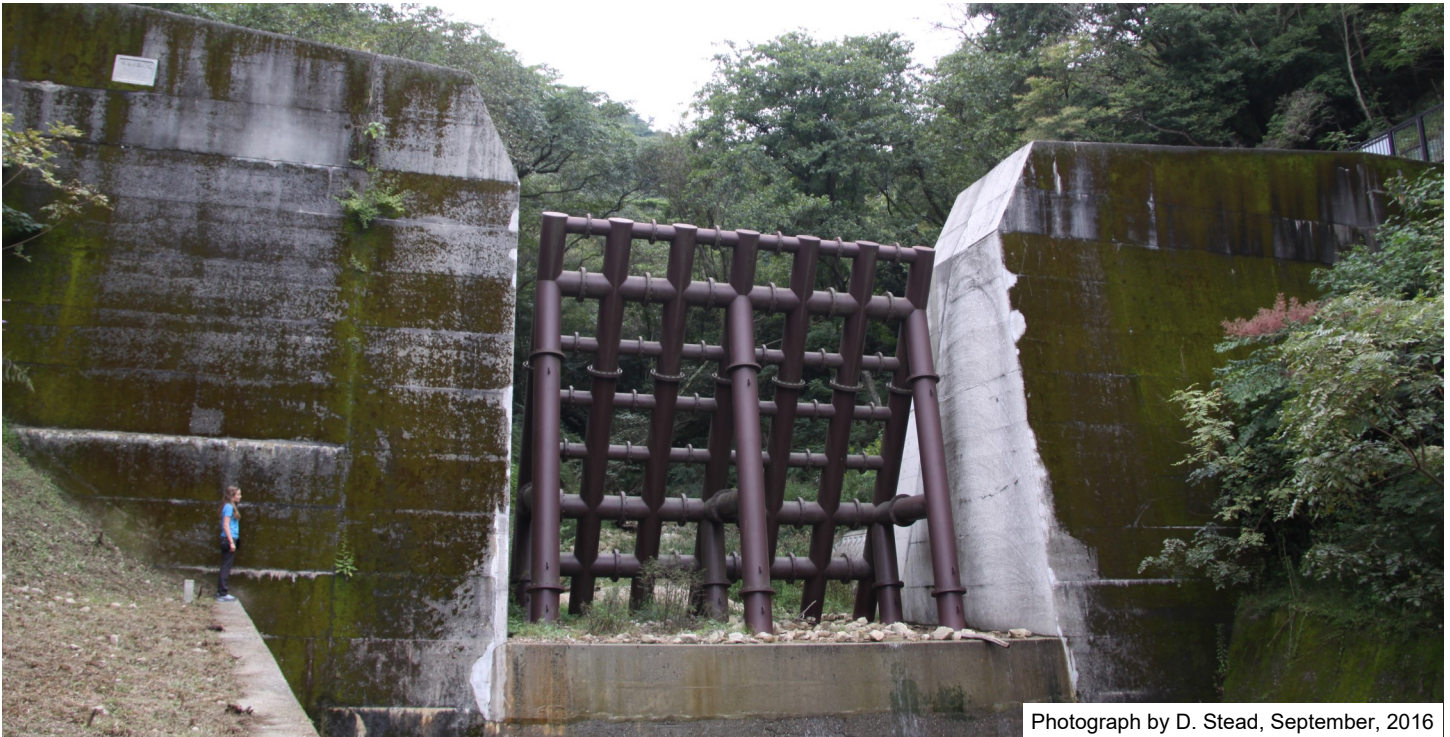
Mitigation measures Open check dam with concrete sidewalls and a grid outlet structure

General notes Used to be a closed dam (built in 1968); recently renovated to incorporate the grid (2013). Dam is 12.5 m tall. Cost of \$770,000 CAD for the renovation. No maintenance since renovation.

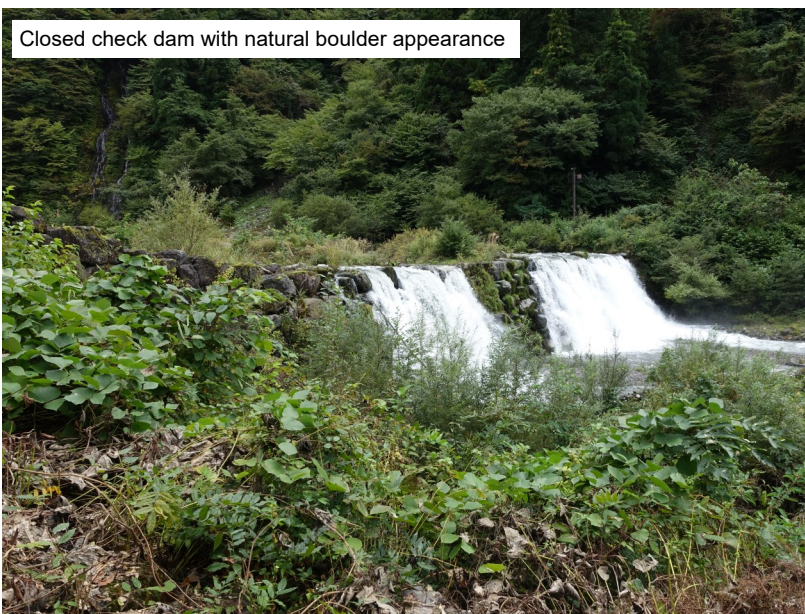
Closed check dam with natural boulder appearance

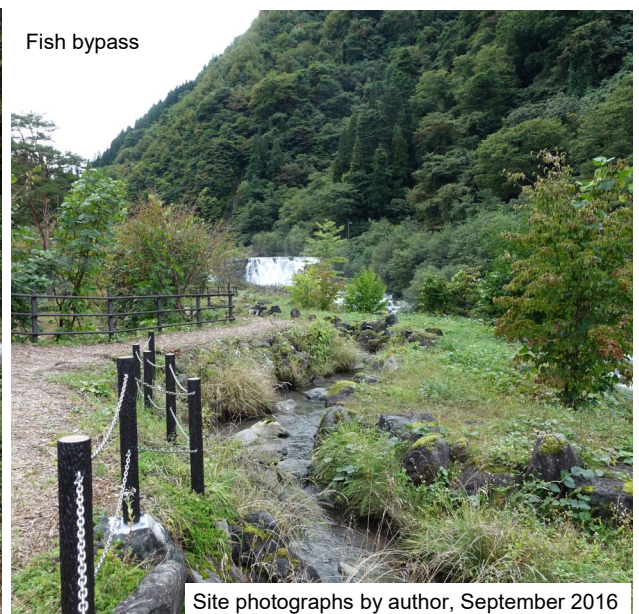
Fish bypass

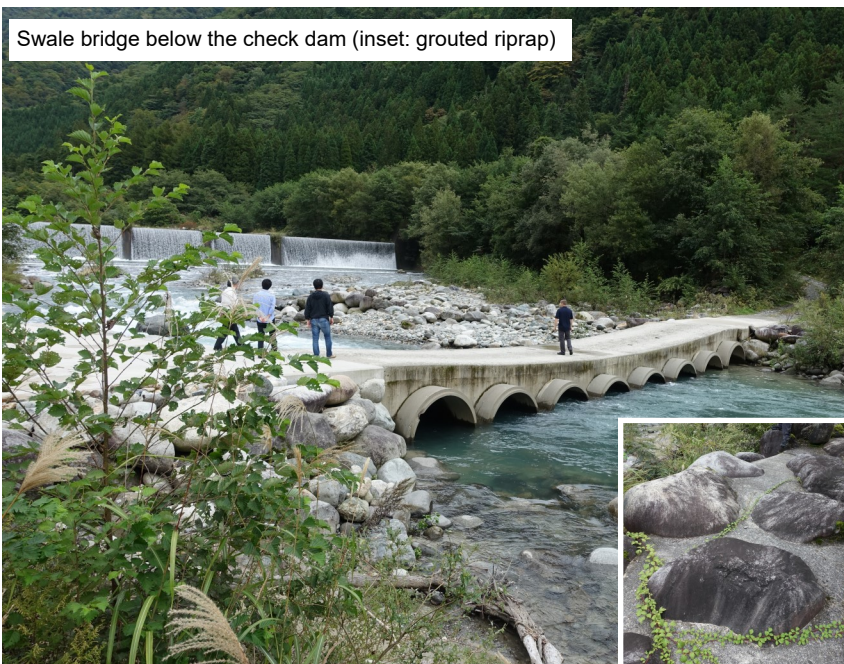
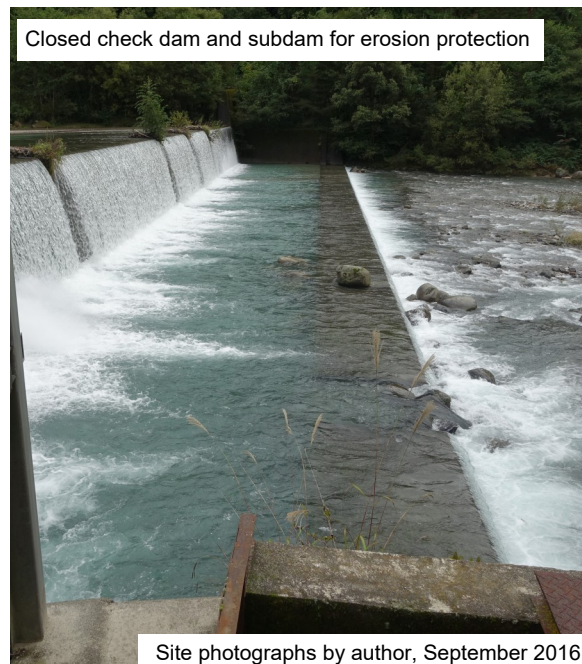
Mitigation measures Closed check dam; swale bridge with culverts; fish weir; monitoring

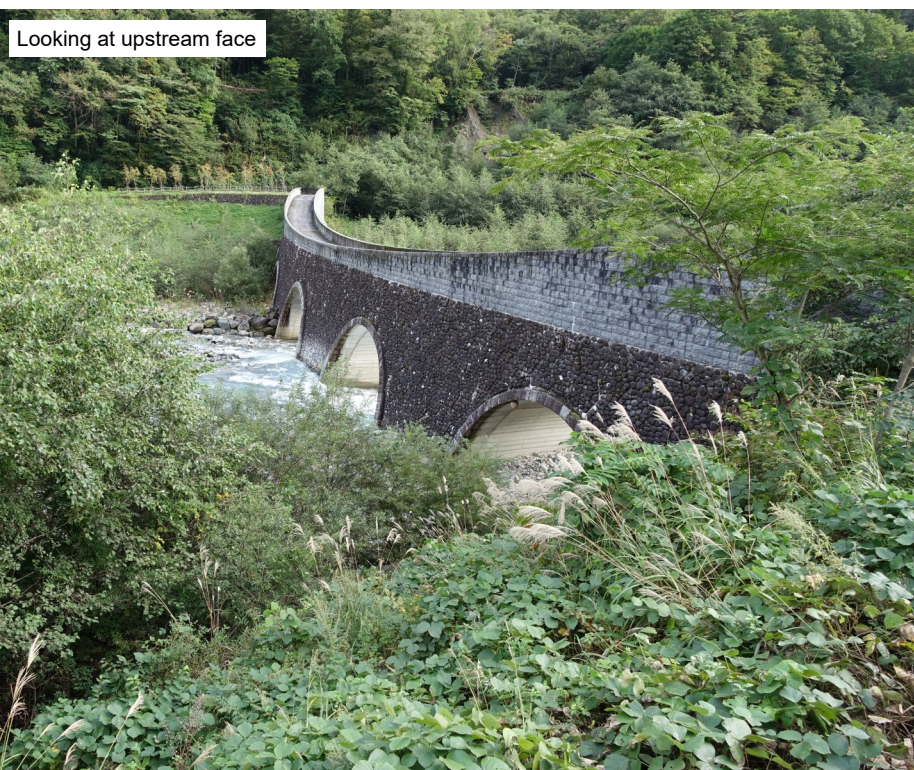
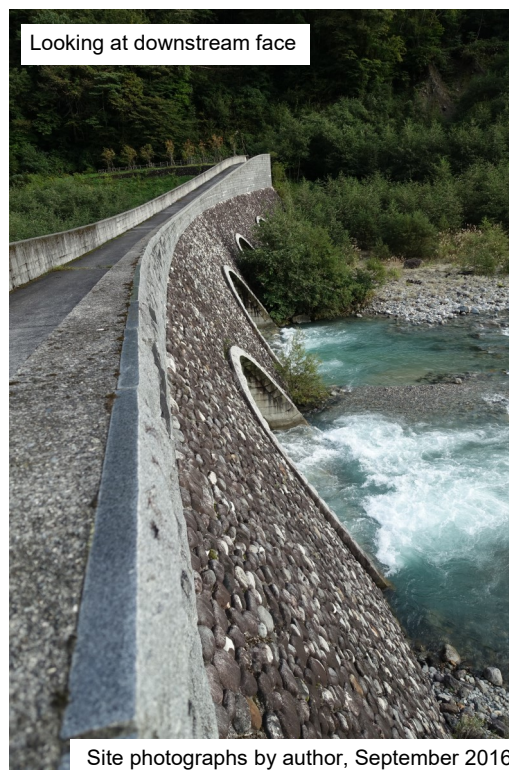
Mitigation measures Open check dam with large arch openings and decorative stone facing.

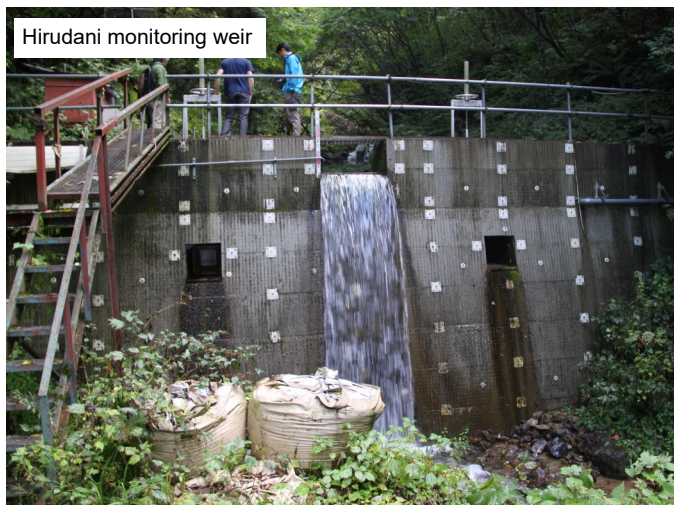
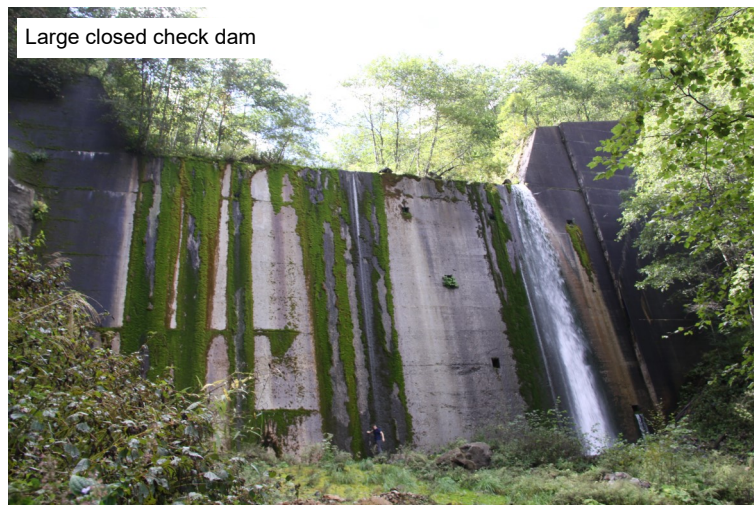
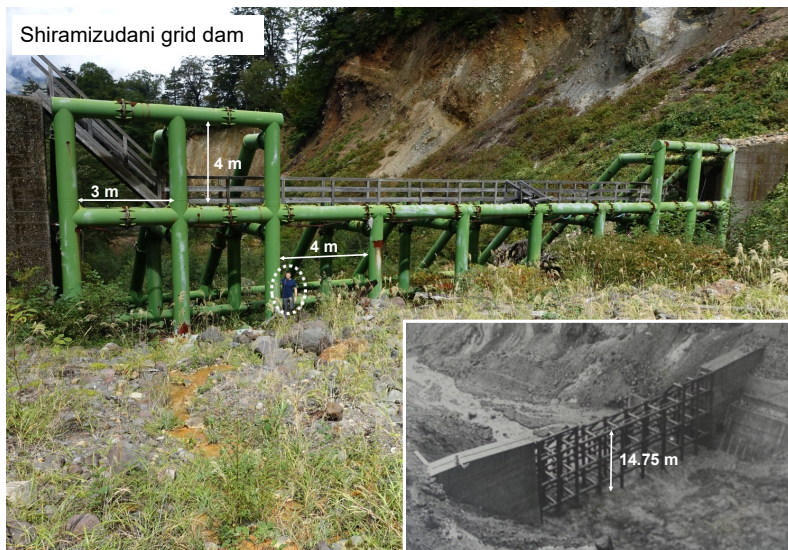
**Shiramizudani grid dam**  
 Completed in 1980, constructed by Kobe Steel Company. Design discharge: 94 m<sup>3</sup>/s. Height: 14.75 m. 4395 m<sup>3</sup> of concrete and 242 tonnes of steel. 4 x 4 m openings in the middle, 3 x 4 m openings on sides. Used to use 2x D90 in the 1980s. Maintained 2 or 3 times since construction. 21,000 m<sup>3</sup> capacity.

**Hirudani**  
 Completed in 1975. Empty basin by opening slots approximately every year. Approximately 50 m<sup>3</sup> per year. Using TDR sensors to monitor sedimentation.

**Ashiaraidani channel**  
 Installation of Swiss plate geophones, and Japanese microphone plates.

**Check dams**  
 Large check dams in upper watershed; open dam under construction in village.

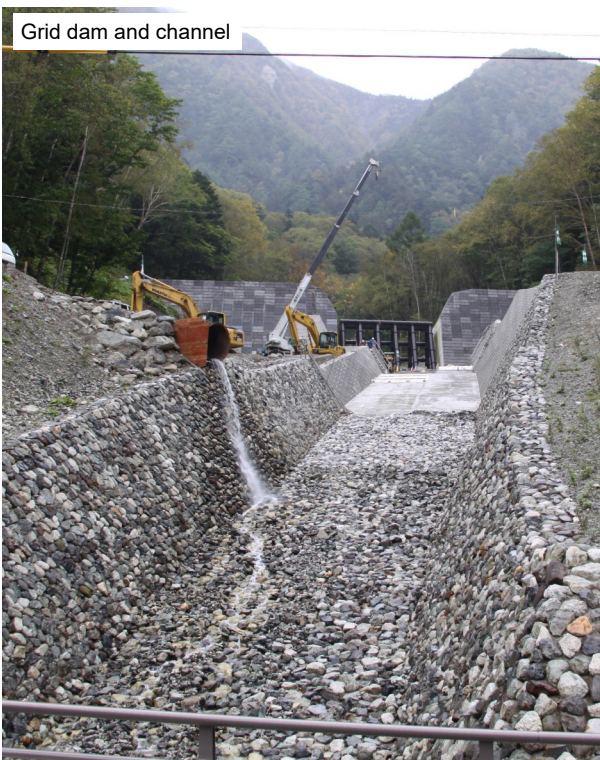
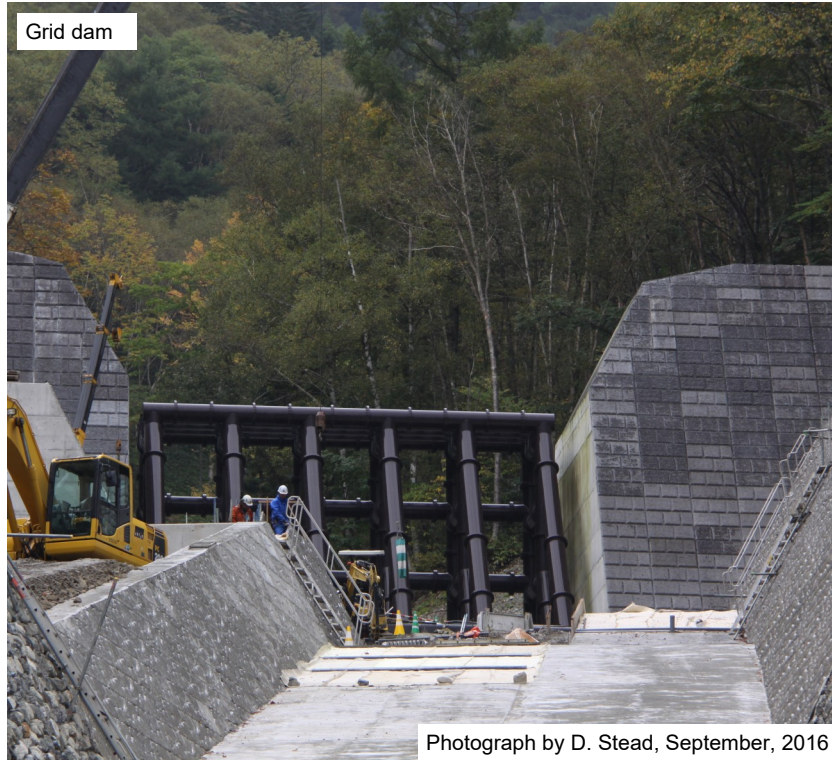
Mitigation measures	Open check dam and erosion protection
Process type	Debris flows
General notes	Active construction site on the access road to Kamikochi National Park

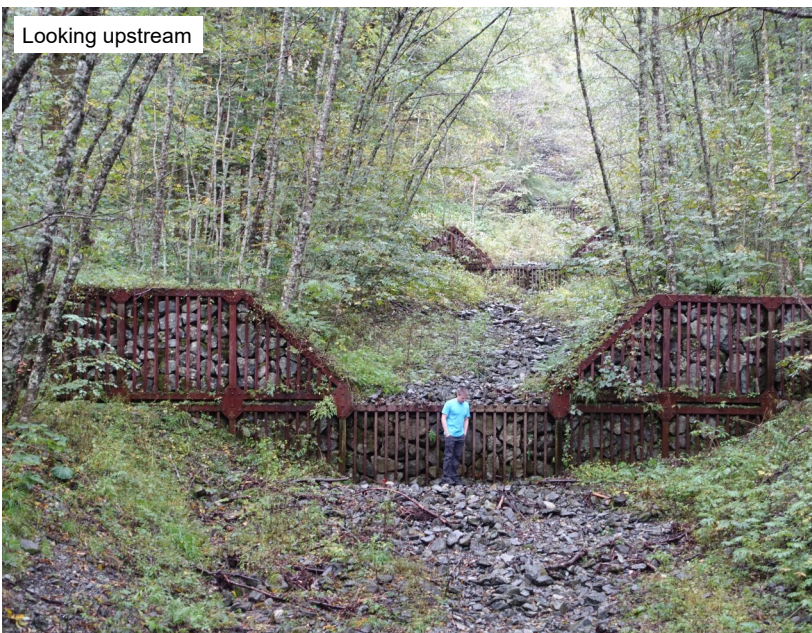
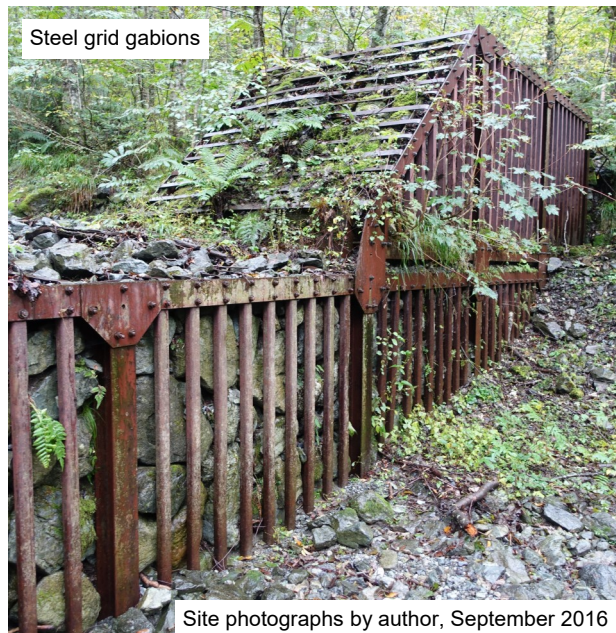
Mitigation measures	Closed check dams
Process type (and basis)	Unknown (debris flows?)
General notes	Check dams created from steel posts, filled with cobbles and boulders from the stream

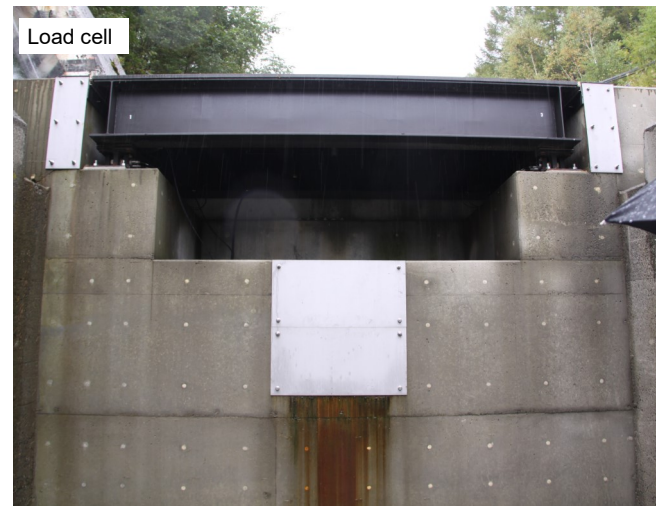
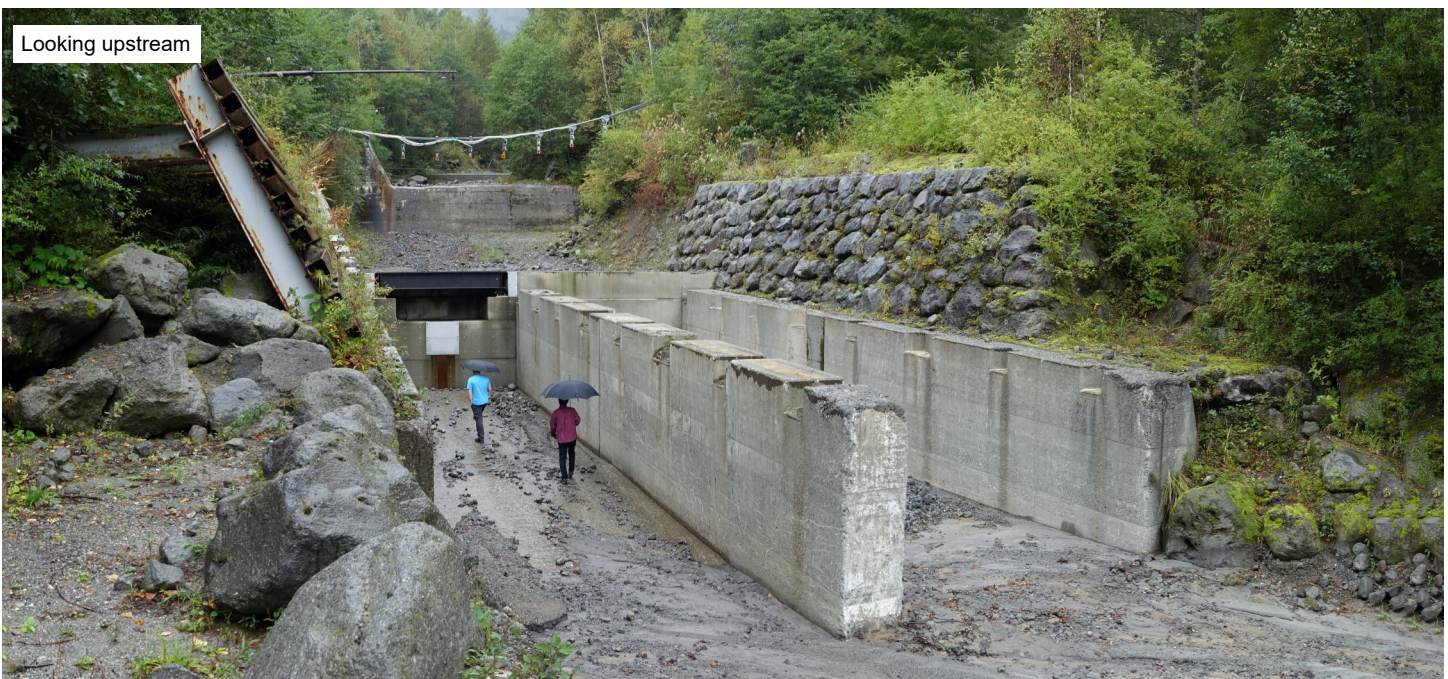
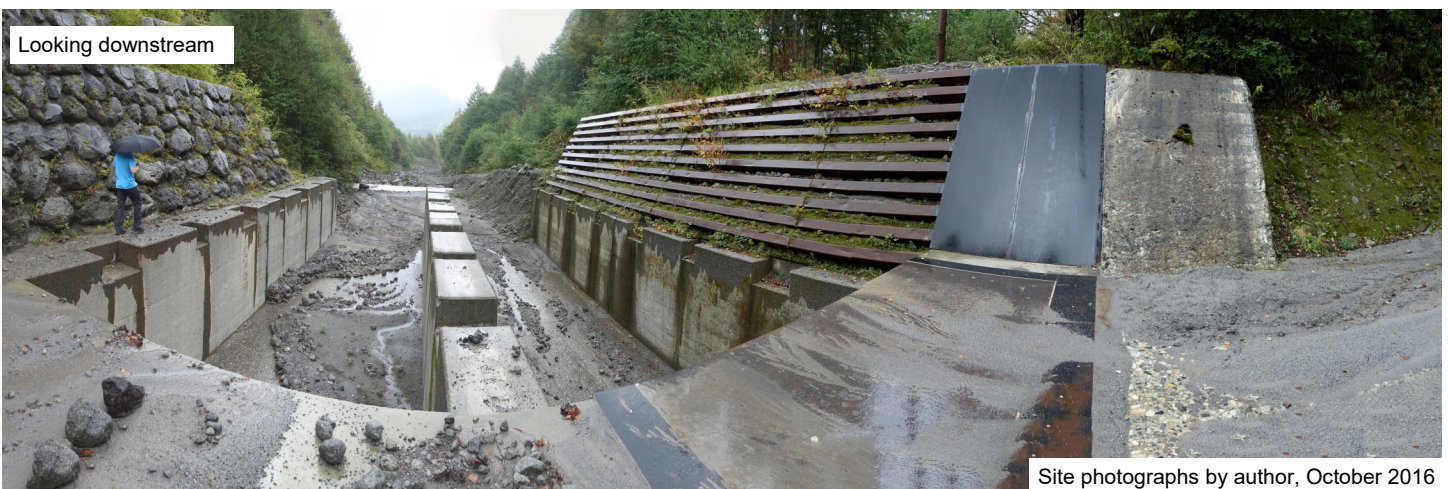
Debris breaker      About 3 m high from base to top of grill. Other geometry information not available because the grid has been removed. It was stressed that the sidewalls are very important to prevent overtopping and avulsion.

Monitoring      The current system includes a load cell and water level sensor to estimate water content and sediment load (fines). There are 11 trip wires upstream; the sensors turn on after at least 2 trip wires are triggered.

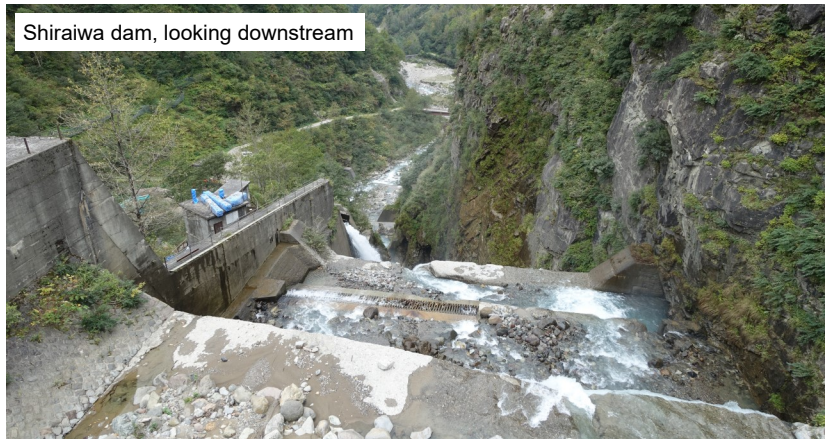
Unconsolidated landslide dam sediments

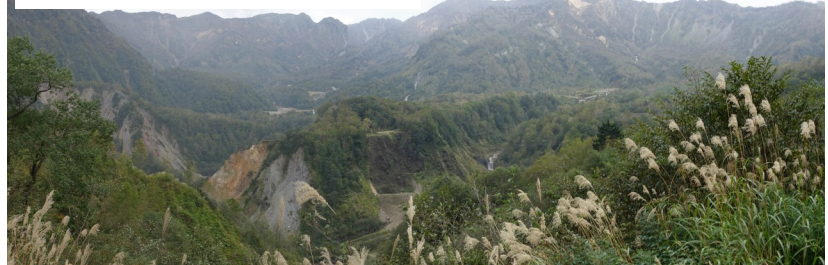
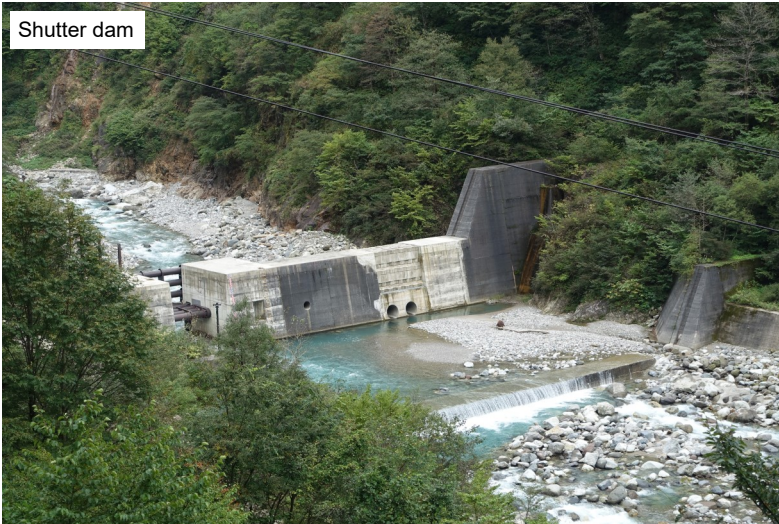
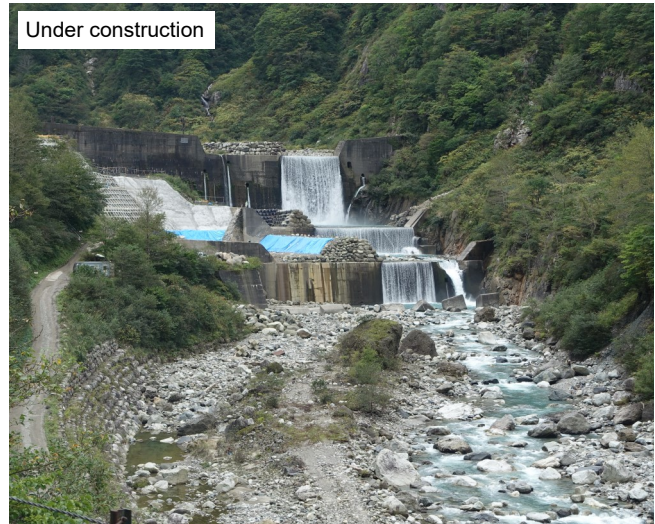
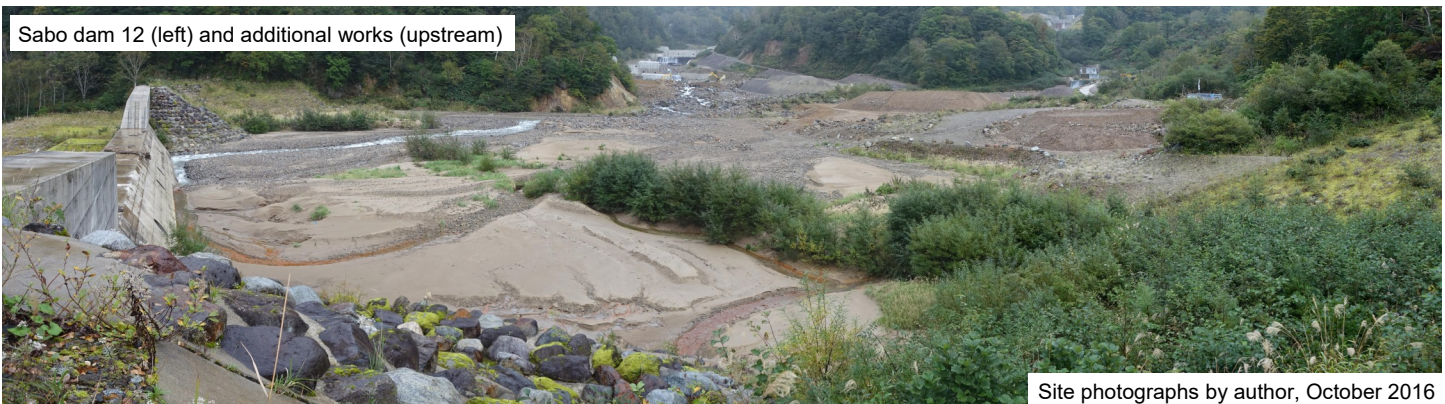
Shutter dam 14.5 m high, 120.5 m long crest, about 15,000 m<sup>3</sup> of concrete and 227,000 m<sup>3</sup> of storage. Shutter is intended to attenuate the dosing process (test case) - to be opened after peak and closed when the water level is back to normal. Optimized with physical models.

Sabo dam 12 17.5 m high. Regulations require that dams larger than 15 m are founded on bedrock. Not possible here, so foundation is grouted. Spacing determined by the extent of sediment deposition upstream of the lower dam, assuming 1/2 the natural bed slope.
