Appendix B

Chief Historical Rockfalls

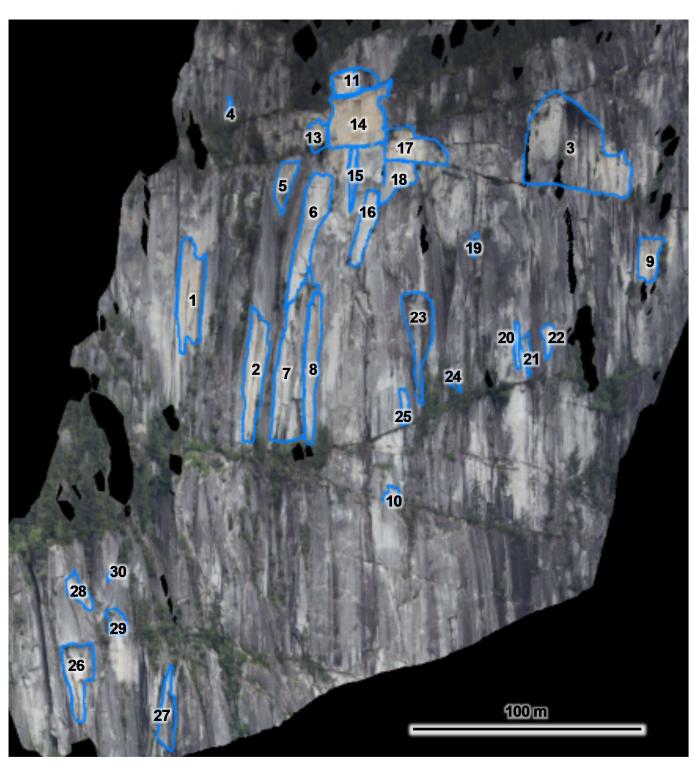
Figure B1: Key plan of identified rockfall scars on the North Wall of Stawamus Chief

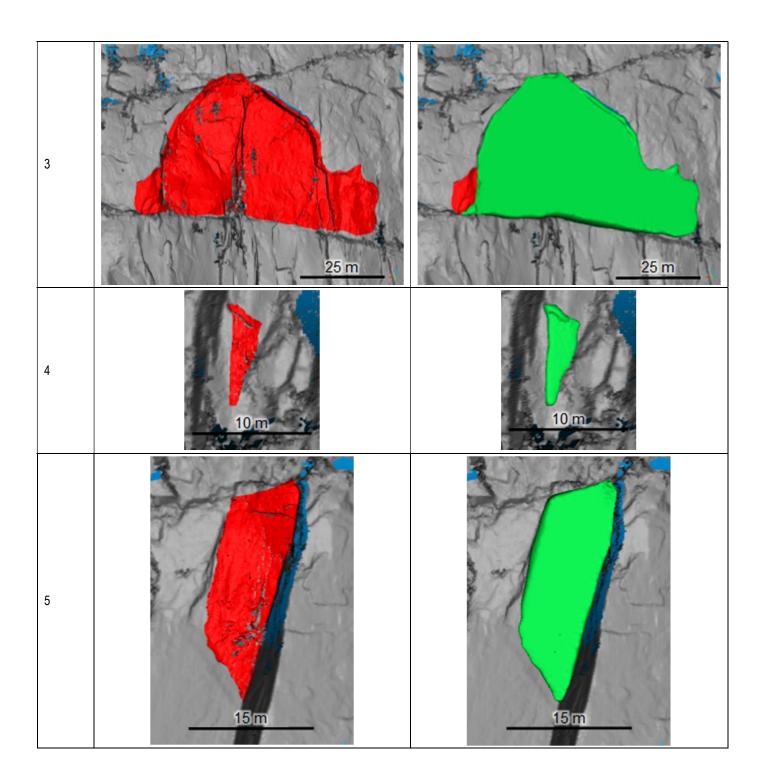
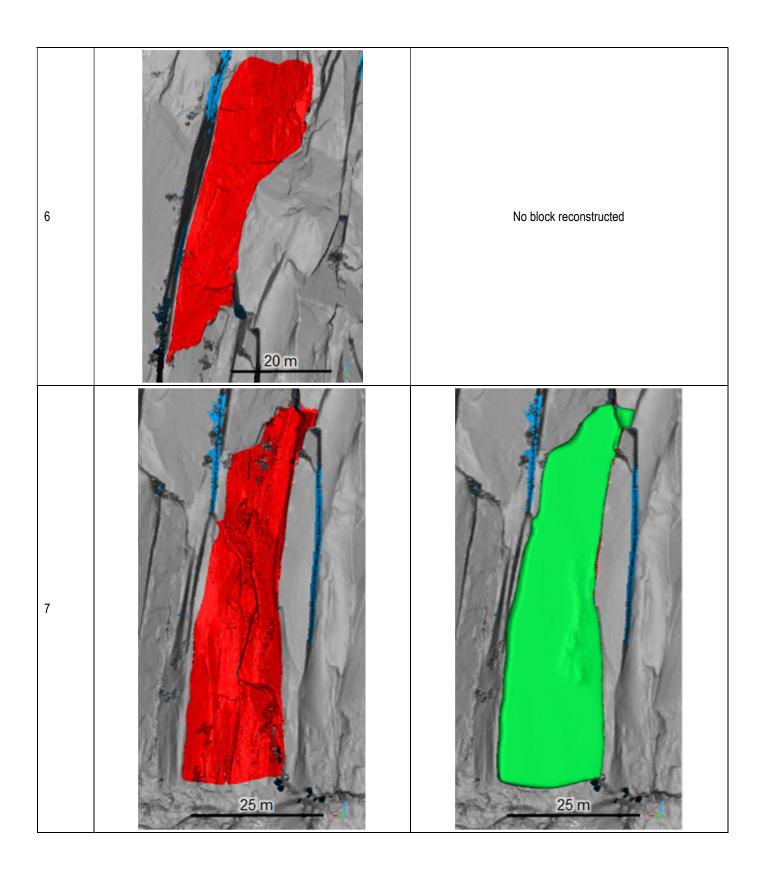
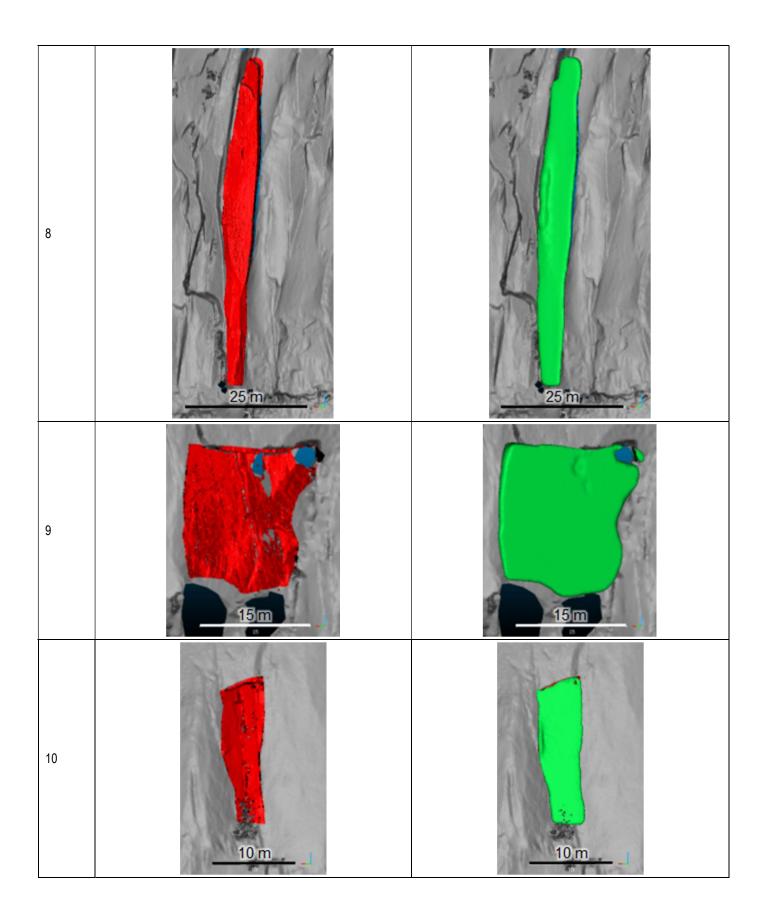
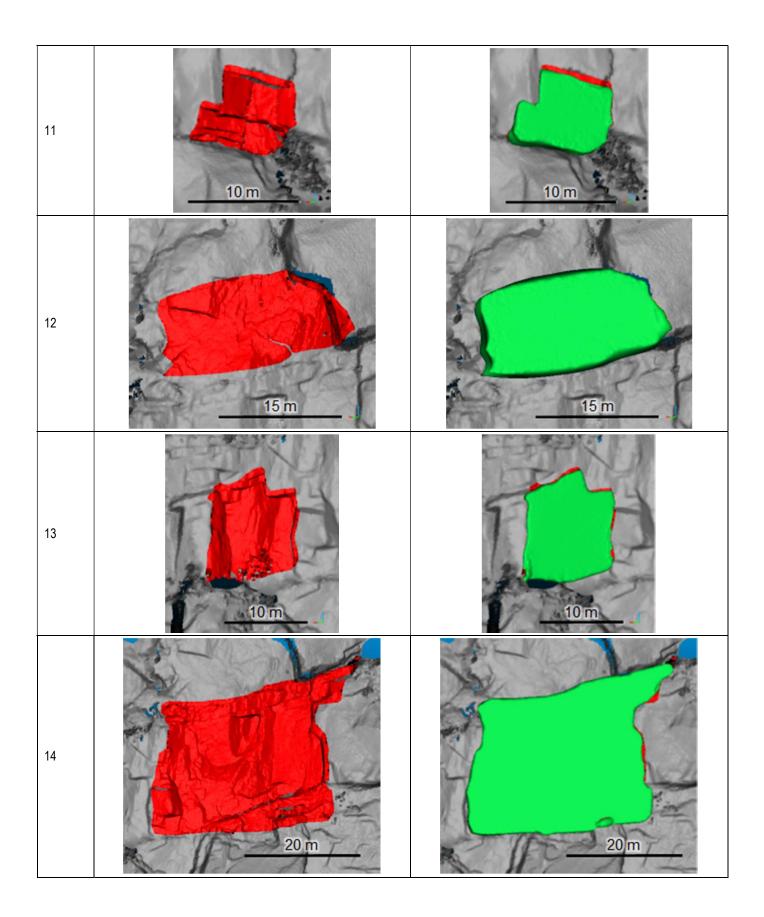
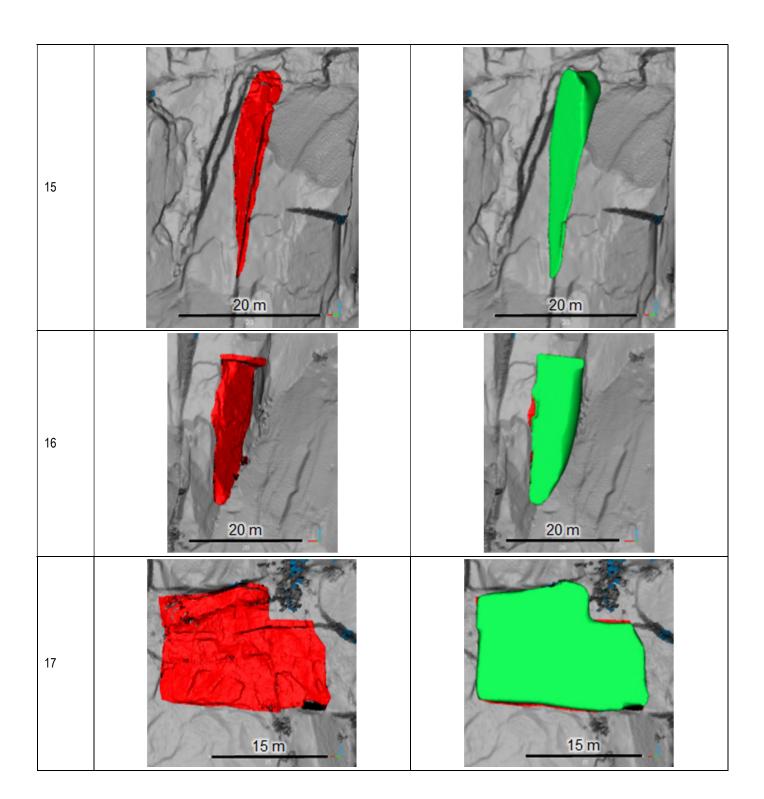
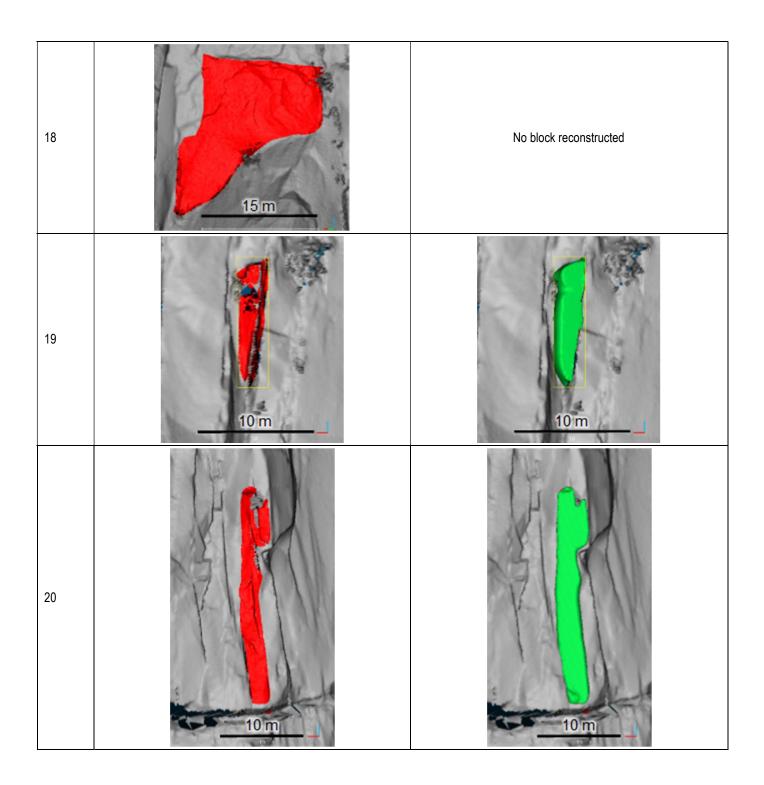
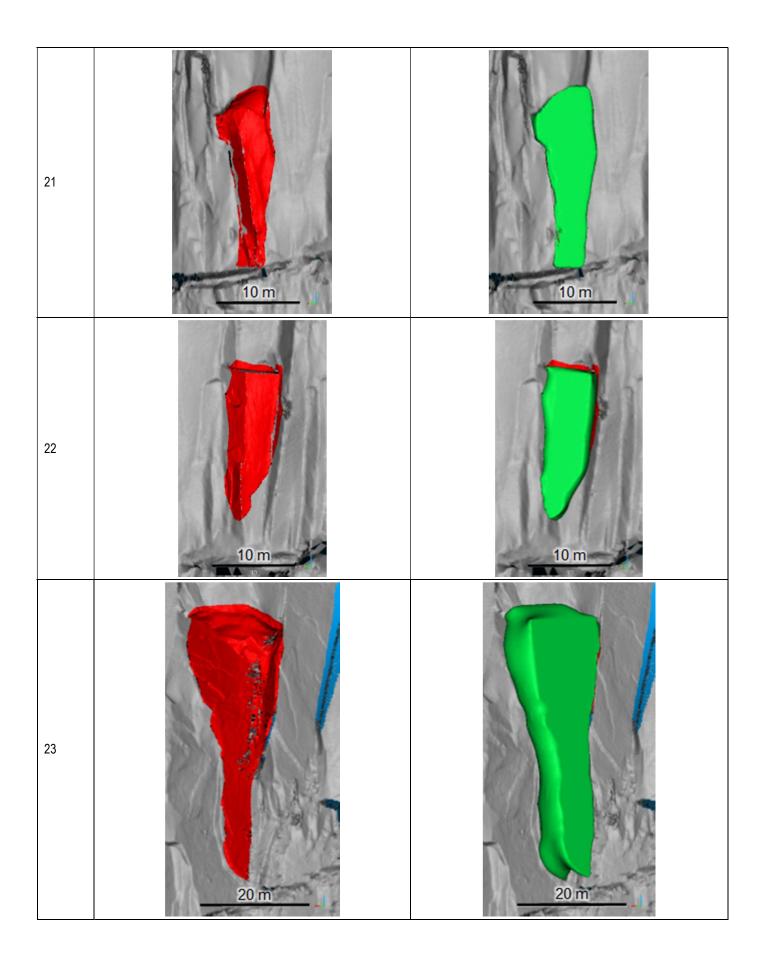
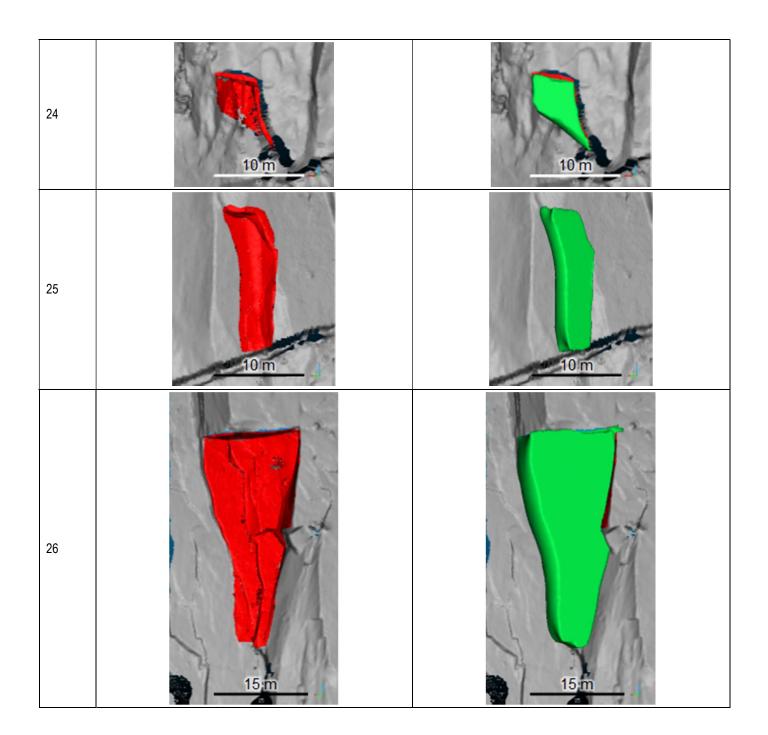
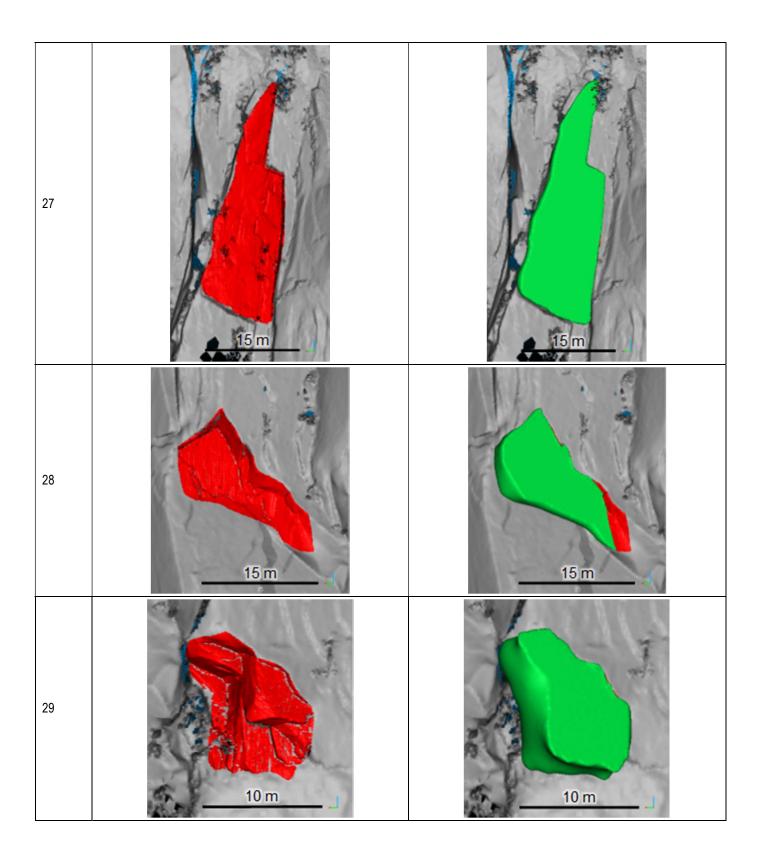
Table B1: Images of identified rockfall scar point clouds and reconstructed blocks

Rockfall number	Scar Surface	Reconstructed Block
1	20 m	20 m
2	20 m
