CHARACTER AND CAUSES OF CHANNEL CHANGES ON THE SQUAMISH RIVER,
SOUTHWESTERN BRITISH COLUMBIA

THESIS SUBMITTED IN PARTIAL FULFILLMENT OF
THE REQUIREMENTS FOR THE DEGREE OF
MASTER OF SCIENCE (GEOGRAPHY)
in the Department
of
Geography

SIMON FRASER UNIVERSITY

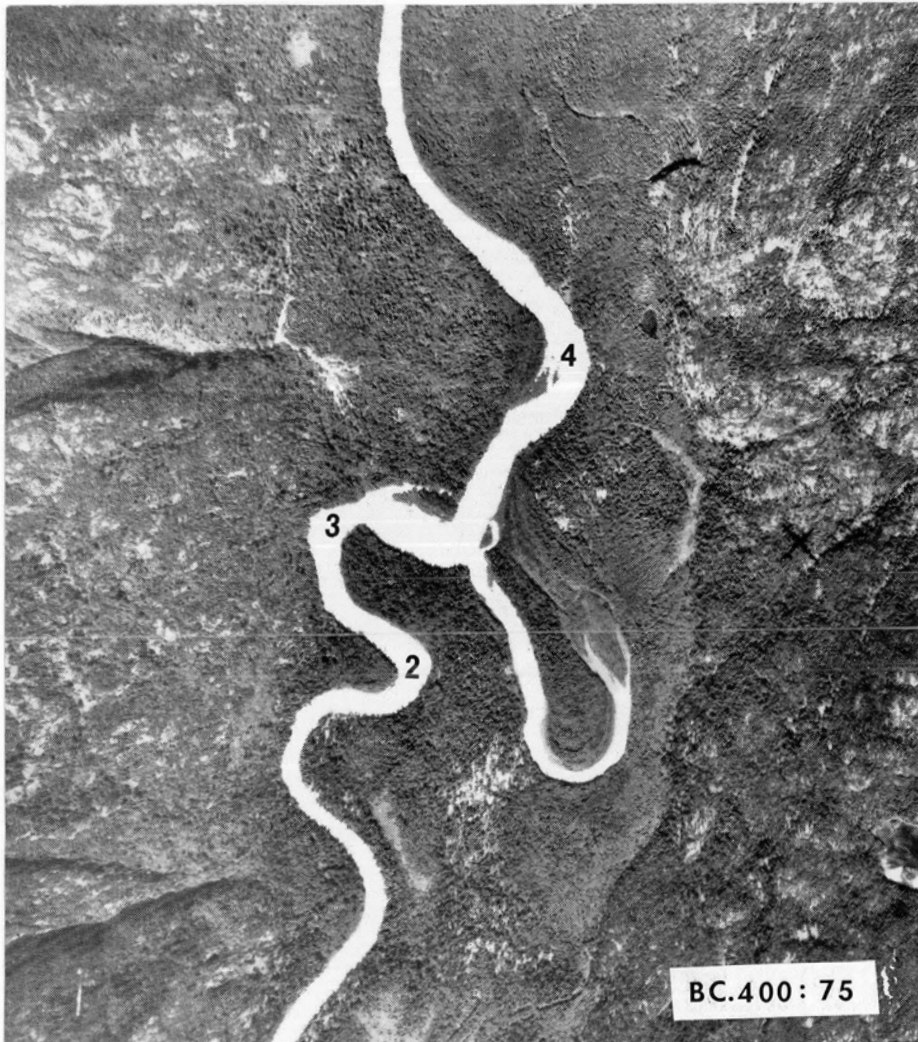
FIGURE 2.4

Aerial Photograph of Lower Meandering Reach in 1947

North is to the top of photograph. Numbers represent studied bends.

The meandering reach of the Squamish River is located between the braided reach on the upstream and the straight reach on the downstream end of the river (Figures 2.4 and 2.5). This reach was selected for study mainly to assess the character of channel changes in the confined and freely migrating meander bends. The elevation of the valley floor of the meandering reach is between about 50 and 80 m above sea level.

Channel changes in the Lower Meandering Reach of Squamish River include the cutoff of an old meander loop prior to 1947 as Figure 2.4 shows. This might have happened in the late 1930's or 1940 when there was a major flood. In the period 1947 to 1984 major channel changes in this reach have been characterized by downstream migration of meander Bends 2 and 3, largely due to erosion of the upstream ends of convex banks and downward migration of the concave bank in bend 2. Bend 3 is an example of a confined bend due to the existence of bed rock or 'hard

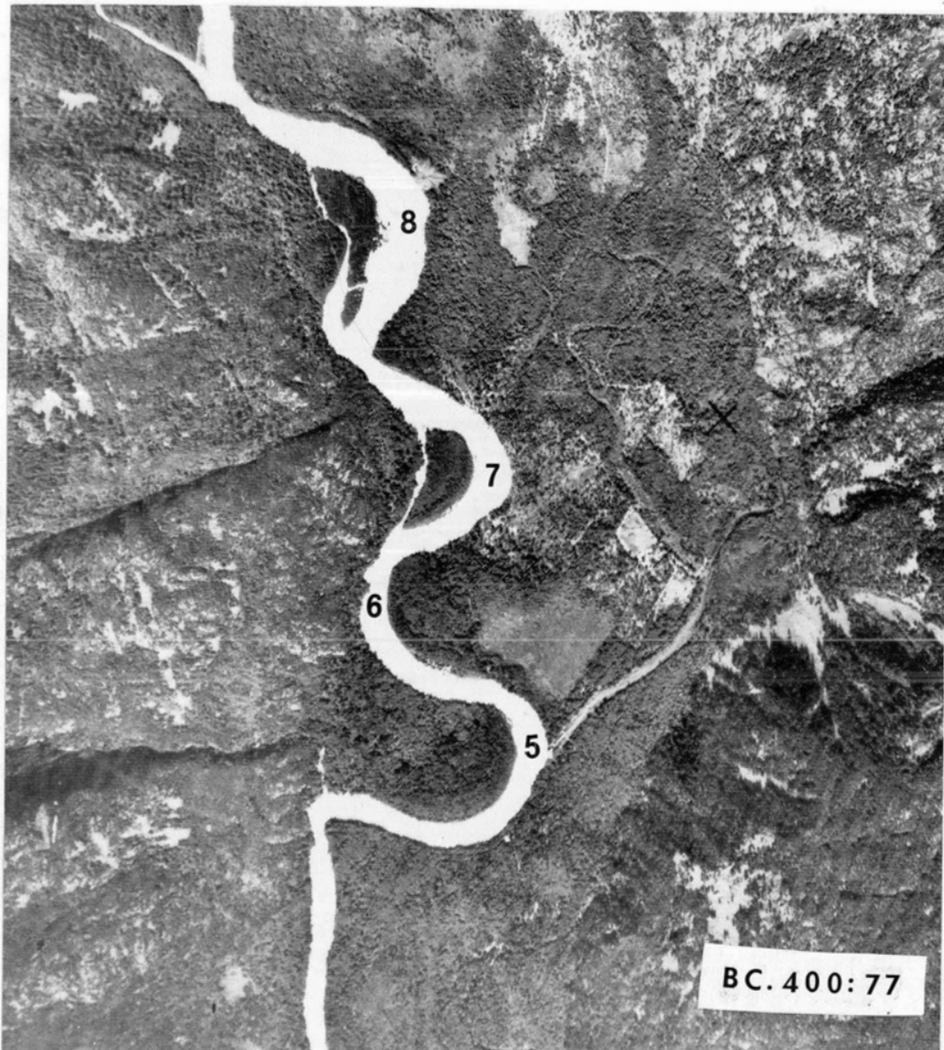
FIGURE 2.5

Aerial Photograph of Upper Meandering Reach in 1947

North is to the top of photograph. Numbers represent studied bends.

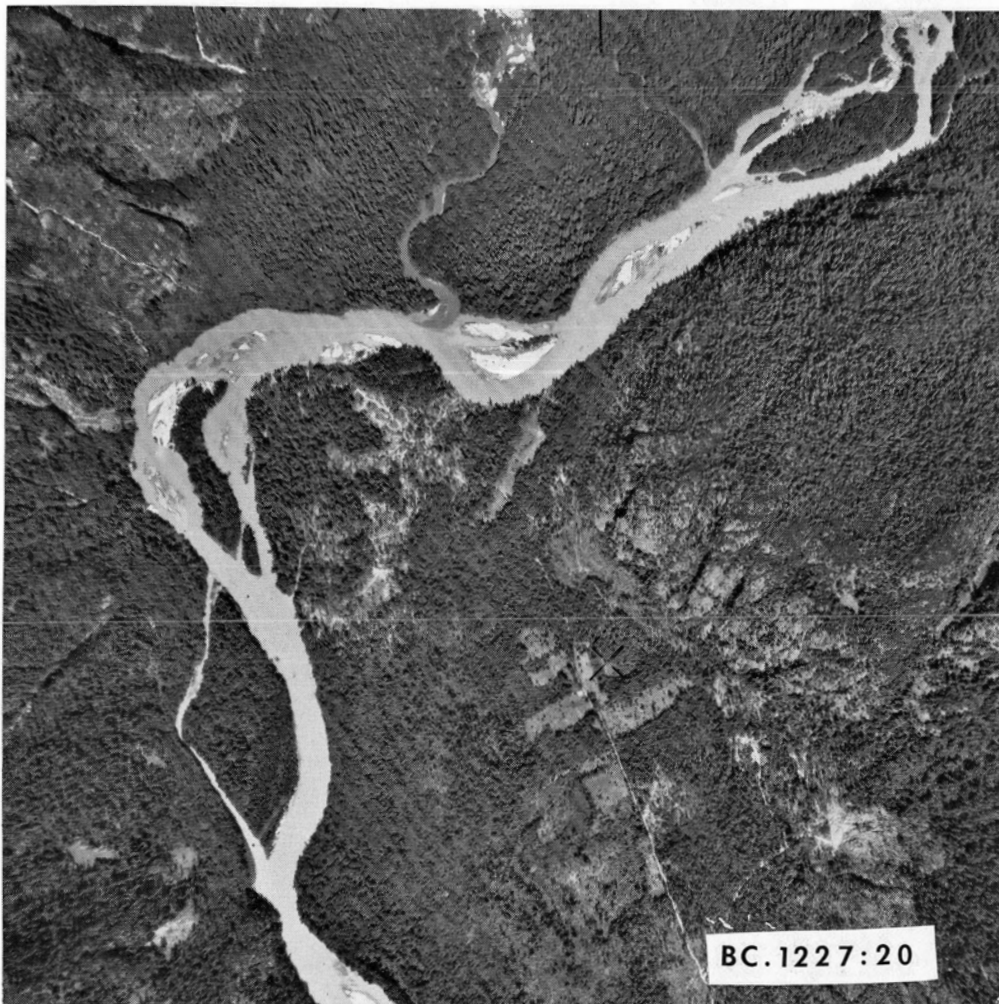
FIGURE 2.6

Aerial Photograph of Squamish-Ashlu Bend Reach in 1951

North is to the top of photograph. Numbers represent studied bends.

This reach is located in the transition zone between the braided and meandering planform types where the Squamish River joins the Ashlu River (Figure 2.6). The valley floor of the Squamish-Ashlu bend reach lies between about 80 and 120 m above sea level. This reach was selected for study because of the need to assess relative stability of bars and islands in the maintenance of the transition zone.

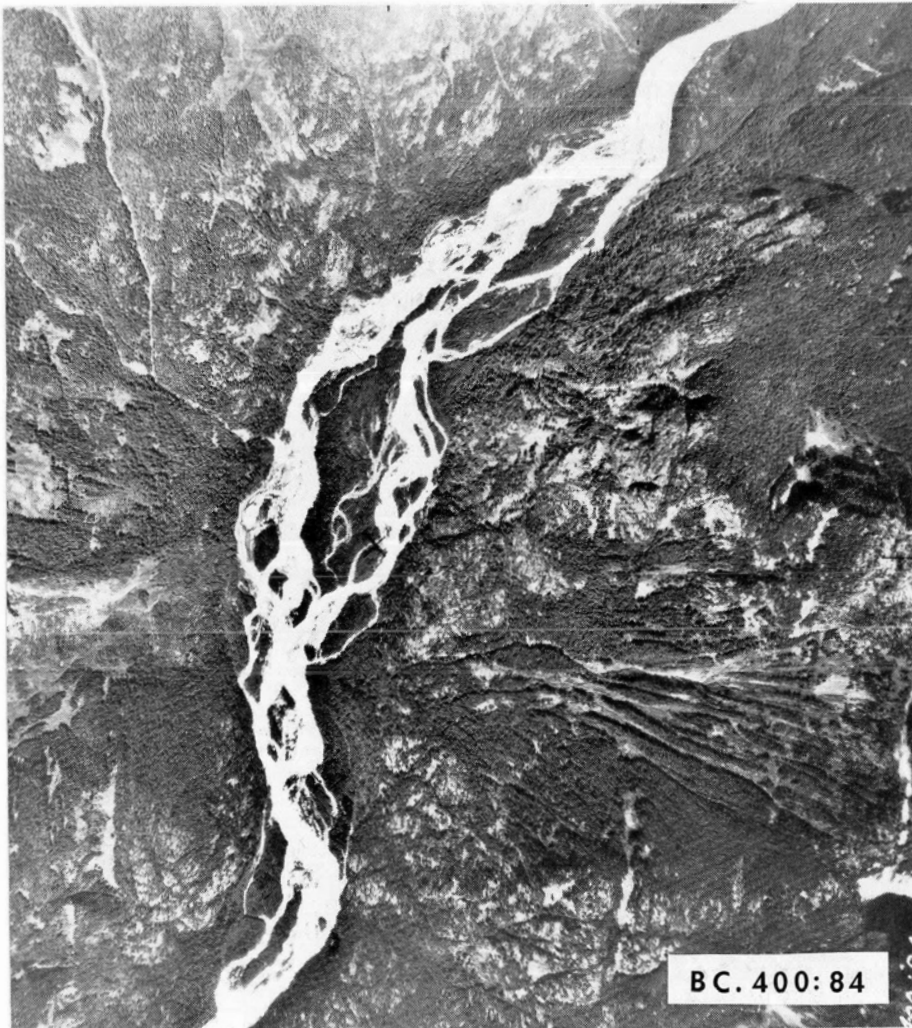
FIGURE 2.7

Aerial Photograph of Braided Reach in 1947

North is to the top of photograph.

The braided reach stretches downstream for about 20 km to the south from Turbid Creek at the head of Squamish River lying north of the 50 degree line of latitude. Located within the headwaters region the elevation of the valley floor of this reach is between 300 and 400 m above sea level. This reach was selected for study because of its distinctively braided planform (Figure 2.7).

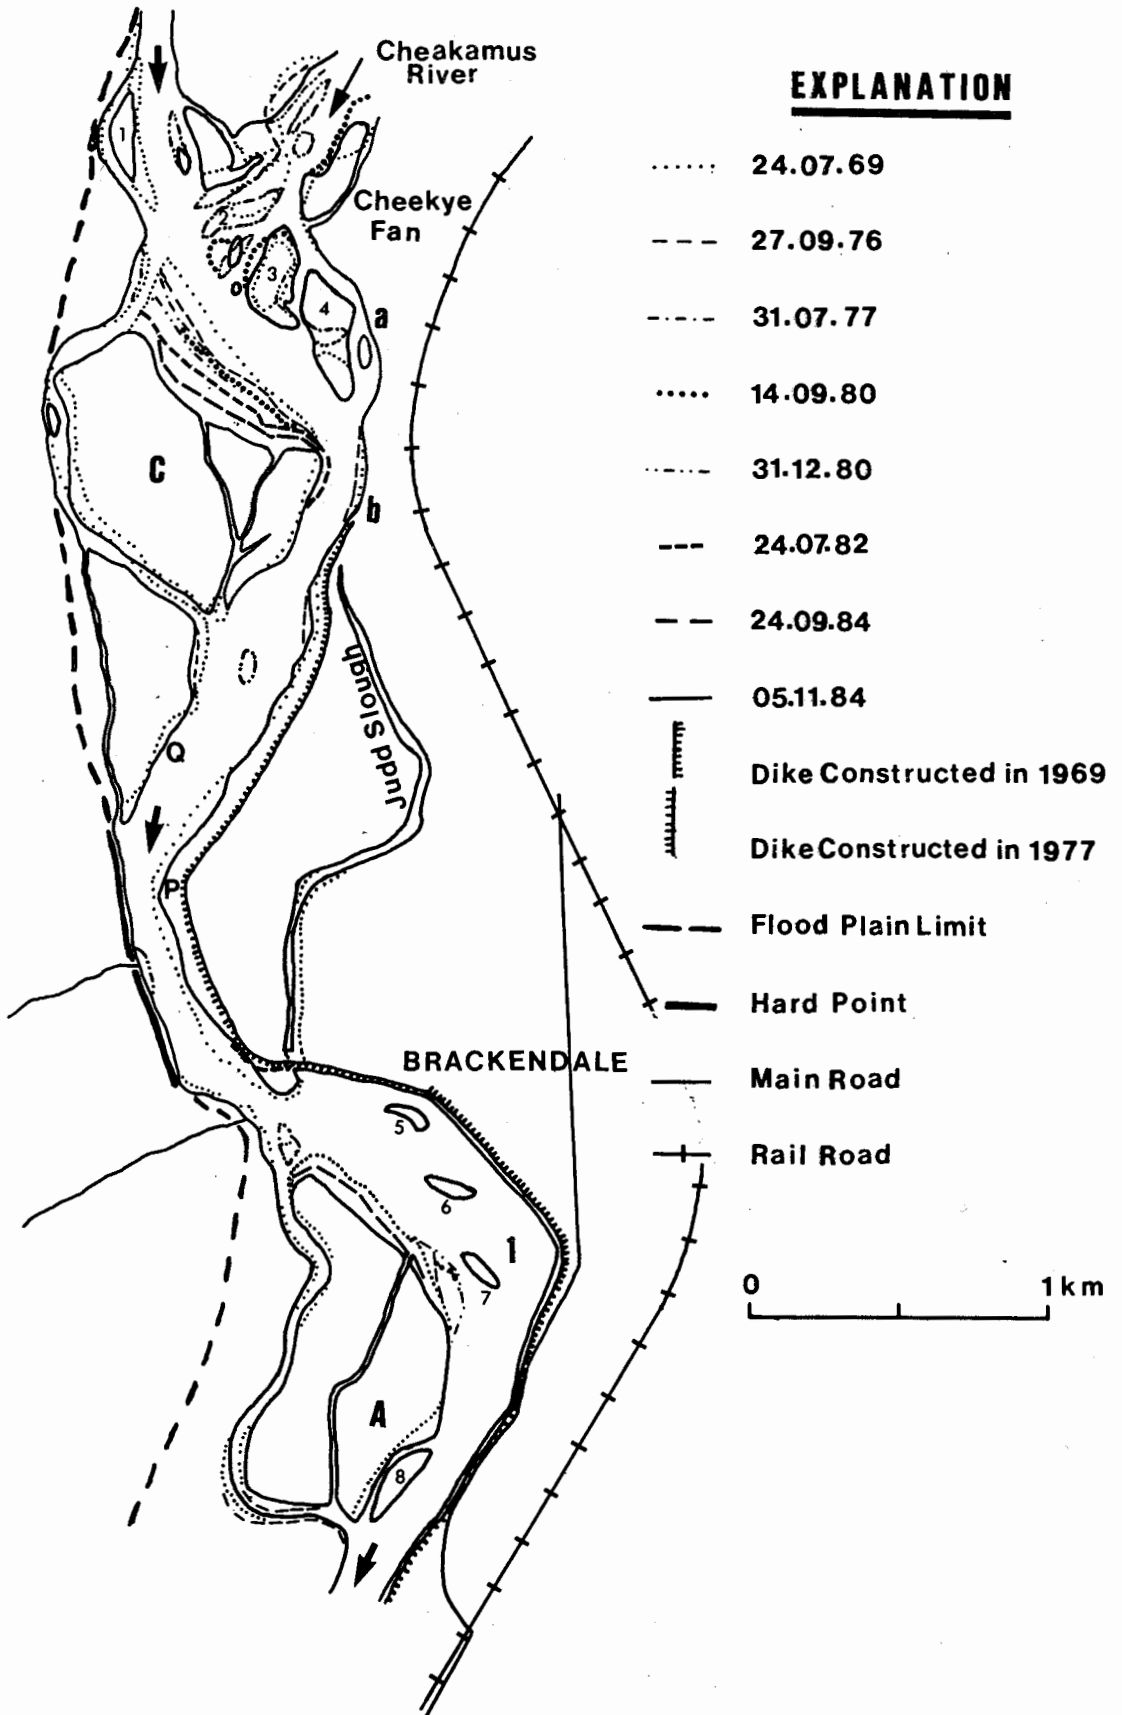
FIG.4.2

CHANNEL CHANGES IN CHEAKAMUS-MAMQUAM REACH
FROM 1969 TO 1984

Considerable lateral channel migration occurred at site (P) and (Q) and along the concave bank of Brackendale Bend (1) from 1947 to 1969 as Figures 4.1 and 4.2 show. Among other factors the migration of Brackendale bend (1) is explained in part by exceptionally high deposition of gravel sediments around Brackendale Island (A) and its subsequent development due to vegetation growth. The likely source of these sediments is the head of Baynes Island (C) which suffered tremendous bank erosion during the same period and erosion of the Cheekye Fan in the 1950's.

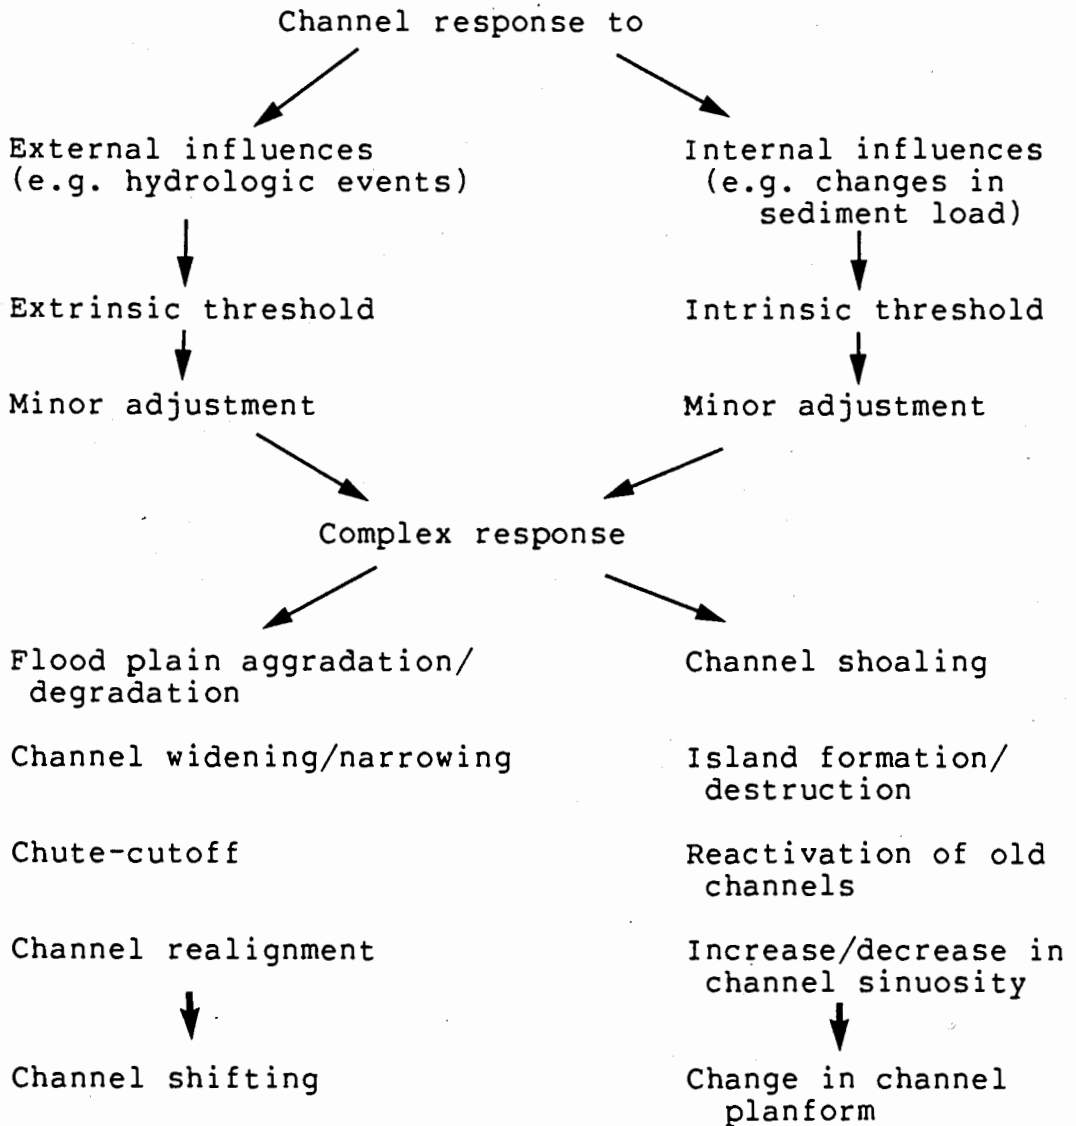
FIGURE 5.7

An Idealized Explanatory Model of Types of Channel Change*

* Model is an extension of Schumm's (1977; Fig. 9.1; p. 323) types of landform response to change.

reach would experience channel shifting in the period of such adjustment. On the other hand, if dominant types of change comprise channel shoaling, island formation or destruction, reactivation of old channels, increase or decrease in channel sinuosity; the river or subreach would experience change in planform type in the period of such adjustment. There is no specific order of channel adjustment and no final stage of channel changes is conceived since channels are in constant adjustment with changing hydrologic and morphologic conditions.
